# Fix an iPhone XS with no service

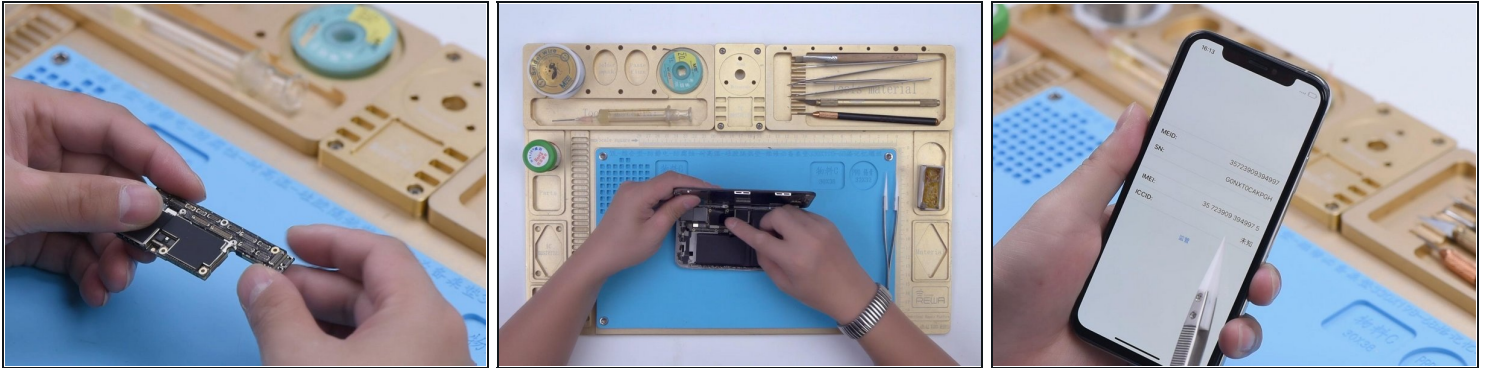
- The phone had no service after being dropped and couldn't be activated after a system upgrade. Firstly, inspect the appearance of the motherboard. The motherboard is not deformed or water damaged.
- Then we install the motherboard on the phone to test. Connect the display and battery. Insert the SIM card. The phone can be turned on. However, the ICCID is not showing, which indicates that the SIM card is not read.

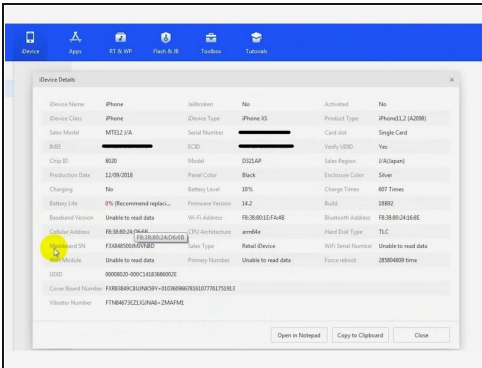
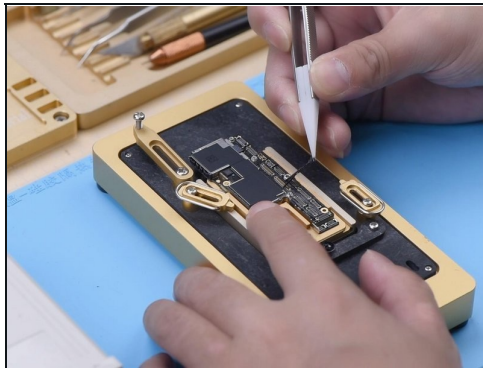
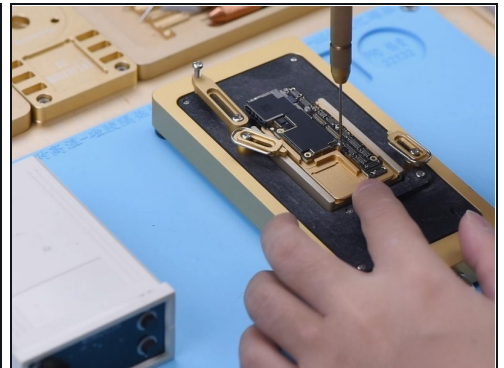
- Connect the phone to the computer. Open 3uTools and view device details. 3uTools is unable to read data of the baseband version and Wi-Fi module.
- Because the phone had no service after being dropped. It can be preliminarily judged that the pseudo-soldering of the middle layer may cause the trouble. Next, we need to separate the motherboard. Put the motherboard on the Heating Platform and peel off the foam.
- To make it easier to remove the logic board after separation, drive a screw on the logic board. Cut through the tape with a sculpture knife.

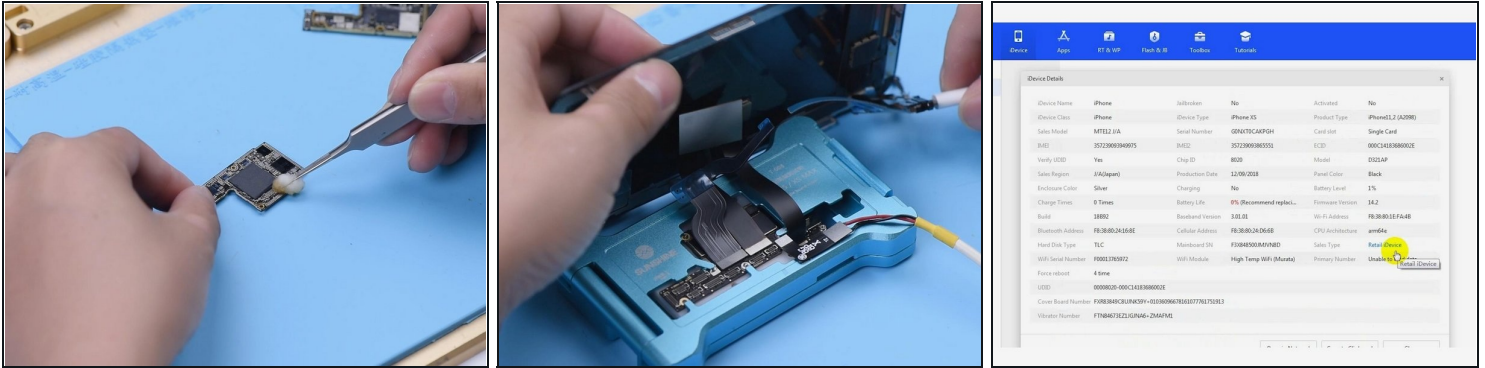
- Clean the logic board with PCB Cleaner and remove the screw. Clean the signal board with PCB Cleaner.
- Attach the signal board and logic board to the Testing Fixture. Connect the screen to the motherboard with a Test Extension Cable. Connect the charging port flex cable and power cable. Then turn the phone on by connecting it with the computer.
- Open 3uTools and view device details. The baseband version and Wi-Fi module can be read. It can be confirmed that the pseudo soldering causes the absence of the baseband version.

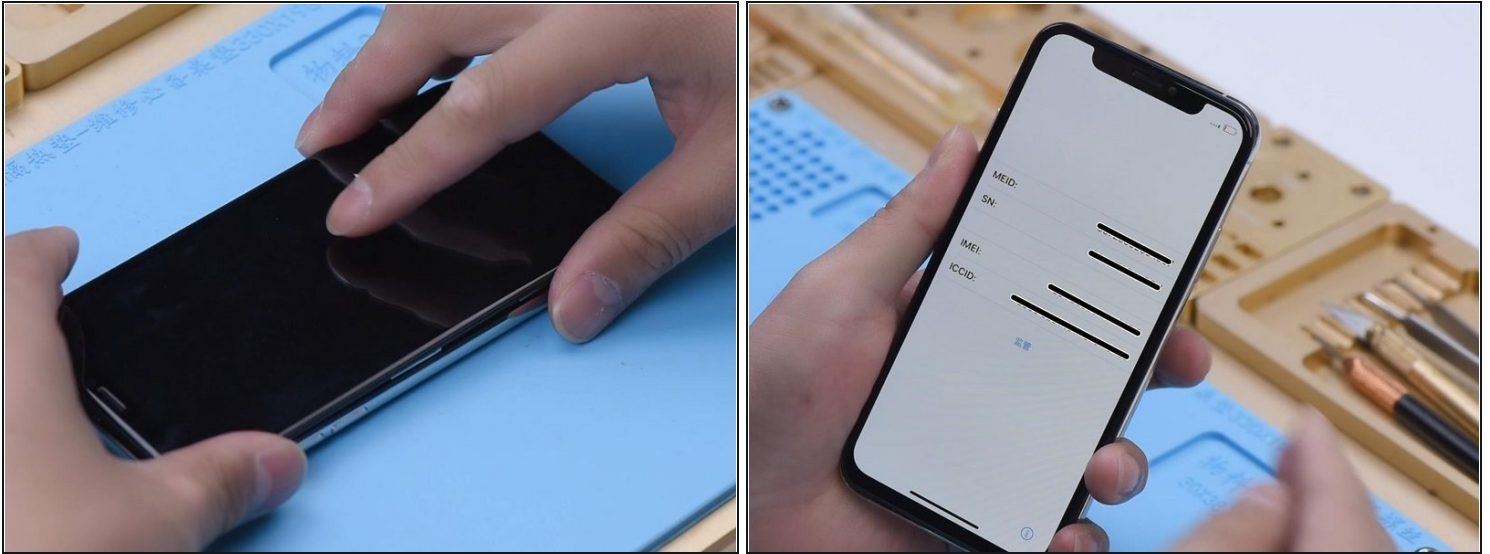
- After recombination, install the motherboard on the phone. The phone can be turned on. Insert the SIM card. ICCID is showing. Because the phone has a network lock and we don't have a SIM card of the carrier. No further tests can be conducted.

The iPhone XS had no service after being dropped. 3uTools couldn't read the baseband version when we connected the phone to the computer. Through motherboard separation and testing the phone on the testing fixture, we confirmed that the no service trouble was caused by the pseudo soldering of the motherboard middle layer. ICCID came back to normal and the fault was cleared after we recombined the logic board and signal board.
