2010 Mazda 5 How to Troubleshoot Oxygen Sensor

One year after replacing the rear oxygen sensor...

Written By: LarsWH

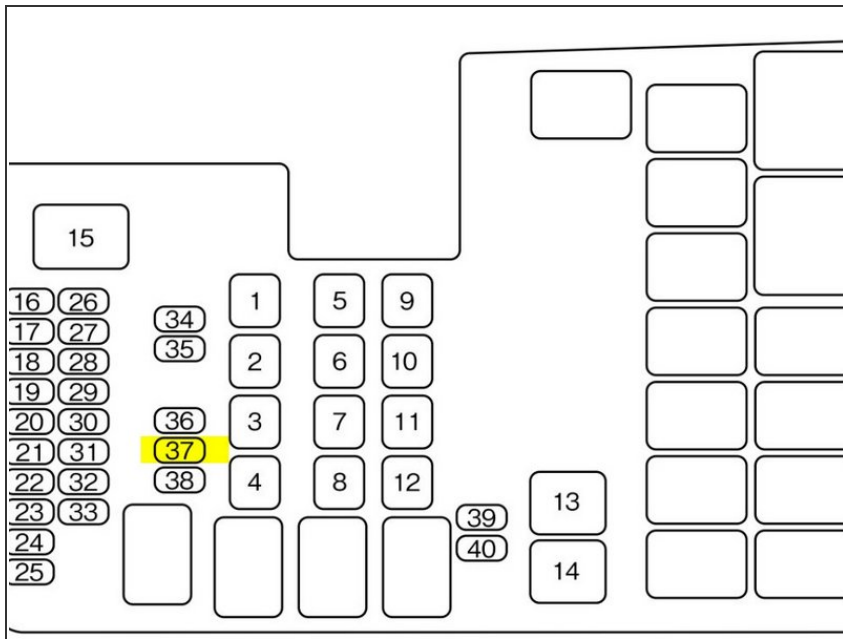
Step 1 — Fuse box check

As the device was fairly new, I suspected it was something else. Clearing the fault code while the engine was warm, seemed to work, so I suspected the built-in heat element was not working. However the fuse #37 was OK (see <https://www.autogenius.info/mazda-5-2007...>)

- Check the fuse for the pre-heating of the oxygen sensor (in this case #37)

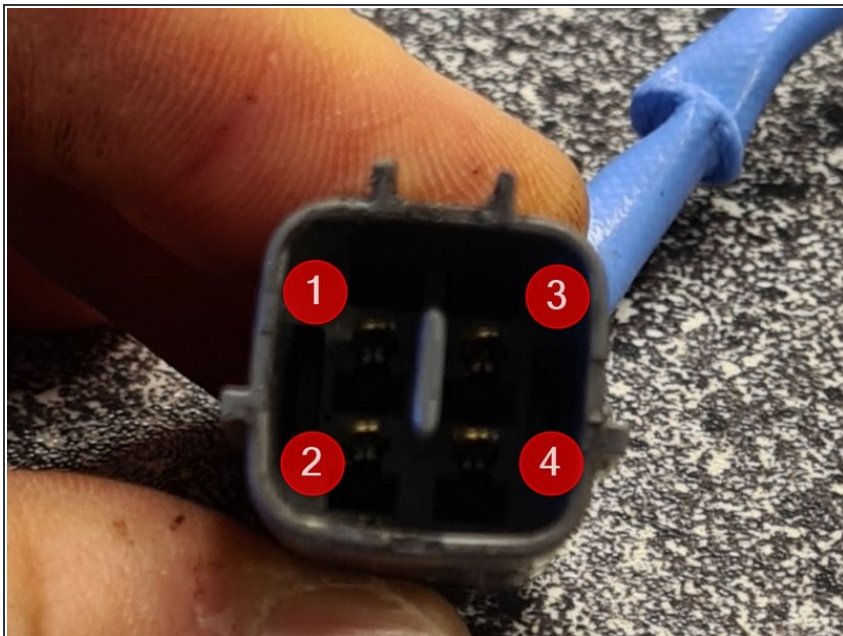
Step 2 — Enumerate pins

- Unplug the sensor and decide on a numbering scheme. Also clean the pins to ensure this is not a connection problem

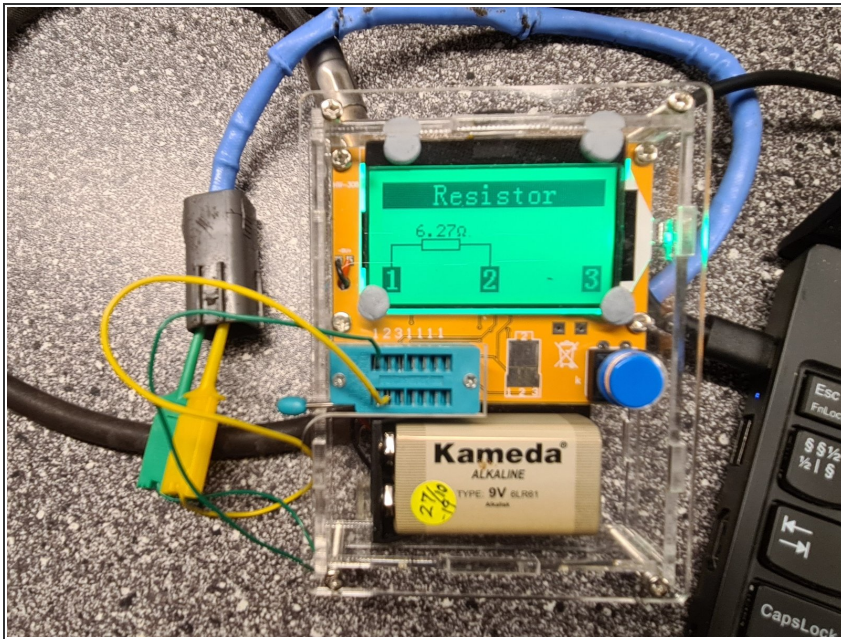
Step 3 — Measure

Pins	New sensor	Old defect sensor
1-2	5.06 Ohm	6.2 Ohm
1-3	48 pF	6.5 Ohm
1-4	49 pF	52 kOhm
2-3	46 pF	0.9 Ohm
2-4	49 pF	53 kOhm
3-4	46 pF	53 kOhm

As you can see from the table above, there clearly is a difference in the behaviour of the new and the old device.

- Check all combinations of the pins of problematic sensor. See comparison chart above (with the new replacement sensor).
- If you do not have such a tester, a normal multimeter (resistance and capacitance) should be sufficient
- If you would like a transistor tester, you can search Aliexpress for one. It is an amazing little device.

- Pin 1-2 is the pre-heating element, and should show around 5-6 Ohm (meaning that the pre-heating must be using around 60W)
- All other combinations of pins should show a capacitance around 50 pF

There is a clear difference in the measurements when comparing the defect part and the new replacement part.

I installed the new device and followed the instructions:

- clear the error codes
- disconnect the car battery for some minutes
- take the car for a 10 minute drive
