BCG800XL Grinder Jamming due to Worn Impeller

This guide will walk through replacing the impeller to fix the most common cause of jamming with the Breville BCG800XL and BCG800 Smart Grinder.

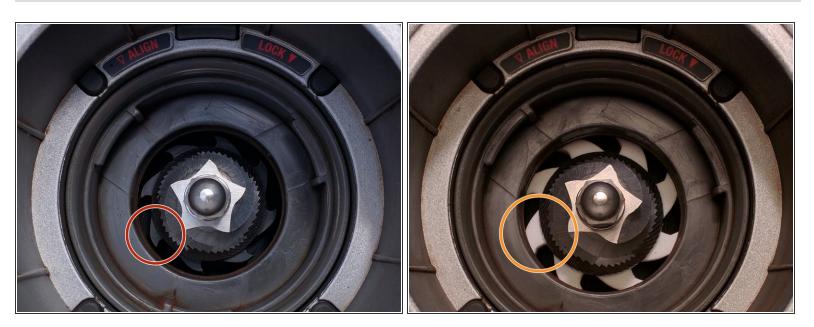
Step 1 — Inspect your grinder impeller

- Unplug your grinder before completing this repair to avoid electric shock.
- Remove the hopper and take the upper burrs out. Empty out any coffee grounds (An air gun or vacuum helps) and then inspect the impeller blades.
- If the impeller can fit through the hole (ie: be removed just by taking out the lower burr) then it definitely needs replacement.
- A good impeller should not be removable without dis-assembly and the tips of the impeller blades should not be visible.
- if your impeller is made of **stainless steel** rather than plastic you likely have a newer model with significant design changes (eg: BCG820). Stainless steel should not wear out and so your problem is elsewhere.

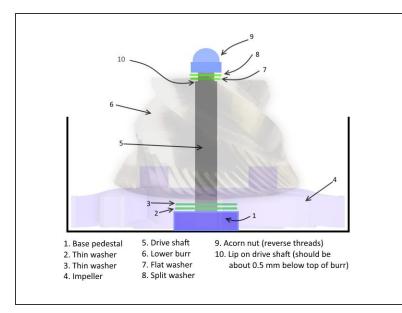
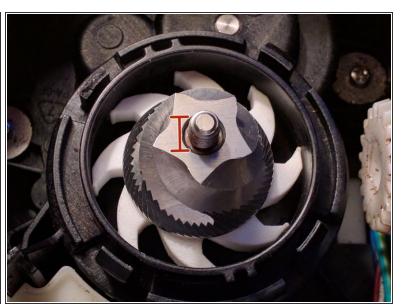
Step 12 — Checking Fit and Burr Elevation

- Before reassembly, check that the conical lower burr and impeller fit well onto the driveshaft with both steel washers underneath. Make sure all parts in the cutaway diagram are accounted for.
- The lip on the drive shaft should be within about 0.5mm of the top surface of the conical burr.
 When the nut is tightened it will squish to about flush.
- If the burr is too high above the lip on the shaft (higher than in the pic), try putting the acorn nut + washers on (See 7, 8, 9 in the pic), tightening hard, and then taking it back off.
- If the lower burr is still sitting too high on the shaft, take a quick detour to <u>Step 20</u> and then come back.

- TOO CLOSE (ie: grinding too fine): If the burrs are too close, or even touching (but centered), the nut on the lower burr may not be tight enough. With the ratchet and 10mm socket, give it a quick counter-clockwise jerk. If that fails, recheck your fit-up against the second photo to make sure the lower conical burr is the proper height.

- If it's clear that the lower burr is sitting too high on the impeller, see the 3rd picture and sand the area highlighted in RED. While doing this, periodically install and re-check the lower burr height until it matches photo #2. Careful not to sand off too much as it's easy to remove thickness but hard to add it back.

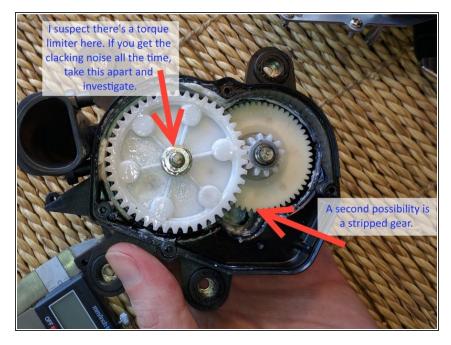
Step 21 — Troubleshooting #3: Horrible clacking sound when running (Even without beans!)

- If it sounds horrible when running (even without coffee beans) like this: https://www.youtube.com/watch?
 v=PcQcbHIP...
 then it's probably either a damaged torque limiter or a stripped drive gear. FYI: The situation in the video was the aftermath of a rock getting jammed in the burrs.

- I don't cover tear down all the way to the gear box. Step #9 is as close as I go. In the photo though there are 4 washer screws and 2 screws on the encoder. If you remove those you'll be well on your way to investigating the gear box.

- The options to fix either of these are not as well explored, so if there is damage here and you fix it successfully, post a comment below. FYI: Breville has a repair service for about \$90 and that may still be the best option in this situation.

- The torque limiter may be "fixable" by stretching each of the radiallydistributed springs about 2mm each. This should increase the torque at which it slips.

The drive gear on the right has a potential source found by a user below (Thanks Dave Gordon!): http://www.forumappliances.com/breville-... This is not yet verified to work, but the price is reasonable, so if you try it out and it works, post below so we can know!

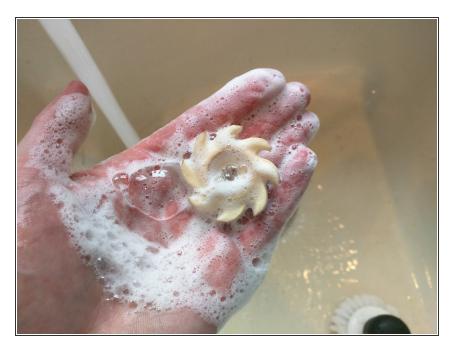
Step 22 — Troubleshooting #4: Static Electrical Charge on Coffee Grounds

- Occasionally a user reports statically charged coffee grounds coming out that seems to defy the laws of gravity. They float up into the air and cling to things, making a mess!
- Often it will stop on its own after the impeller gets a few days of use. It's a bit of a mystery however, I believe the issue arises mainly in dry climates, with certain beans in combination with the plastic impeller.
- To fix the issue, simply give your impeller a scrub and rinse in the sink and then pat it down with a towel until dry.
- This slight bit of moisture seems to take care of static issues permanently. I suspect it gets us by until the impeller builds up a natural coat of coffee, which also serves to prevent static charge.
- See also: https://www.youtube.com/watch? v=T0Dh1W40...

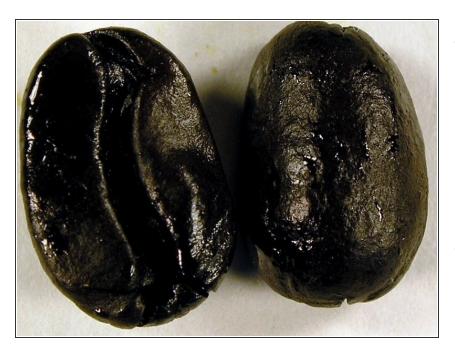
Step 23 — Troubleshooting #5: Clumpy Grounds or Little to Nothing Coming Out

- Some beans, especially the "roasted so dark it's nearly charcoal" variety can be way too oily. The characteristic is that rather than grind to a powder it turns to "paste" in the lower chamber. This is obviously bad, because it then comes out in clumps or not at all.
- Clumpy grounds, for some reason tend to overshoot the portafilter and make a mess. I suspect this is because the large clump size has more mass, and comes out of the chute with too much momentum.
- If you pull the upper burr, and see what looks like a nice smooth black surface where the impeller would normally be, then that's your sign.
- The Fix: Clean the lower chamber, or at least break up the cake of grounds, and switch to a less oily roast.
