How to Lenovo Tab 2 A7-10 Error: PMT changed for this ROM it must be downloaded - solution

Written By: ZFix

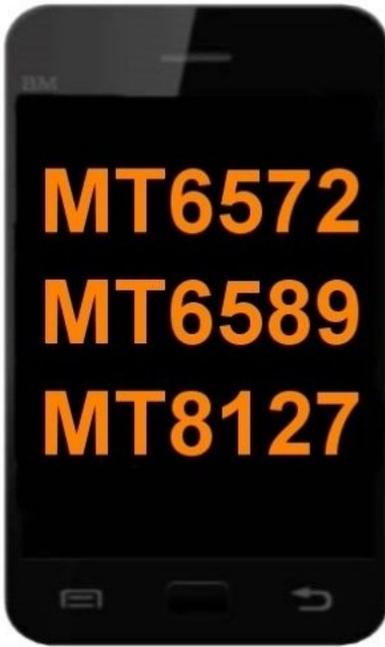
PMT changed for the ROM

Sometimes when you try flashing stock firmware via SP Flash Tool you get the error. How to fix it.

Fixing PMT Changed for the rom

- In SP Flash Tool interface, click Format tab
- Select Format whole flash except Bootloader click Start and reconnect the device.
- When the format procedure finished, go back to to Download tab
- Load scatter file of the firmware you wish to flash click Download and reconnect the device.
