# Philips steam ironing station GC9640 solenoid valve coil replacement

Written By: John Maier

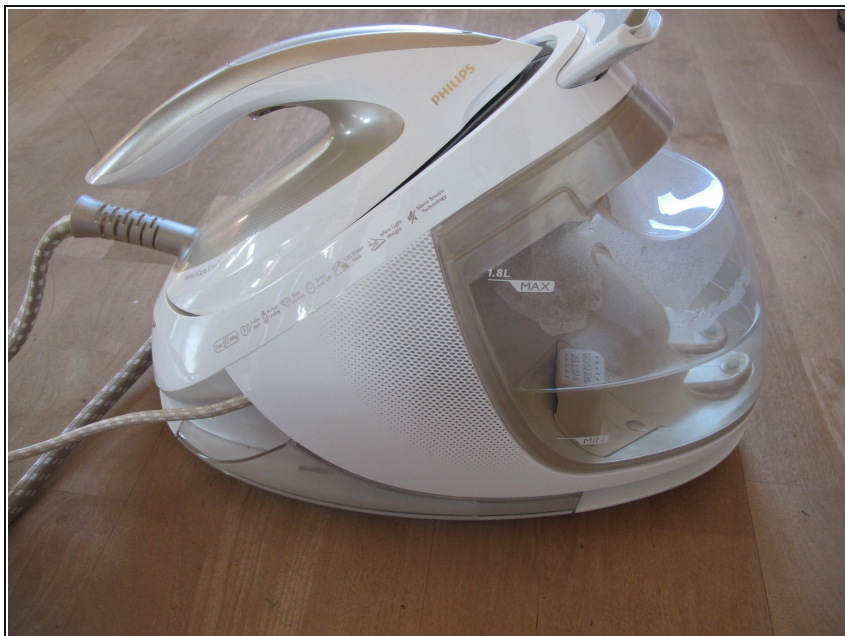
## Step 1 — Preparation

- Pull out the plug. If necessary, allow the device to cool down for 10 minutes. Remove the water tank. Place the iron on a suitable surface.

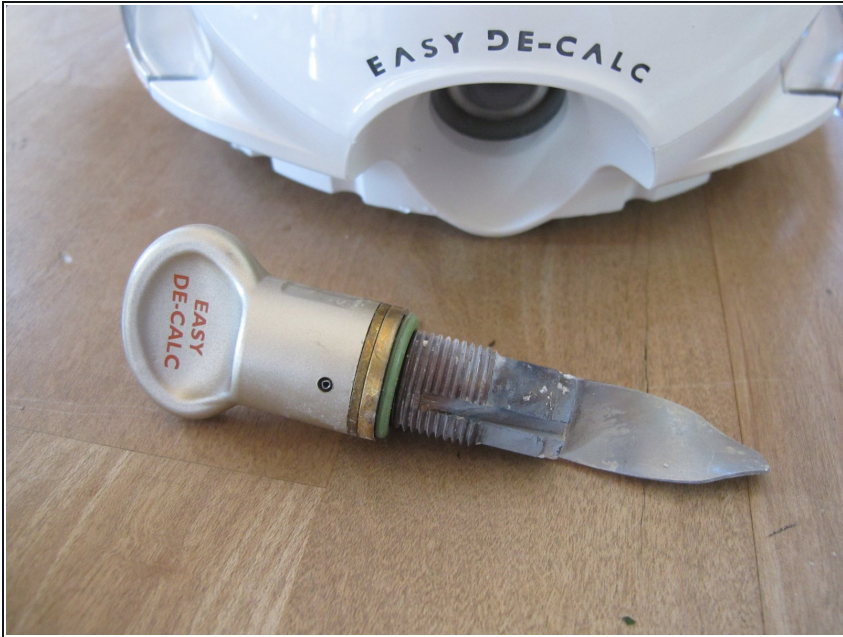
## Step 2 — Empty the steam boiler

- Place a suitable container to catch the water.
- Unscrew the stopper plug counterclockwise and set it aside.
