Replacing Coffee Spout Manifold on Nivona Caferomatica 770

Replacement of the Coffee Spout Manifold on the Nivona Caferomatica 770

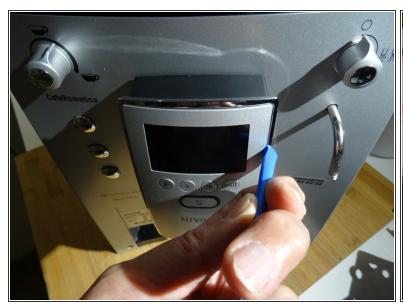
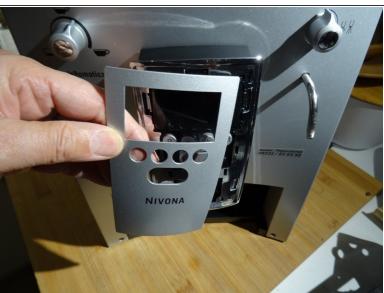
Step 1 — Coffee Spout Manifold

Remove the plastic plate with the 'Nivona' label carefully with a plastic opening tool.

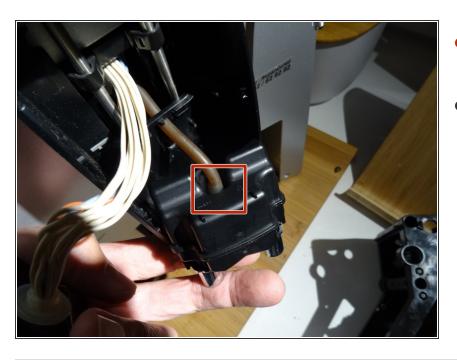
Step 6

- Pull the silicone hose off the coffee spout.
- The coffee spout is disconnected.
