# Replacing Coffee Spout Manifold on Melitta Caffeo Solo

Written By: VauWeh

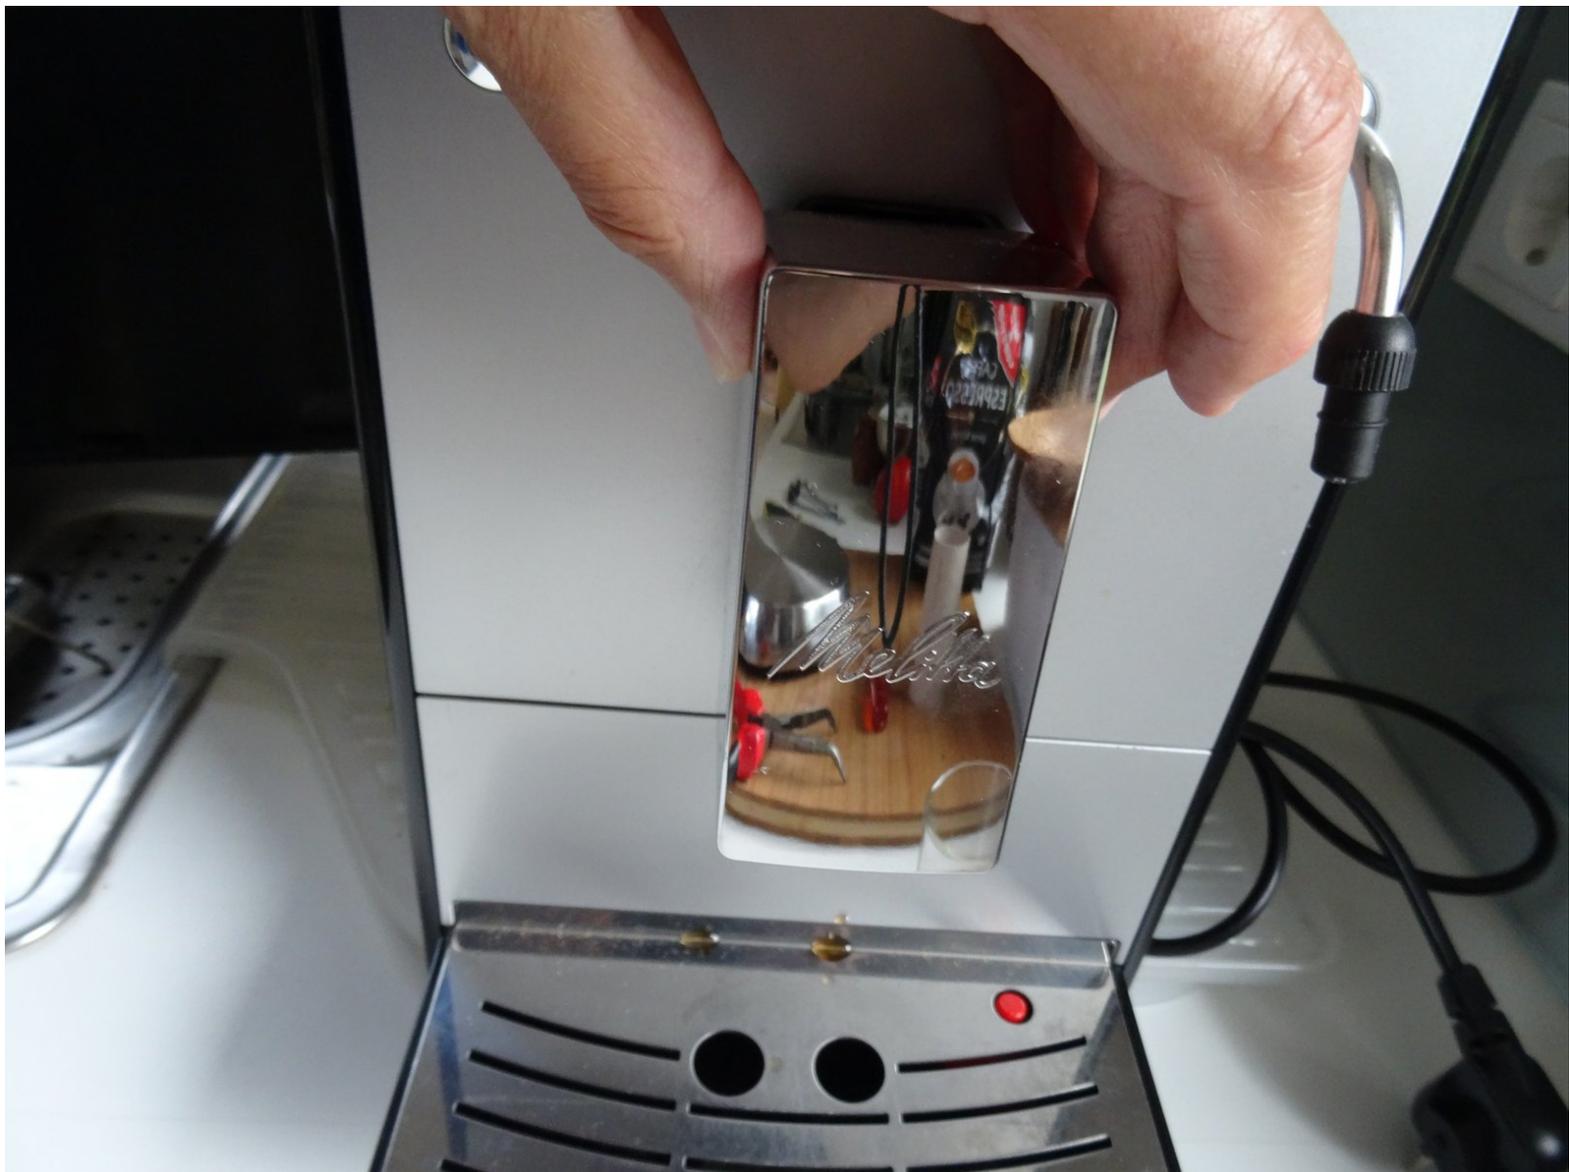
When the Coffee Spout Manifold is clogged with f. E. coffee fat, then the coffee only comes out in spurts, often out of only one of the two jets. The Spout Manifold is a sealed-off compartment with venting valves, which doesn't open and is hard to clean. The replacement part doesn't cost much and the replacement is fairly easy.

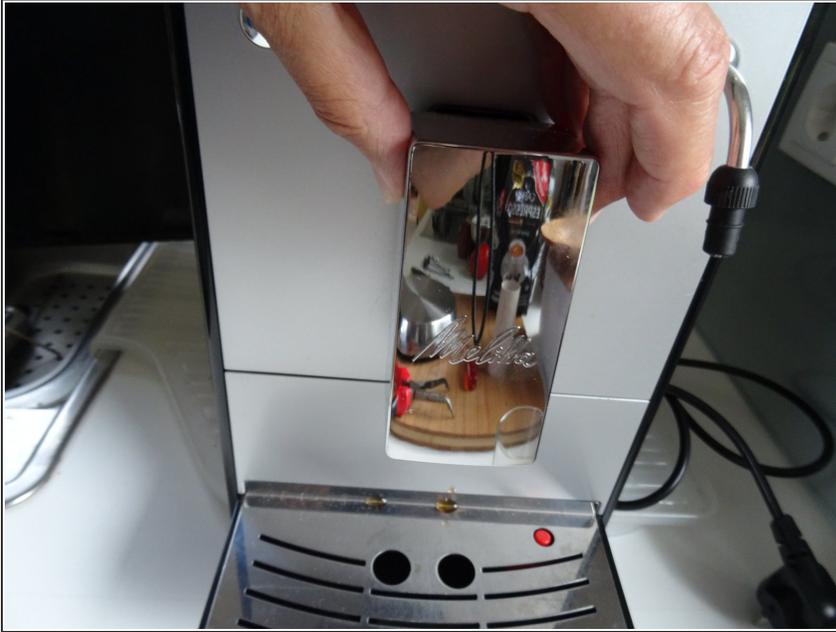
## Step 1 — Coffee Spout Manifold

- ⓘ The glossy cover over the coffee spout is only snapped into place.
  - At the cover bottom you will find a tab in the middle above a catch. Lift the tab a little with a flat screwdriver and detach it from the catch.
  - Lift up the cover.

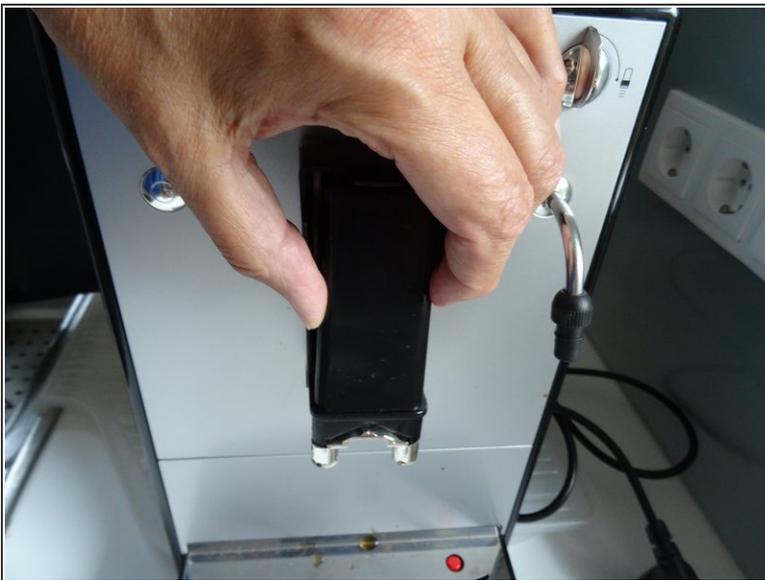
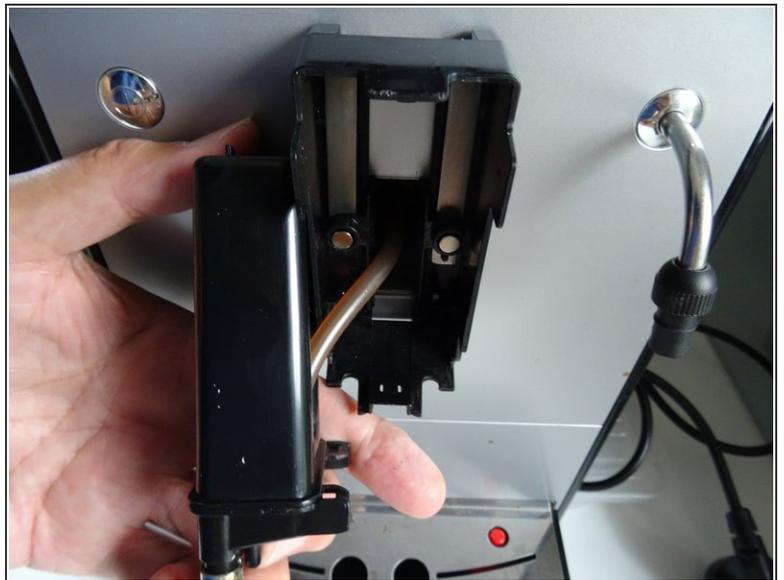
## Step 2

- The coffee spout distributor is only snapped into place. Use your fingers to grab it from the top and lift it away from the machine. The first time it may stick pretty tight.

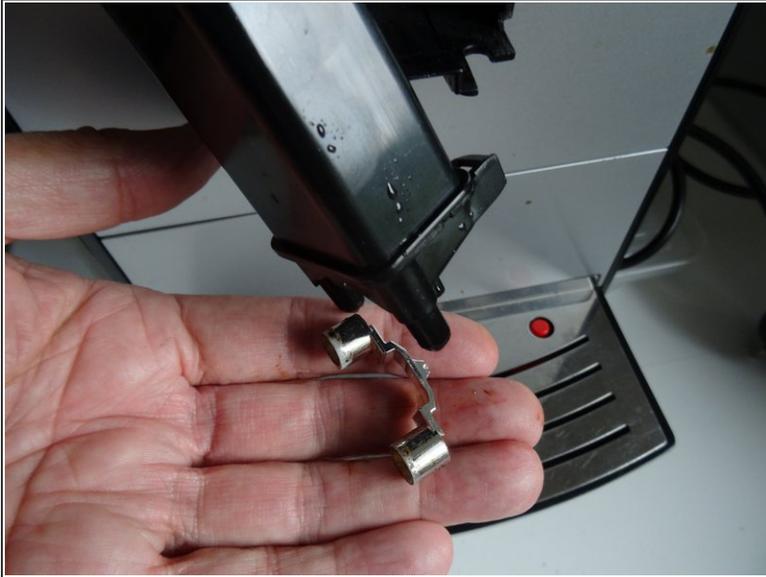
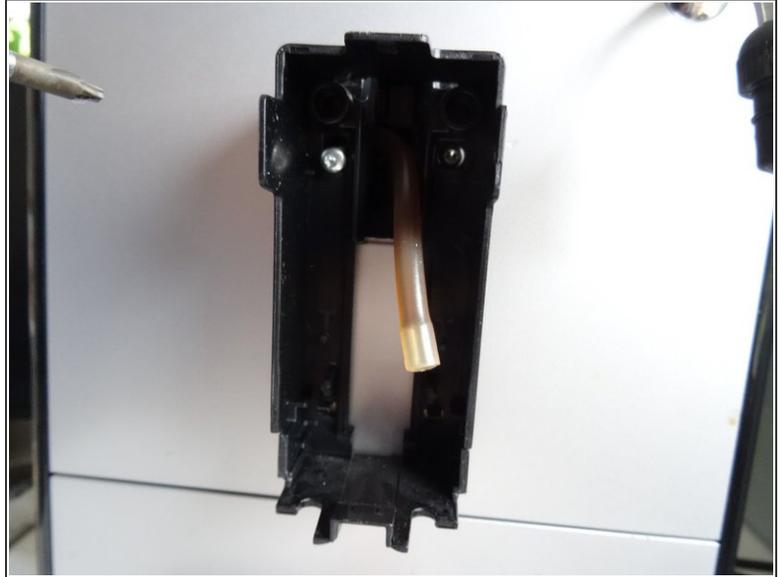
### Step 3

- Remove the chrome trim from the outlet nozzles.
- Slide off the inlet hose.

Repeat the steps in reverse order to reassemble the device.
