iRobot Roomba i7 Side Brush Replacement

iRobot Roomba i7 Side Brush replacement and maintenance guide.

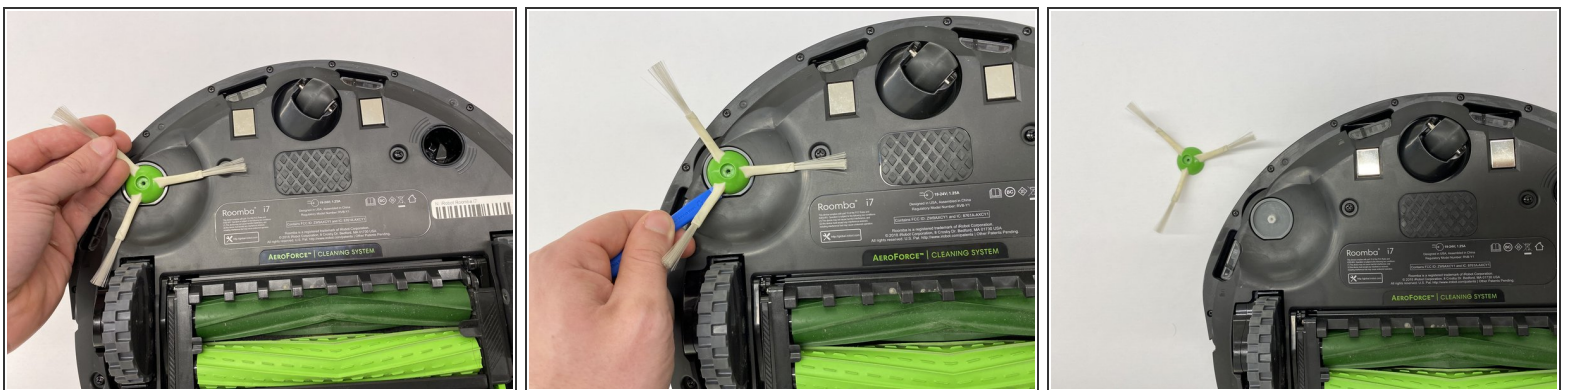
Step 2

- After unscrewing the side brush screw, gently pull the brush up, as shown in the picture.
- If the side brush is difficult to pull, use a plastic opening tool to take it out.

To reassemble your device, follow these instructions in reverse order.
