3 - Kettle - Common breakdowns

Written By: Atelier Soudé

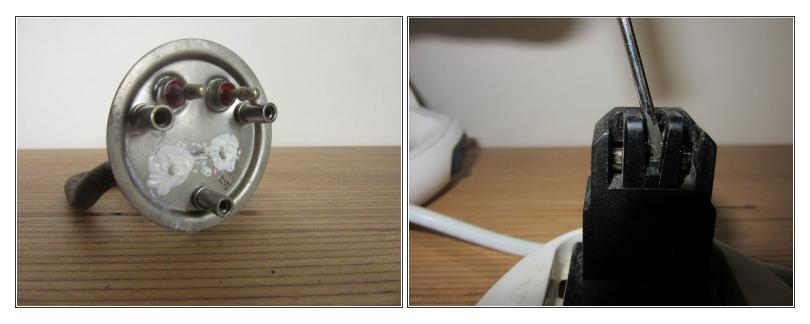
Step 1 — Resistor fault, base

- One of the frequent failures is the resistor insulation fault. This is the case when the device is energized and the differential circuit breaker "trips". There is unfortunately not much to do, except to change the resistance.

- The resistance can also be switched off. Not necessarily tripping at the switchboard, but the water does not heat up. To check the resistance value, you must use an ohmmeter. Knowing that the power of the kettle is between 920 and 1100W, R=U²/PR=230²/1100=48 ohms. Our resistor actually measures 54 ohms

- Another failure may be due to the cable or the socket of the base. To check its condition, simply
 use a multimeter to test the continuity between the terminals of the wall socket and the socket fixed
 to the base. To reach the contacts of this one, press on the protection of the central contact. This
 releases the other 2 contacts.

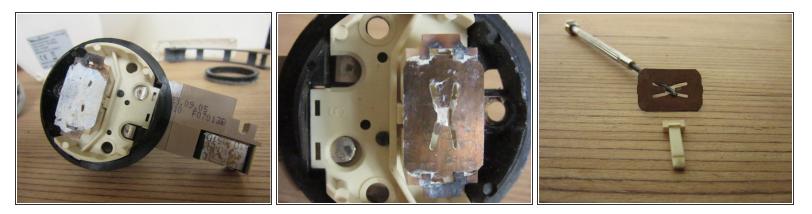
Step 2 — On/off device

- The problem was that the water would not heat up when the switch was turned on! After successfully testing the resistance and continuity of the power supply at the base, the remaining element that could be a problem is the M/A device located in the tank.

- It turned out that after removing the part and disassembling it completely, the plate responsible for cutting the high temperature circuit was permanently activated.

- This plate is in contact with the resistor support. It heats up and deforms. While deforming, it presses on a plastic "finger" which presses on another plate which cuts the circuit. Apparently, for some reason, the finger was pressing on the plate continuously, which prevented the current from passing.

- After having shortened the length of the "finger" to approximately 1mm, the normal function was restored. It is possible that in the long run, the plate loses its original characteristics (elasticity) and the device malfunctions.

- Important: when reassembling, do not forget to coat the plate with thermal paste to promote heat conduction with the resistor support.
