Aftershokz Trekz Titanium Teardown

Taking a look inside to see if repairs are possible at all. Spoiler - they are not.

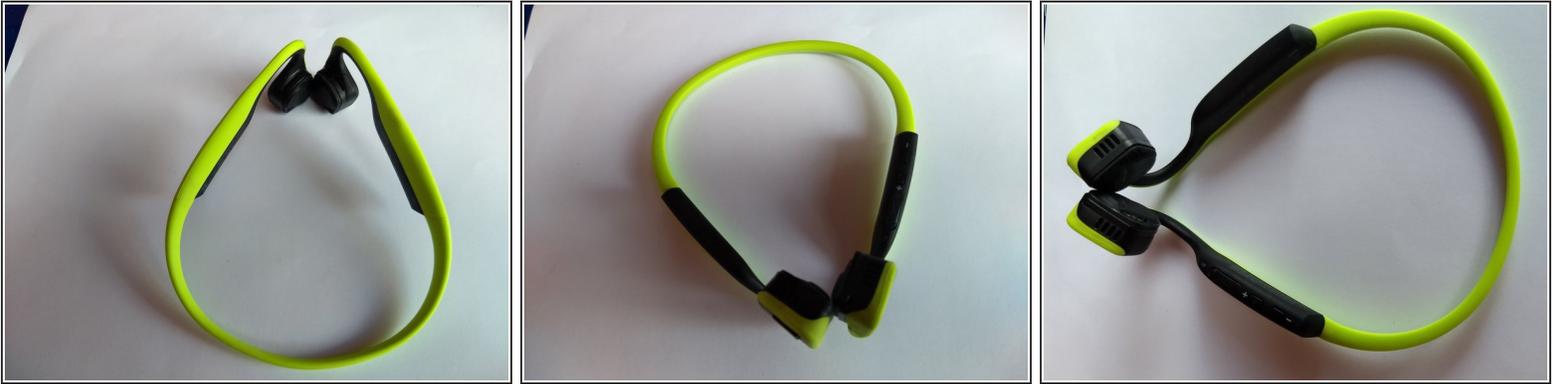
Step 1 — Intact headphones

- Intact headphones before disassembly begins
- Intact to a casual glance at least; the right speaker rattles, and this appears to be a common mode of failure.
- These headphones are a little under 3 years old, and have been used for running a few times per week.

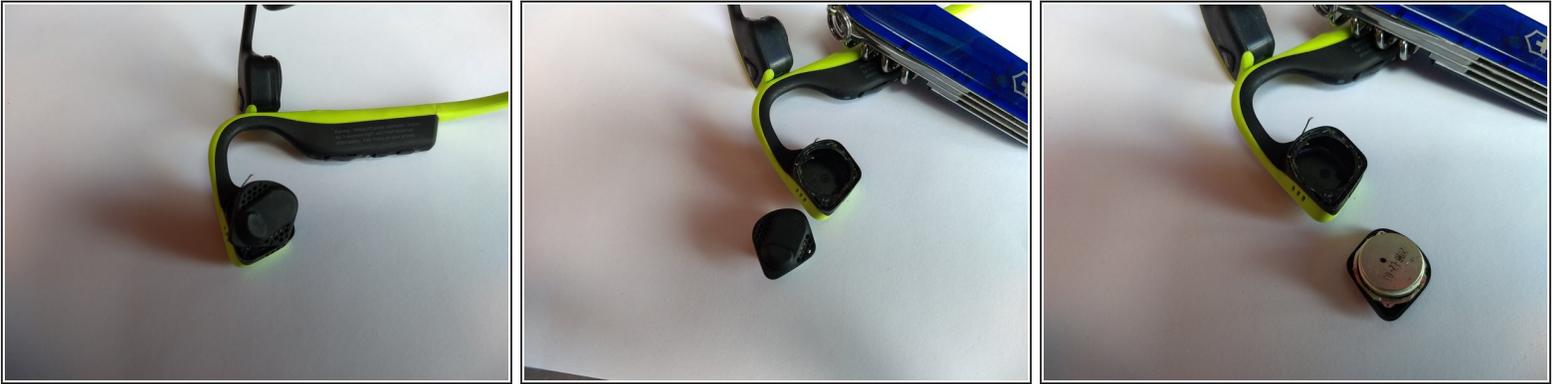
Step 2 — Right earpiece

- There are no screws or other points for tool access.
- There is a seam around the rubber earpiece, so let's start poking there.
- The rubber comes away easily. Some weak adhesive appears to be used to keep it in place, but it requires only a gentle pull using only fingers to peel it away.
- Unfortunately this peels not just the rubber, but the entire earpiece including driver. Not, however, including the wires.
- On the plus side, it no longer rattles.

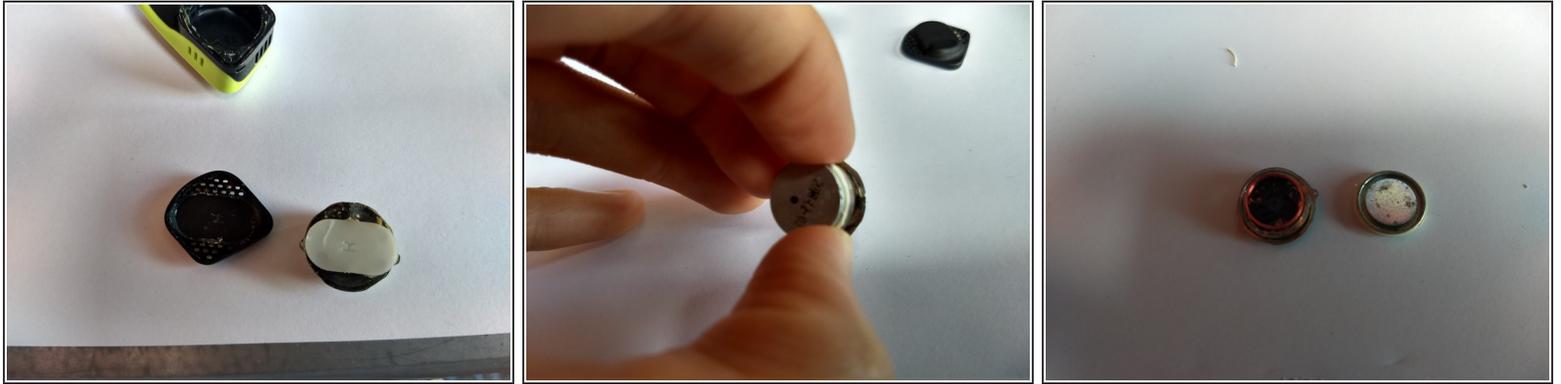
Step 3 — Right speaker

- The rubber does peel away from the rest of the driver quite easily. It should be possible to do this without detaching the driver from its wires - we'll test that with the left in a bit.
- This is a surprisingly strong magnet given there is no discernible force felt outside the headphones when assembled.
- It reads 2018-12-03
- The magnet can be separated from the rest of the speaker with some assistance from a penknife. Only the white sealant around the outside holds it in place, otherwise it simply slots between the red coil and outer plastic case.
- Further disassembly does not appear possible without causing serious damage.

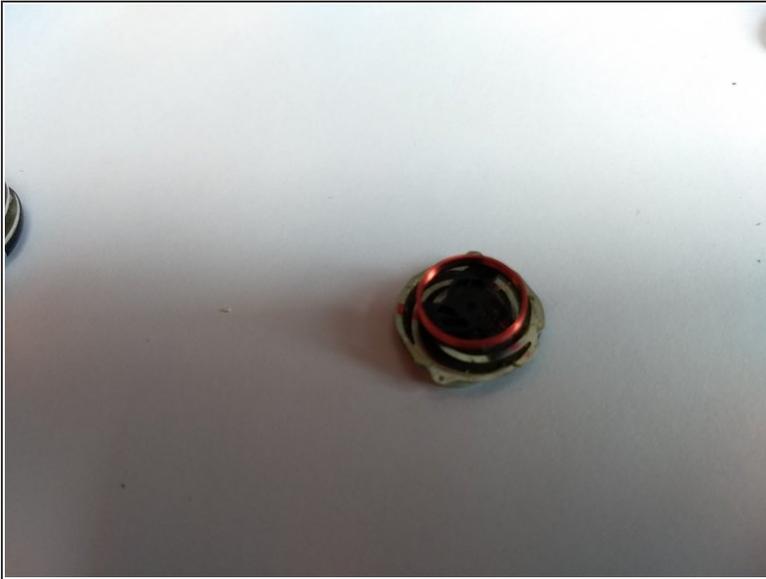
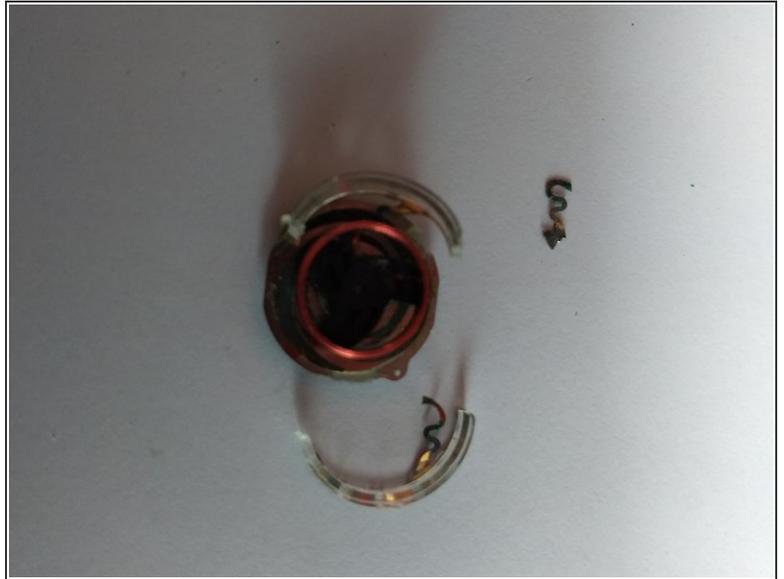
Step 4 — Causing serious damage

- Turns out the plastic outer ring is not just for support, it appears to form part of the circuit between the incoming wires and the driver.
- If there is a correct way to dismantle the speaker, this was not it.
- There don't appear to be any servicable parts in here.

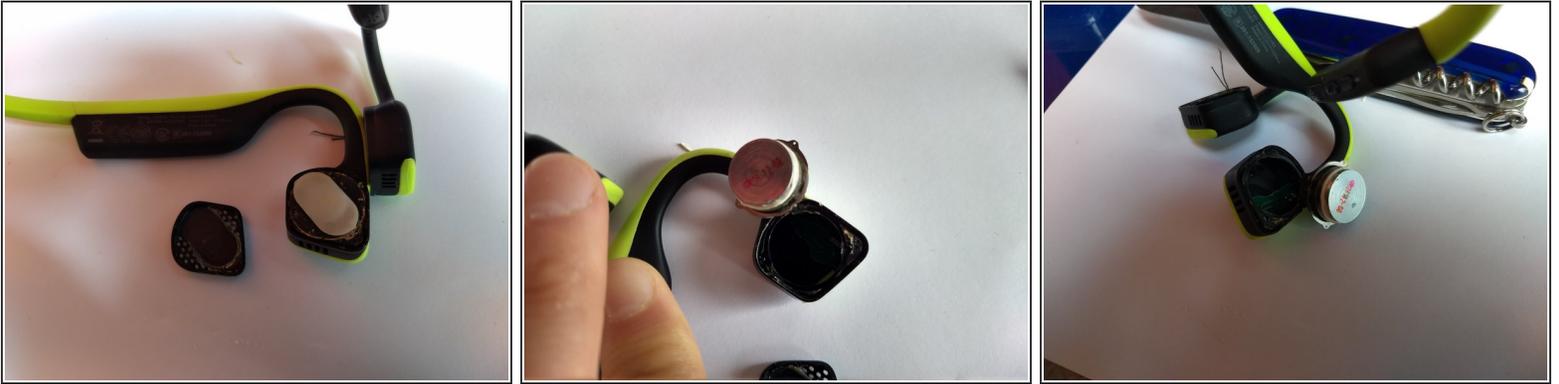
Step 5 — Left earpiece

- Knowing what's coming, this time we can peel the external rubber without damaging the rest.
- The speaker is again held on by thin wires coming through the arm, this time in blue.
- This magnet reads 2018-12-01.
- On this side, a small portion of circuit board is visible. Perhaps unsurprisingly, this appears to carry two simple wires connecting to the single button used for play/pause/skip.

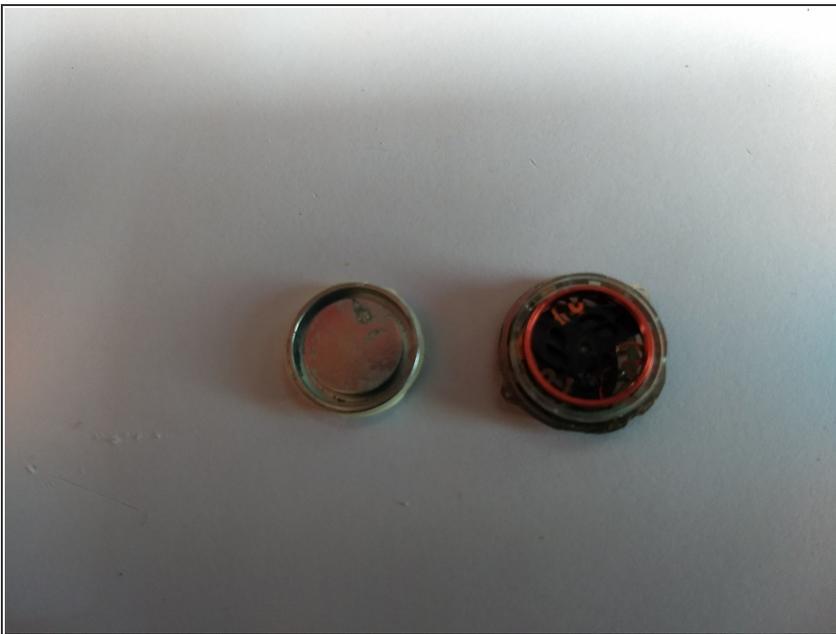
Step 6 — Left speaker

- The left speaker appears identical to the right one.
- There should be a microphone somewhere. Since the speakers are identical and there is no obvious separate piece, these may both be doing double duty as mics.
- With a bit of care it would be possible to remove the magnet without detaching the speaker from its connecting wires, but it's not clear there would be any benefit from doing so.

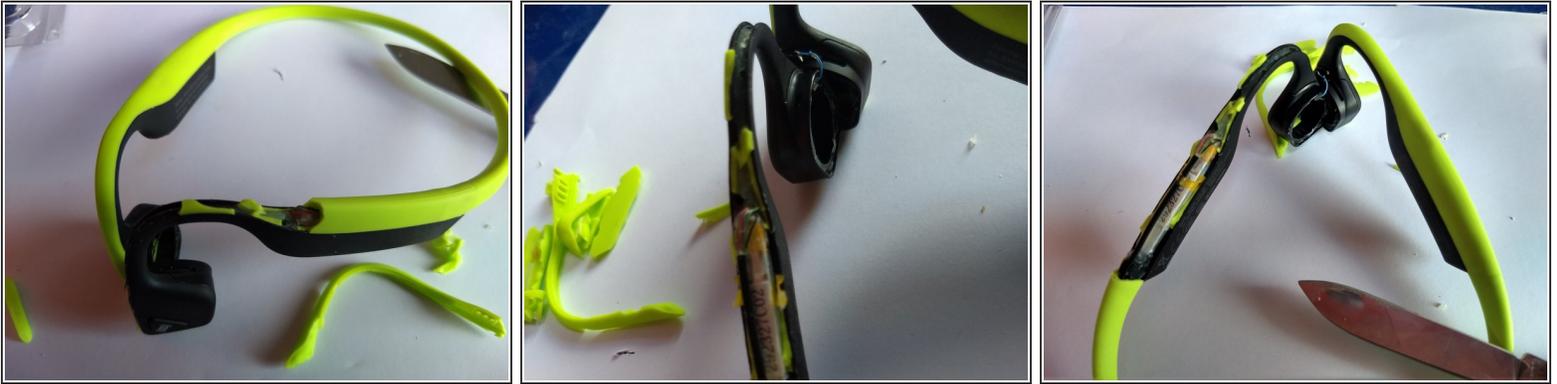
Step 7 — Left body

- The black is hard plastic, the green (other colours available) is soft. They are not designed to be separated.
- We can see the side of a battery here. It reads 292327C02.
- The green plastic is actually three separate pieces, with one bonded to each black plastic piece, and the third wrapping around the headband.

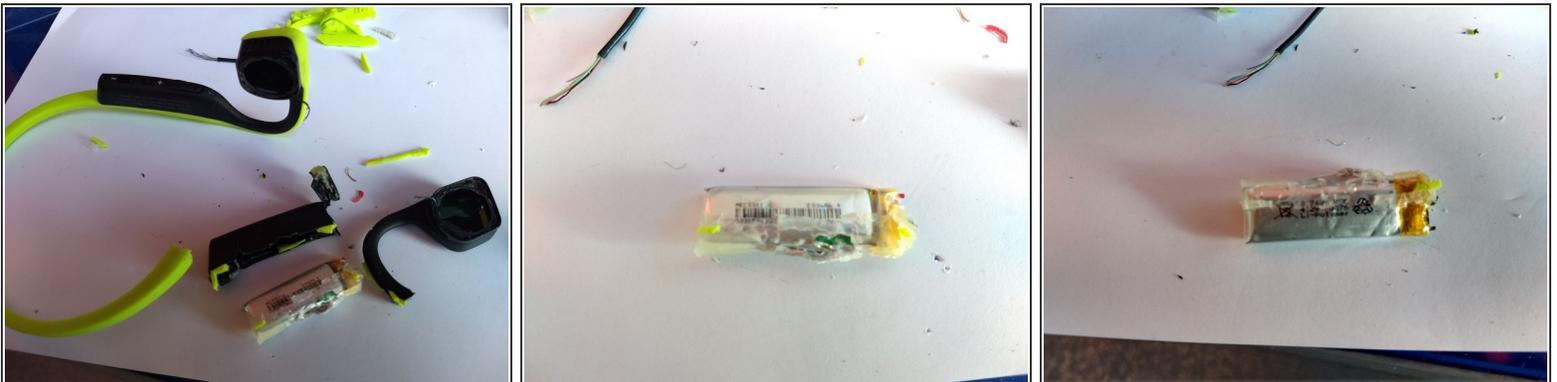
Step 8 — Battery

- The battery requires some persuasion to come out. Lots of adhesive, and a tight fit inside the rigid black plastic piece. It is definitely not designed to be replaceable.
- On one side - Li-polymer, 0.74 Wh, 4.2V. AEC 8376.
- On the other side - 200 mAh, 3.7 V. AEC 531236.
- 0.2 Ah at 3.7 V would agree with 0.74 Wh, so it's not clear what the 4.2V marking refers to.

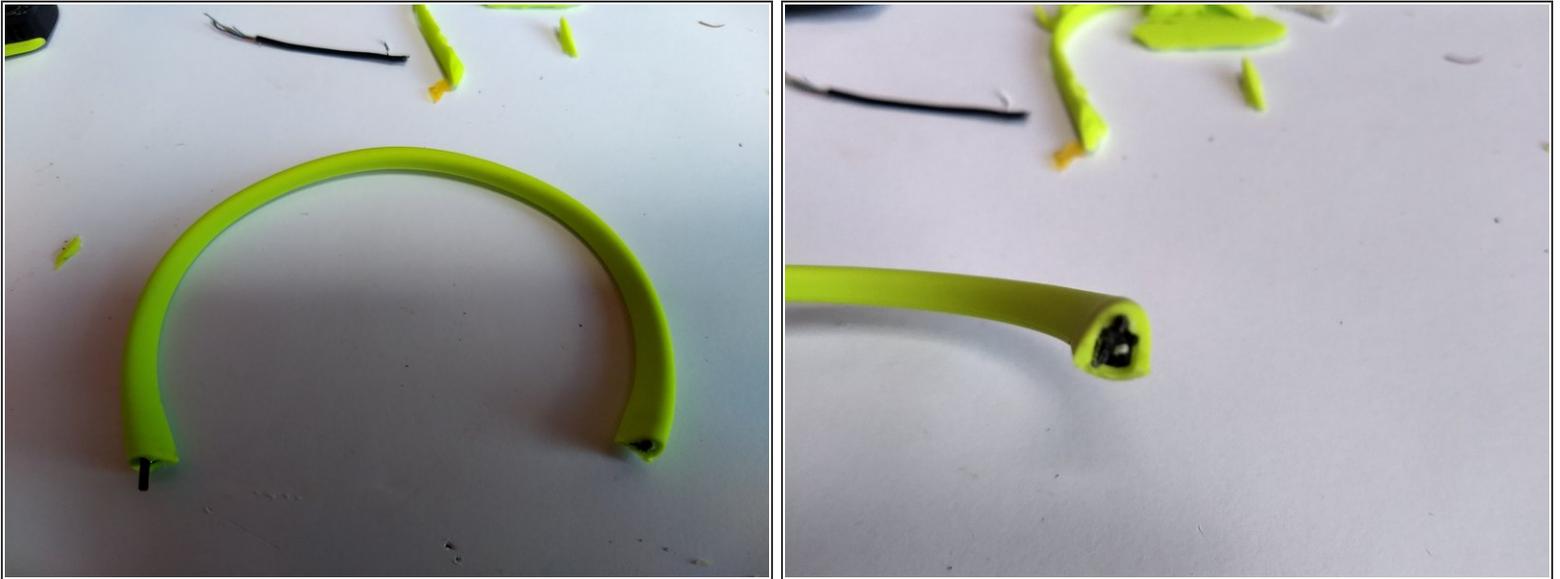
Step 9 — Headband

- The headband consists of hard black plastic wrapped around a thin metal core.
- The wires sit on top of the hard plastic, and the softer green plastic is then wrapped around them together.

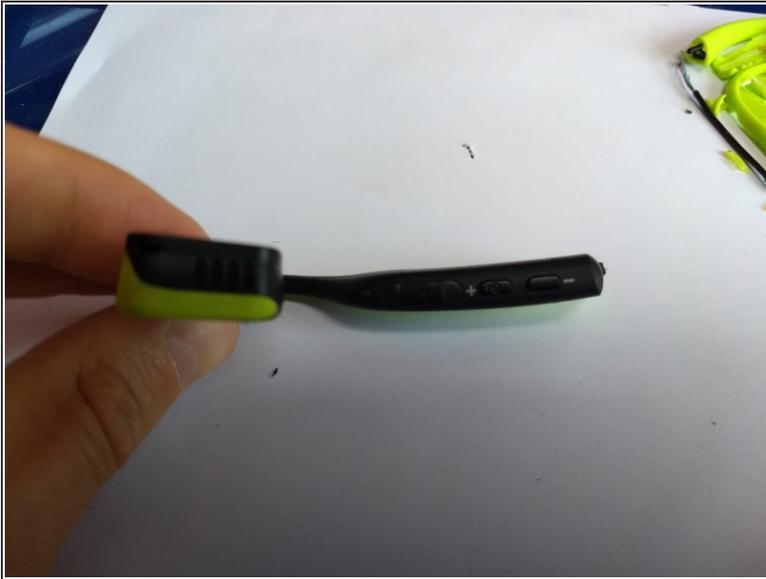
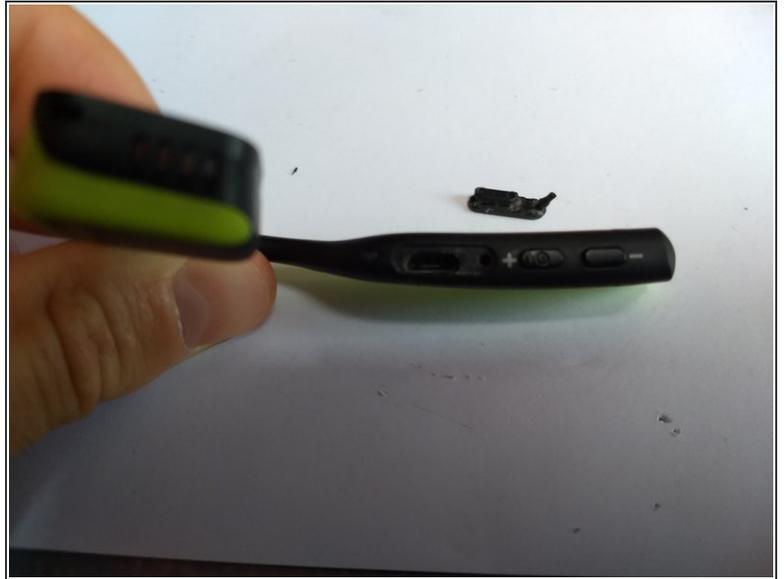
Step 10 — Right body

- The right body contains the power and volume buttons, along with the micro-USB charging socket and LED indicator.
- Presumably this is where the main chipper lives.

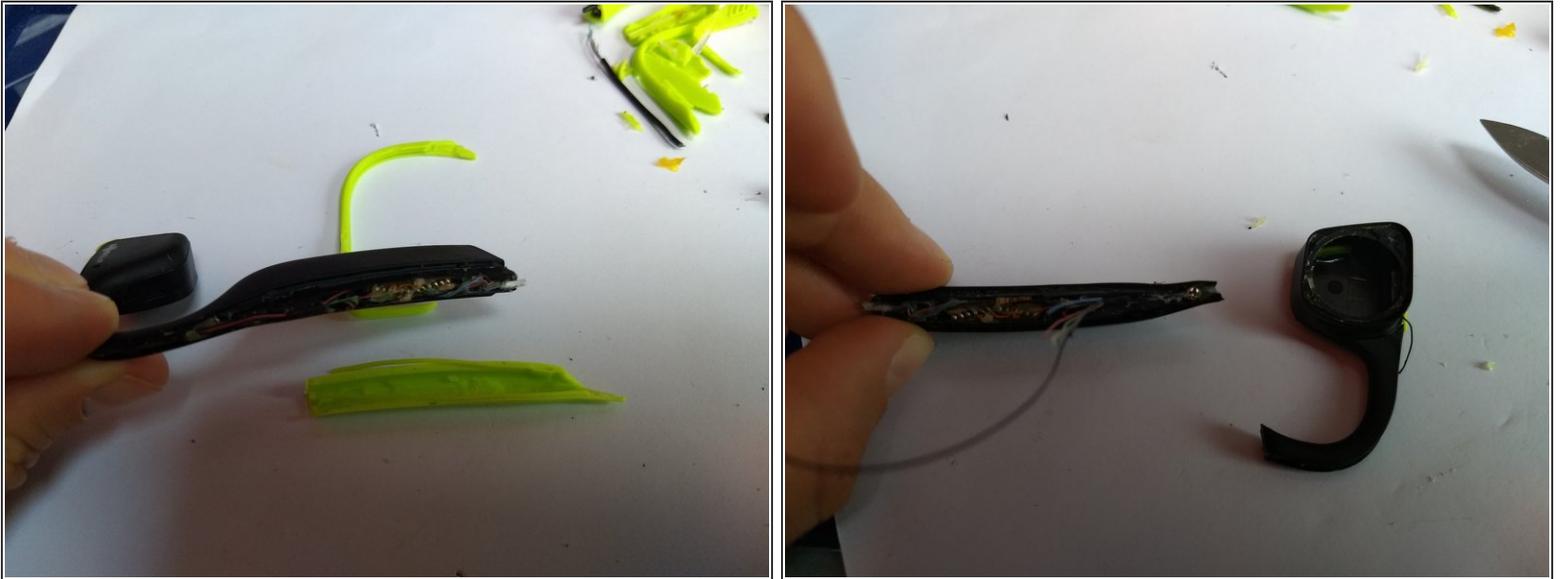
Step 11 — Right body internals

- There is some adhesive down the sides of the circuitboard, but with none on top peeling the softer parts away is much easier on this side.
- There's actually a screw in here. I wasn't prepared for this.
- Once the screw is gone this end lifts out quite easily, but the other end needs a bit of force to free it from a snug fit.

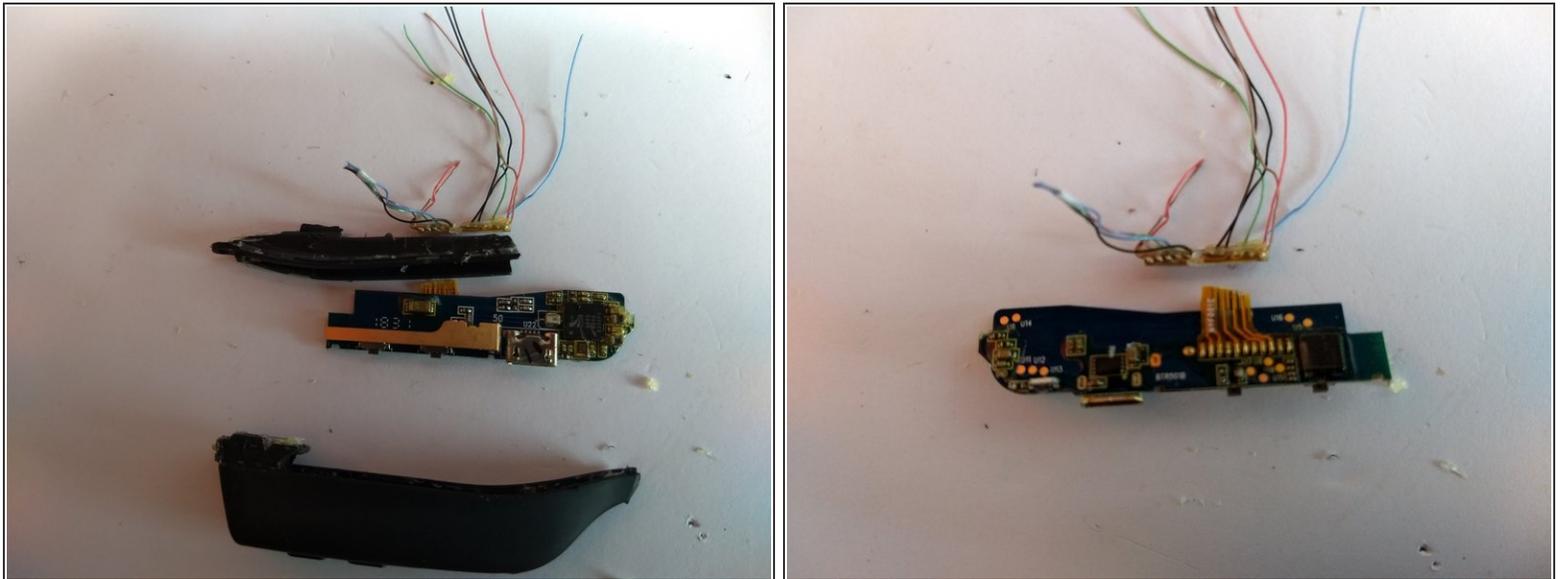
Step 12 — Chips

- The wires connect to a ribbon cable connected to the top of the plastic top, which then runs through a slot to the board. This could likely be dismantled non-destructively if you know what's there (but not without destroying the plastic body to get here).
- Back side contains AXS T1 868 A50P next to the ribbon cable connection. There is also BTR0018, presumably the bluetooth controller. Another smaller chip would require a magnifying glass to read. Others are just labeled Uxx, where xx is some number.
- Front side main chip is CSF 8640 B04G 8334P5. The large copper foil attaches by the back side of the bluetooth chip, and is presumably the antenna.

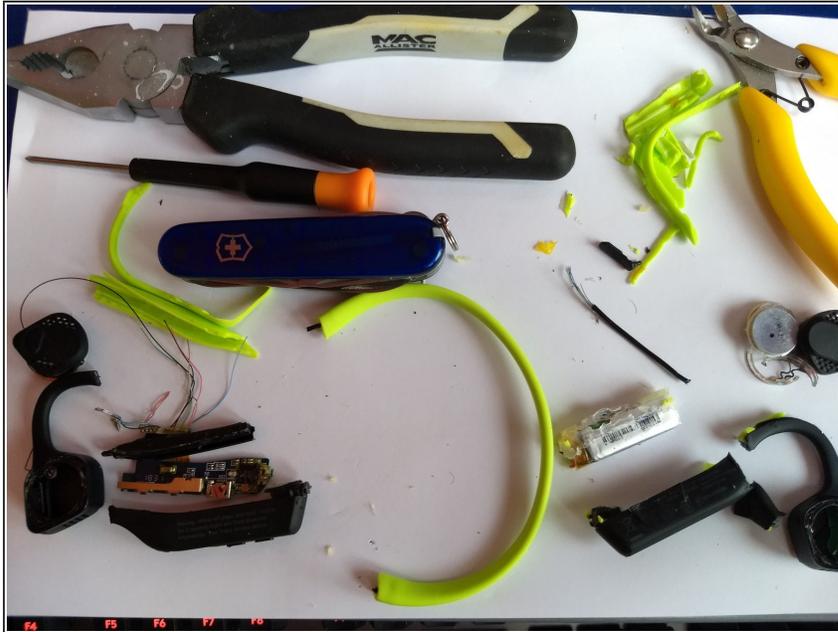
Step 13 — Conclusion

- This may not actually have helped.
- There does not appear to be anything user serviceable or replaceable.
- The speakers may be possible to partly dismantle non-destructively, but cannot be replaced.
- The rattle that inspired this seems likely to have been caused by the left speaker coming partly unglued from the casing. There does not appear to be any way to fix this, other than maybe trying to inject more glue and hoping it doesn't get in the wrong place.
