Fitbit Charge HR Vibration Motor Replacement

Has your Fitbit Charge HR stopped vibrating? Perhaps your Fitbit vibration motor has gone bad. This guide is a tear-down of the Fitbit Charge HR demonstrating how to replace the Vibration Motor for the Fitbit Charge HR.

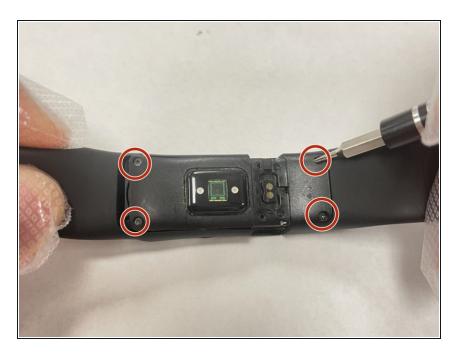
Step 1 — **Vibration Motor**

- Remove the four 2.9 mm screws from the back of the display using a Torx screwdriver.
- Remove the back cover from the device.

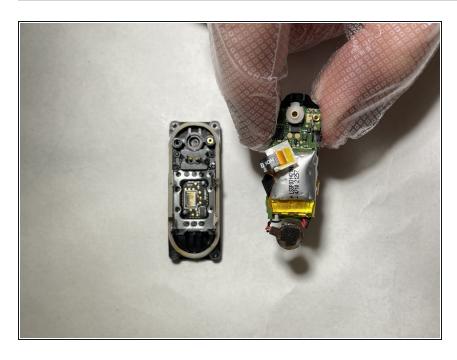
Step 3

Remove the motherboard assembly from the device by gently lifting.

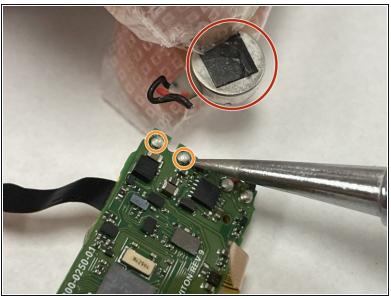
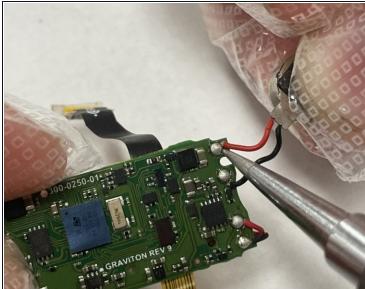
Step 4

- Locate the vibration motor on the motherboard.
- Desolder the red and black wires connected to the motherboard from the vibration motor.
- (i) Red wire is located closer to the outside. Black wire is closer to the inside of the motherboard.
- Replace with new vibration motor.

To reassemble your device, follow these instructions in reverse order.
