# Busch+Müller IXON Core Connecting rechargeable battery

After the drop down of the bike light, it wasn't working anymore. One of the electrical contacts broke loose.

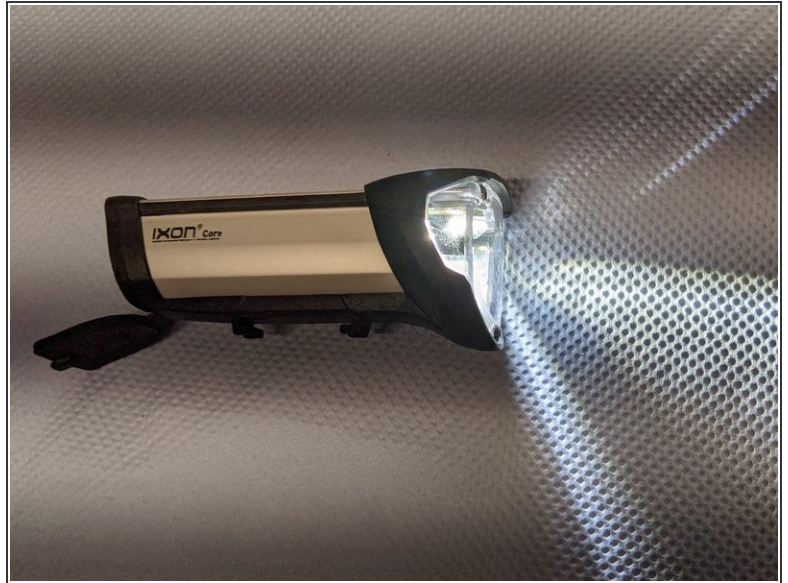
## Step 1 — Missing connection

- Here the loose connection is displayed.
