INTRODUCTION

Unable to raise or lower the volume? Replace the controls sidebar and restore balance to the force.

Step 3 — Controls Sidebar

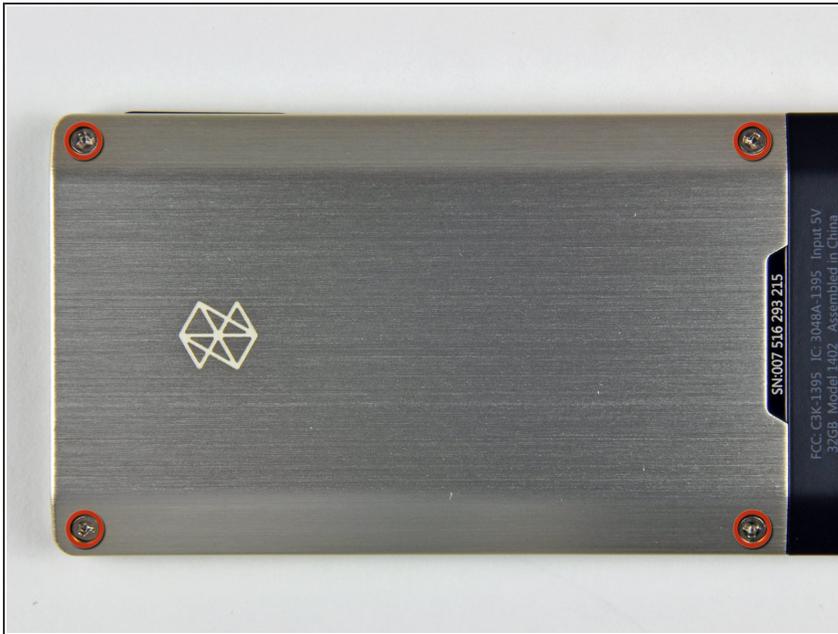
Step 1 — Upper Rear Panel

- Remove the four Tri-Wing screws securing the upper rear panel to the inner chassis.

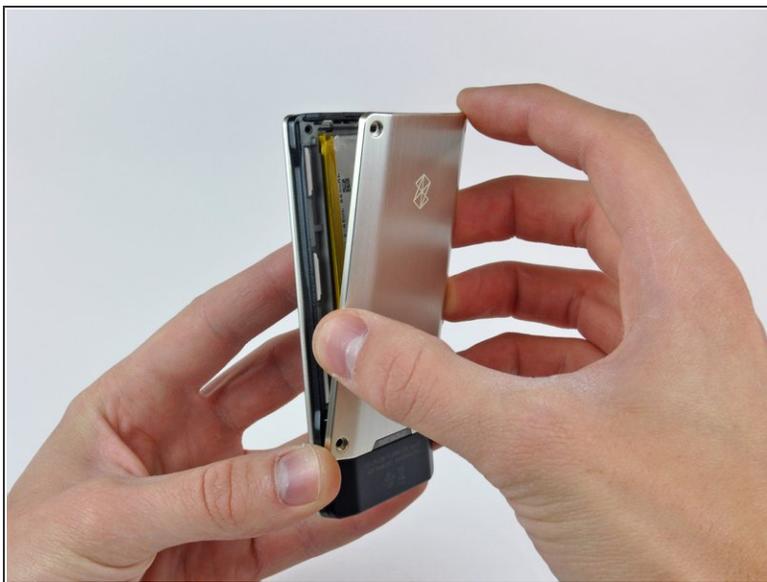
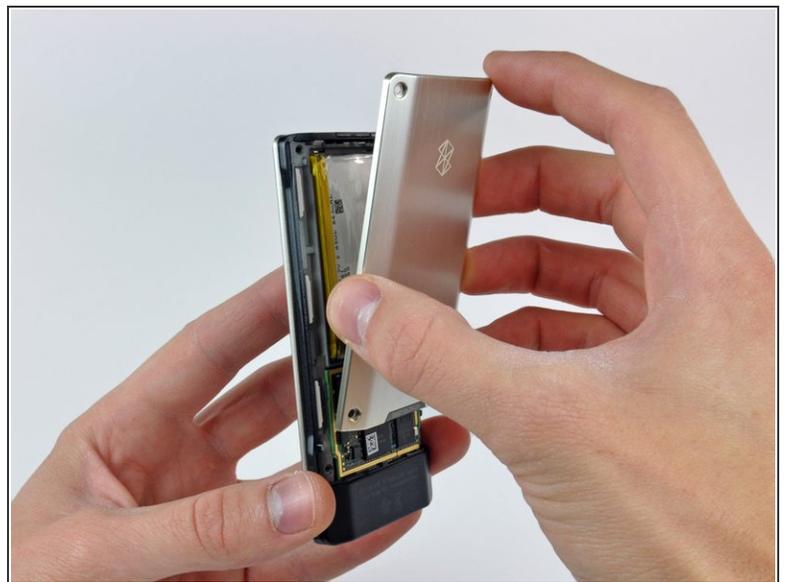
Step 2

- Slightly rotate the top edge of the upper rear panel away from the Zune.
- Lift the upper rear panel straight up off the black plastic lower rear panel.

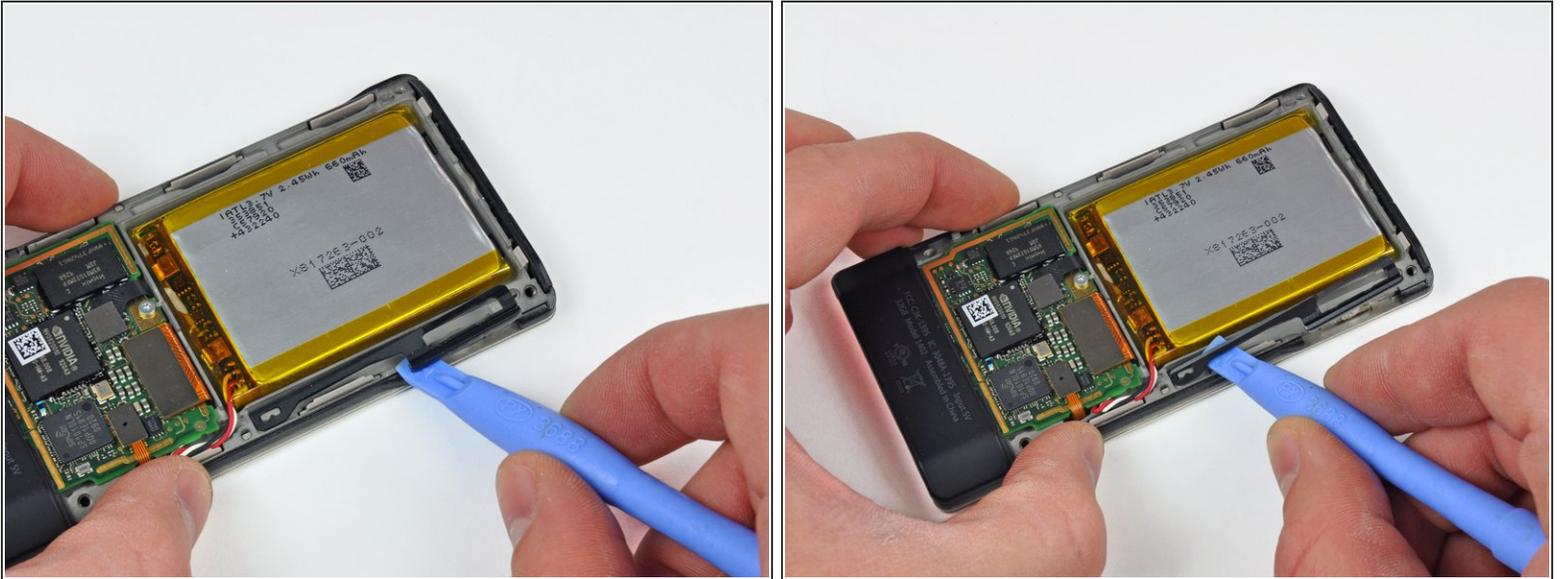
- Use a Zune opening tool to gently lift the media button lever off the post cast into the inner chassis.

⚠ Try not excessively rotate the media button lever about this post.
