Repairing the audio amplifier

This one came to me from a co-worker. It had a "rattle" inside and did not power up. The importance of trouble shooting does become obvious with this repair.

Written By: oldturkey03

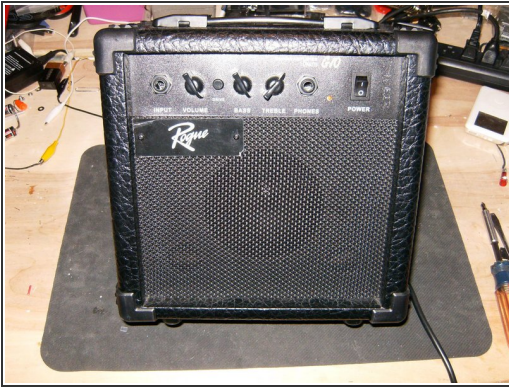
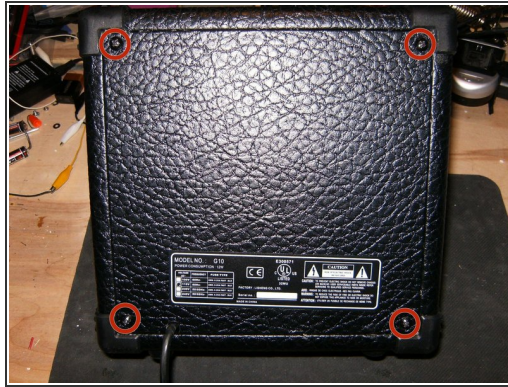
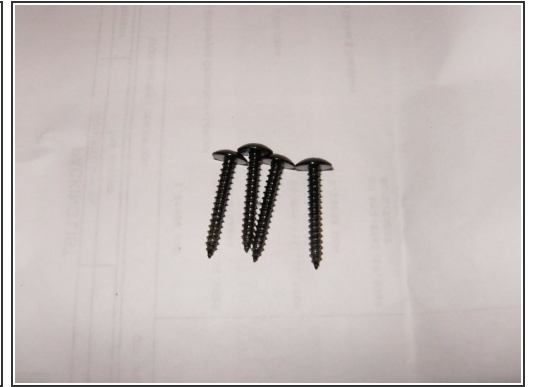
Step 1 — Repairing the audio amplifier

- Here is the Amp in all its miniature glory. total size is 9 1/2 inches X 9 5/8 inches and 6 inches deep. All controls are in the front panel.
- Remove the 4 Phillips head screws from the back panel.
- Here are the 4 #6x1" screws

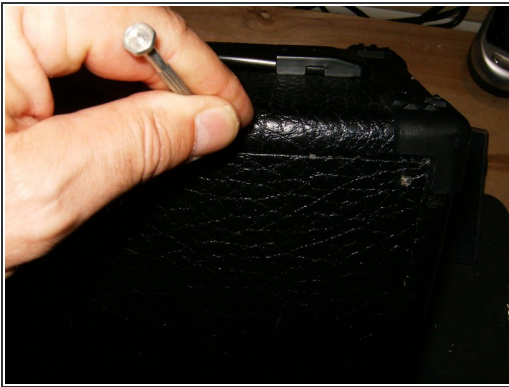
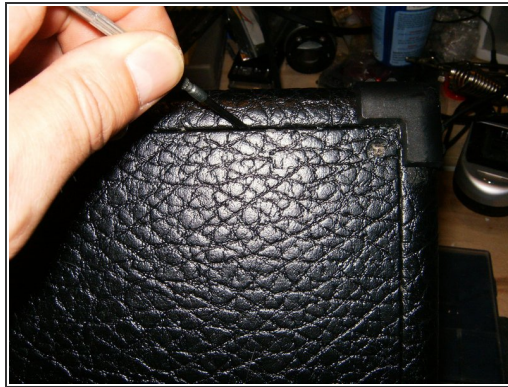
Step 2

- Remove the back panel. Use a small screwdriver, or other instrument to free it from its recess.
- Work your way all around, since the back is a bit snug in the recess.

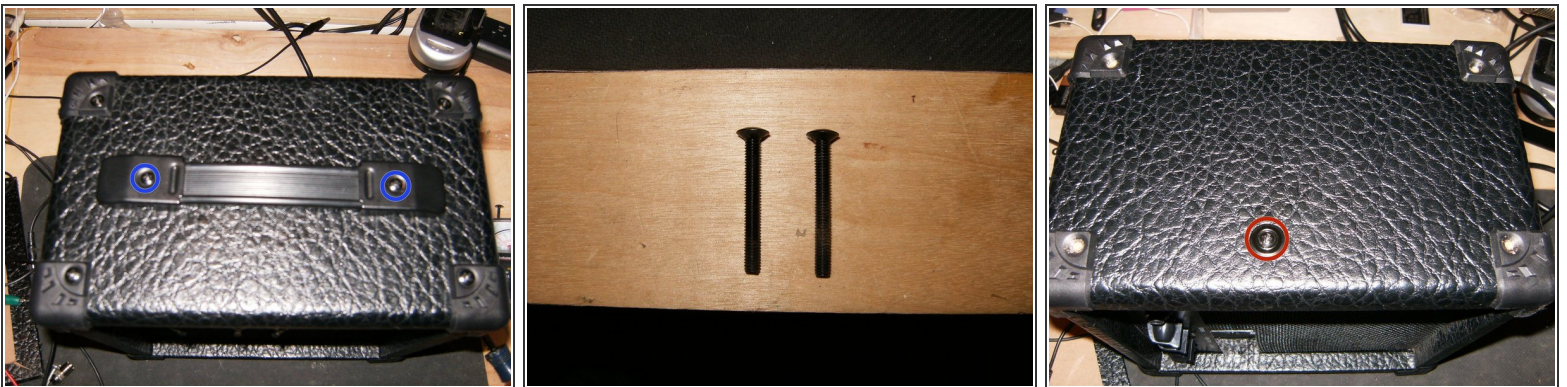
Step 6

- Remove the two Philips head screws from the carrying handle.
- Those are 3mm x40mm
- Remove the Philips screw on the right side of the Amp

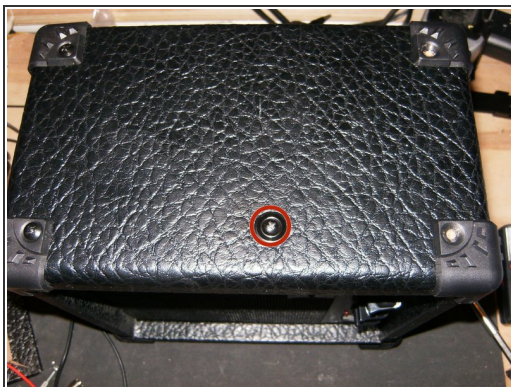
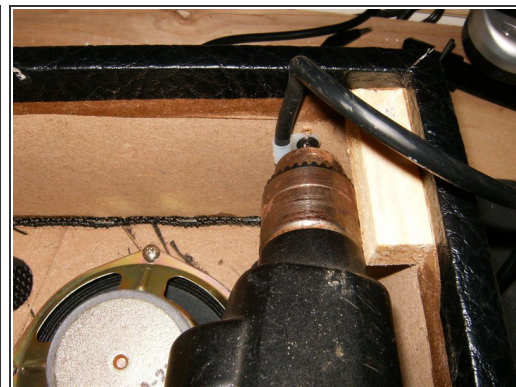
Step 7

- Remove the Philips head screw on the left side of the Amp.
- Unplug the speaker wires.
- Remove the Philips head screw that holds the power cable bracket.

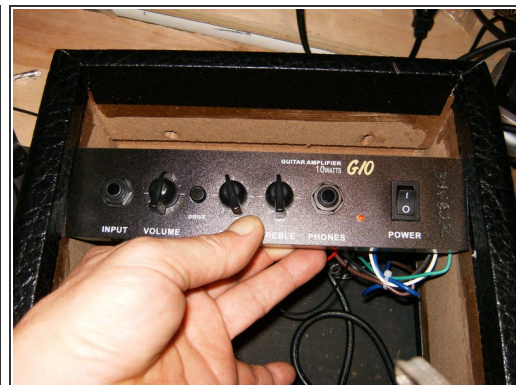
Step 8

- Remove the front panel and the attached speaker.
- Simply lift it at an angle out of the back of the Amp.
- The control panel and the attached PCB can now be removed.
