Epson Stylus Photo 820 Teardown

Teardown of an Epson Stylus Photo 820 Inkjet Printer.

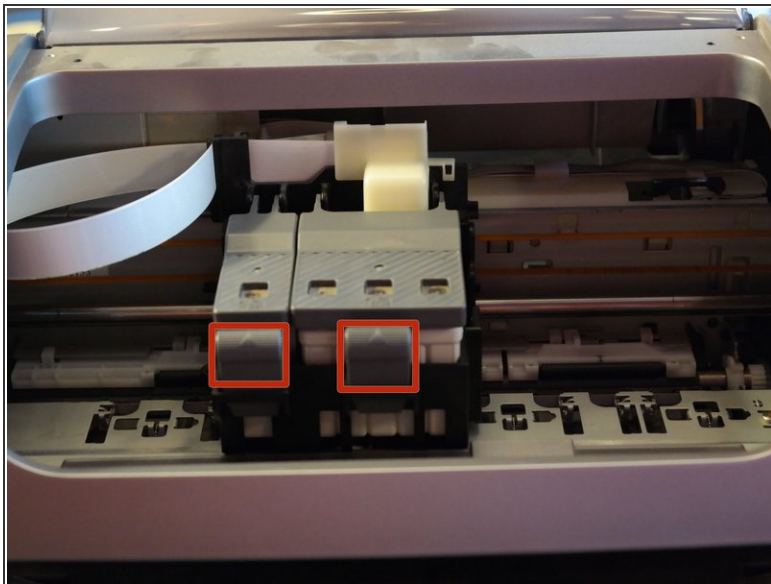
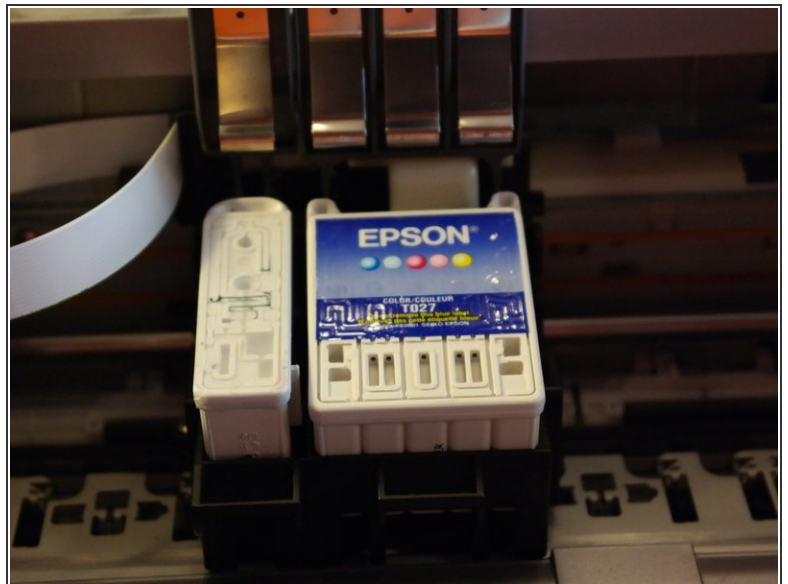
Step 2

- The ink cartridges are replaceable. That is a good sign.

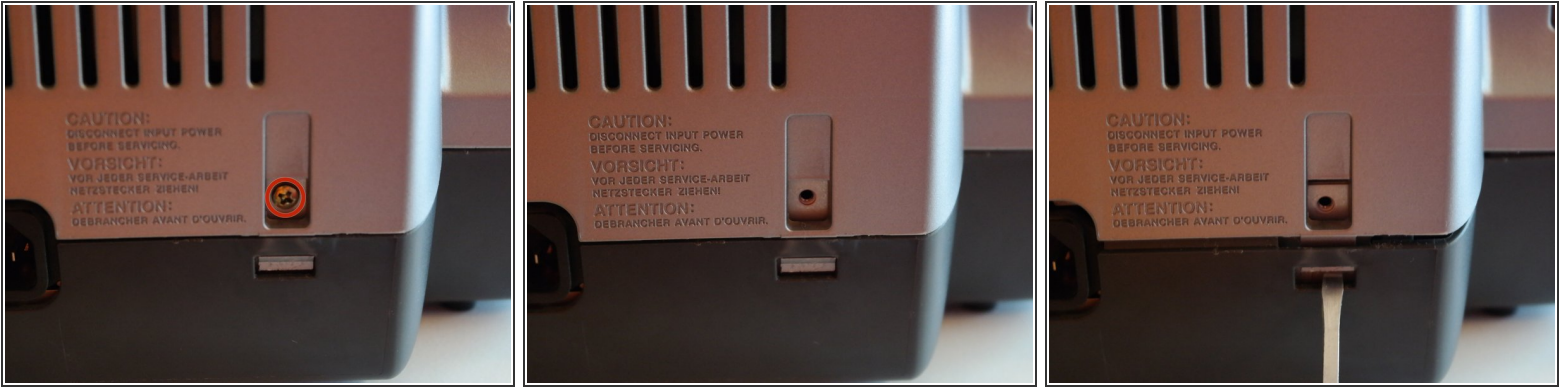
Step 3

- Only one screw on the outside. That looks like a good sign.
- After removing the screw, the three tabs on the back can be unhooked.

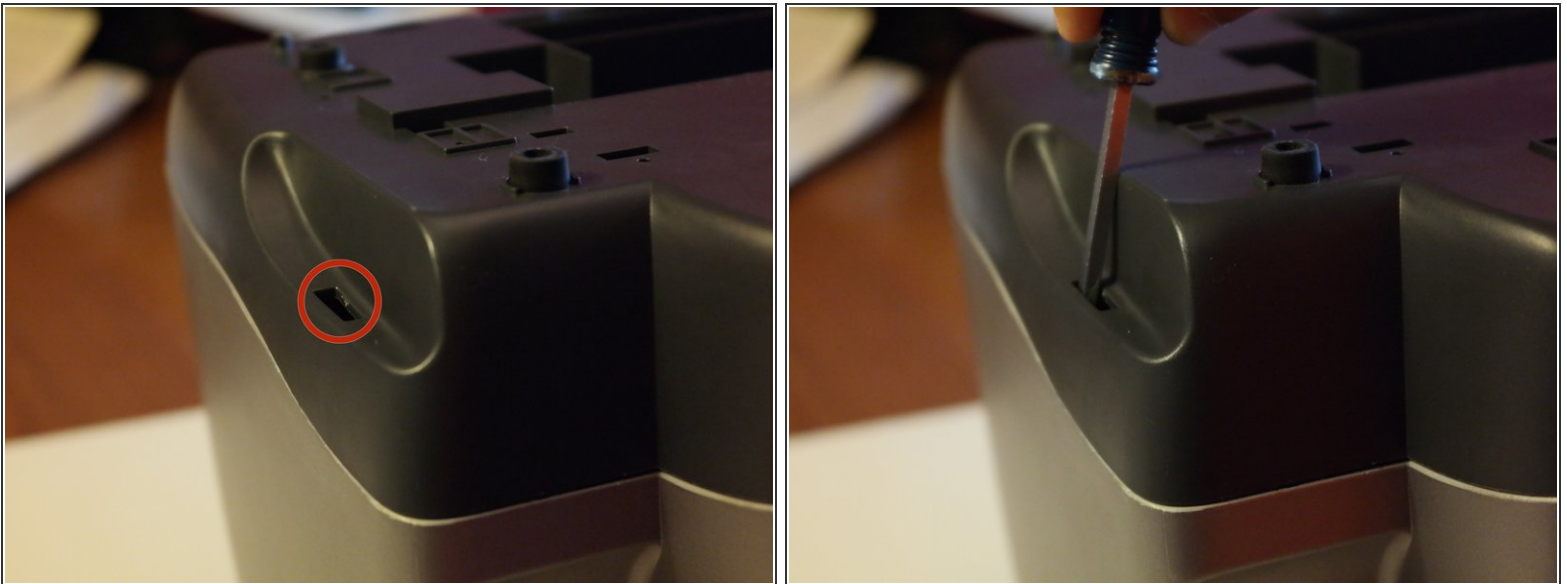
Step 4

- What are these strange slots on the bottom of the printer?
- Answer: according to the existing iFixit guide, they allow access to the tabs holding the cover in place.

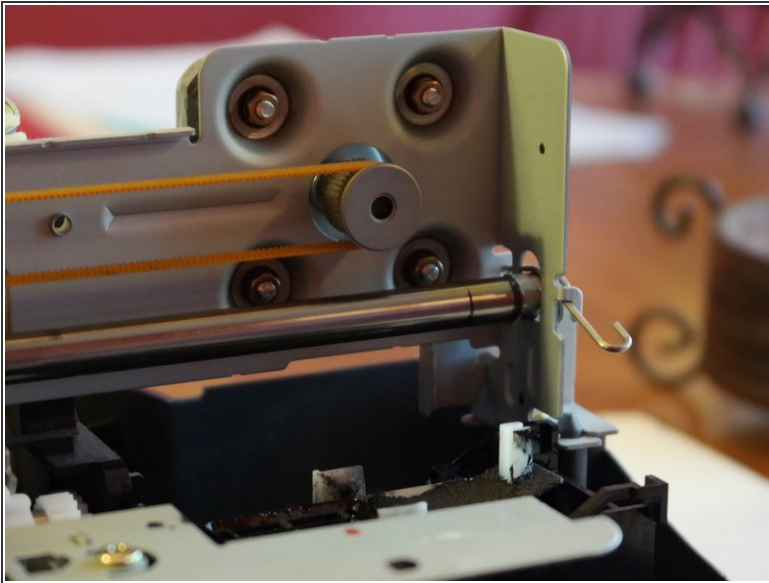
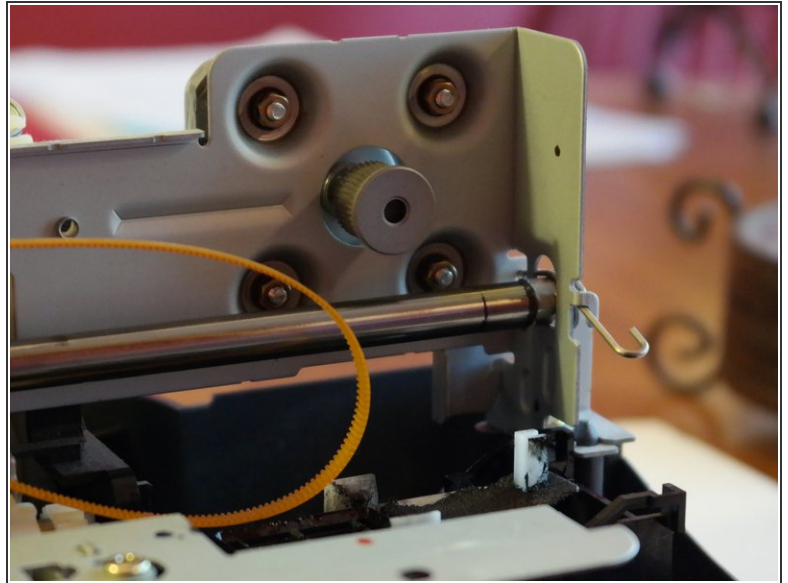
Step 8

- Next step: the stepper motor.
- The drive belt can be easily removed by pressing on a tensioner on the other side of the printer.
+1 for reparability!

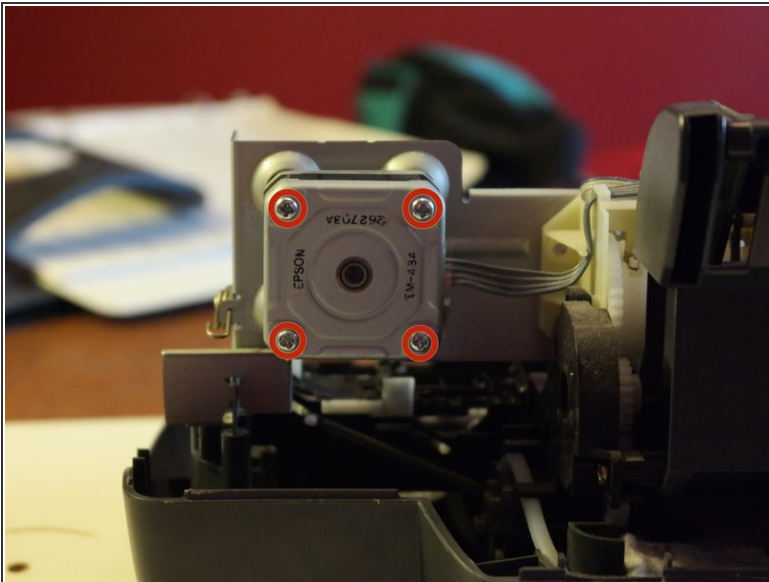
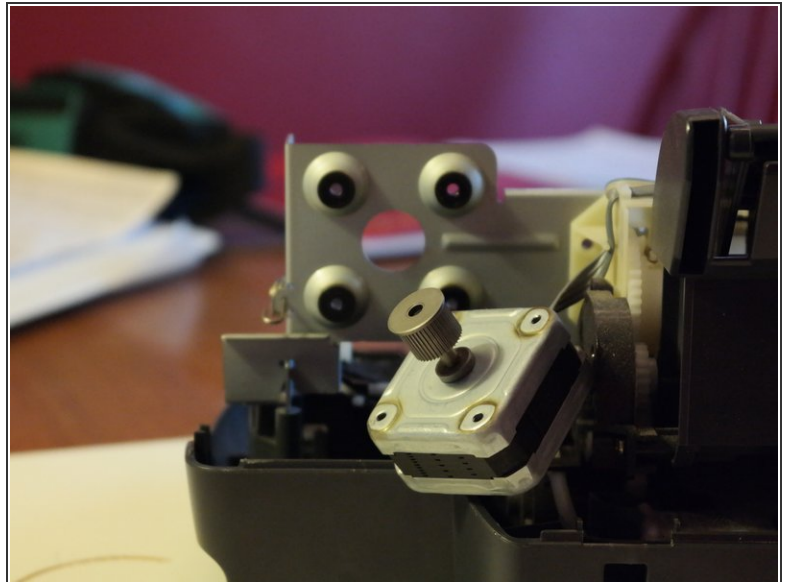
Step 9

- After removing 4 screws, the stepper motor comes out.

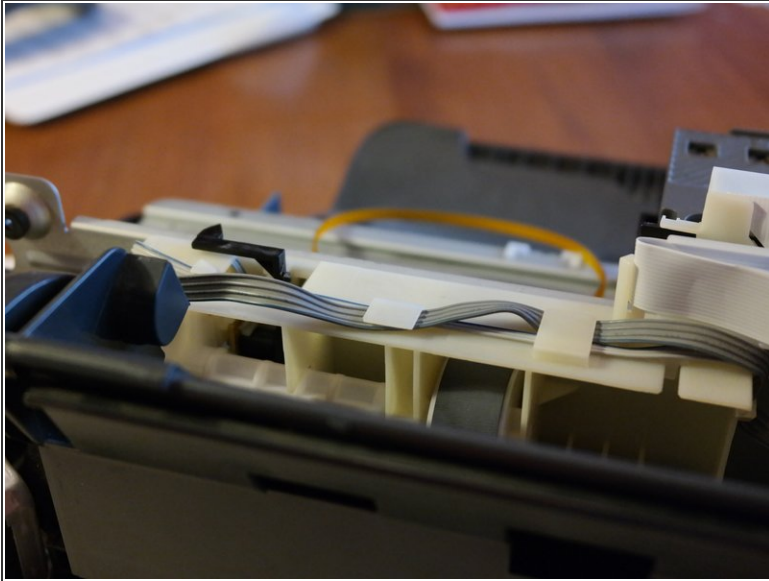
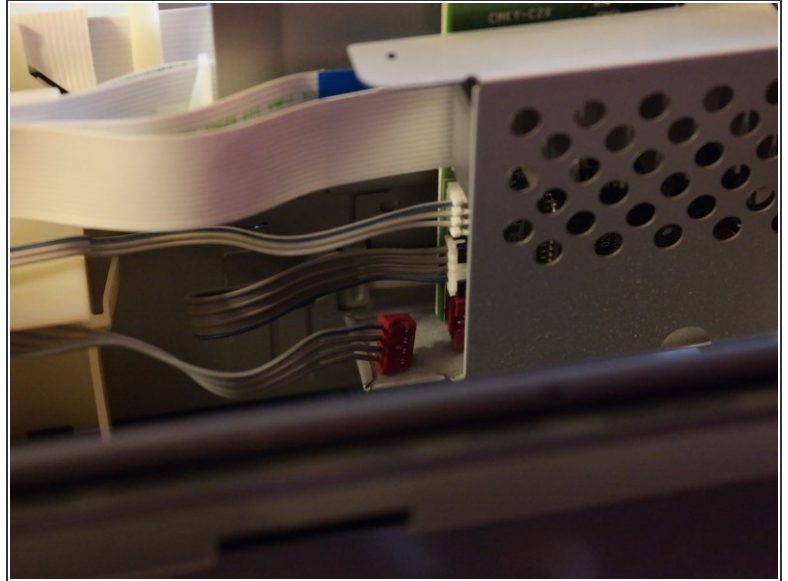
Step 10

- The stepper motor cable is routed through a series of plastic tabs that hold it down.
- It eventually connects to the (hidden) logic board.

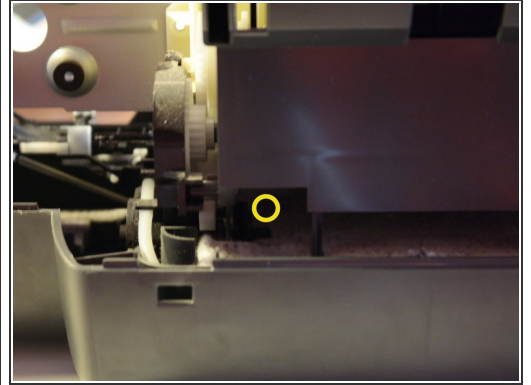
Step 12

- In order to access the paper tray, 3 screws must be removed.
- One in an obvious place.
- One in a less-obvious place.
- And one hidden in a dark place.

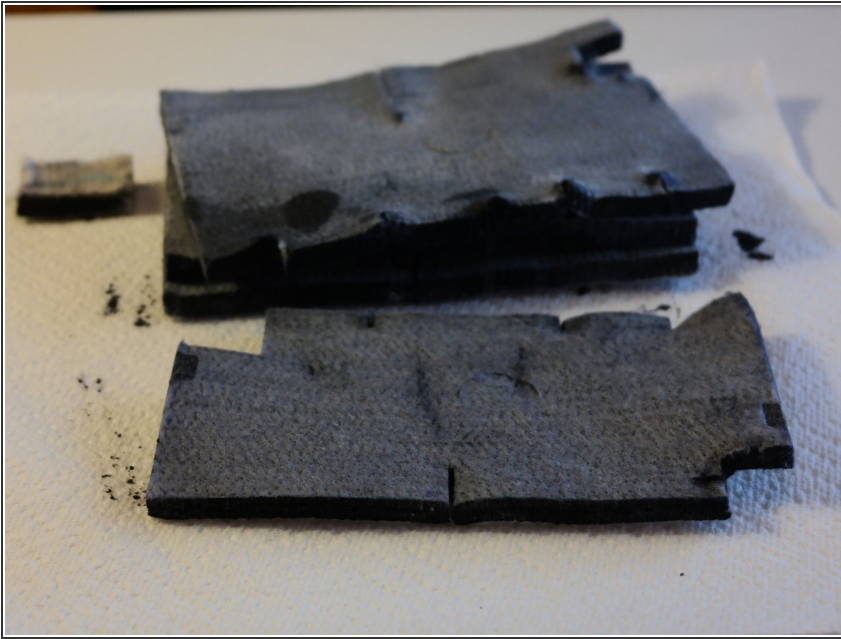
Step 15

- The object at the bottom of the last photo was 5 layers of absorbent padding to contain all the ink that the printer has wasted while cleaning its nozzles, in this case *almost 8 years* of ink.

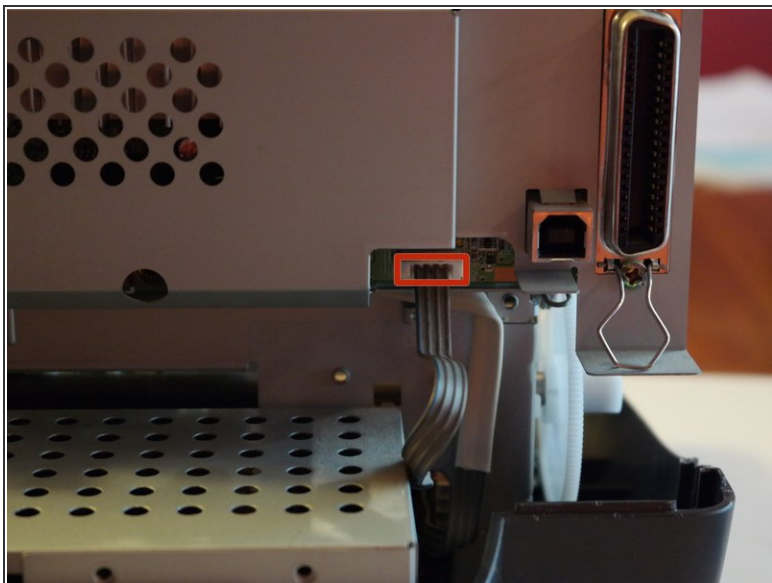
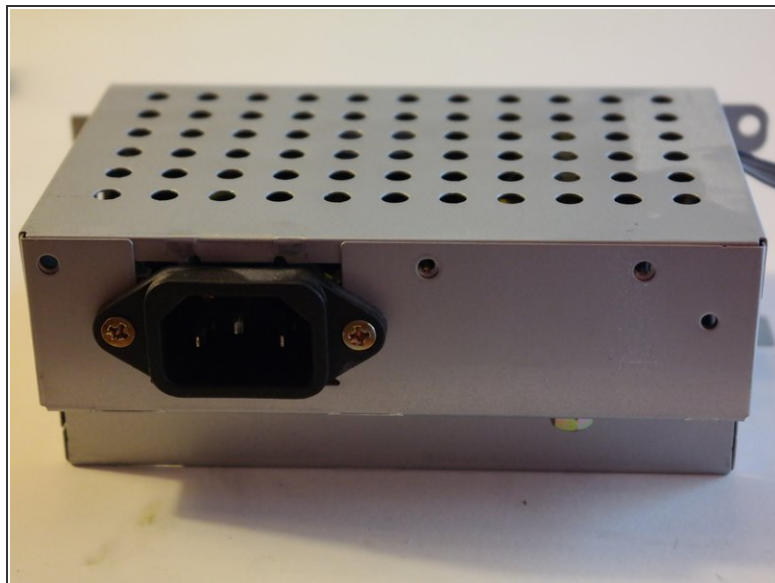
Step 17

- The power supply is connected to the main board by 4 surprisingly thin wires.

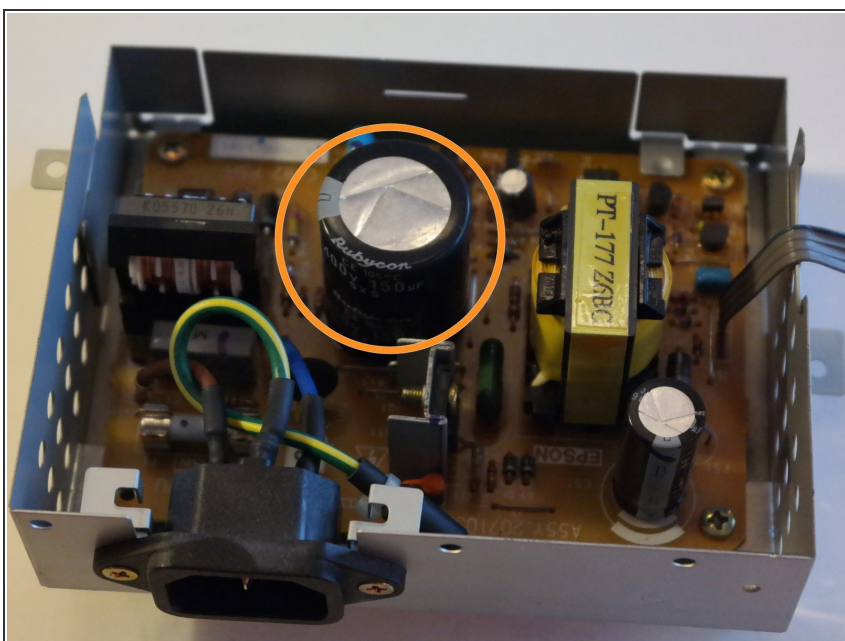
Step 18

- The inside of the power supply.

⚠ The large capacitor (circled in orange) can hold up to 400 volts, which will hurt if you touch it while plugged in.

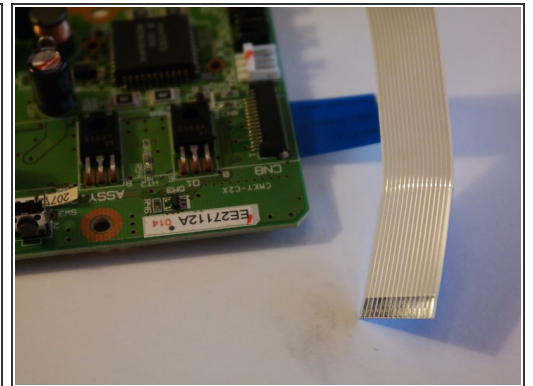
Step 20

- The heatsink is attached to the logic board by these screws.
- The large dual ribbon cable for the printhead attaches to two connectors on the logic board, one on each side.

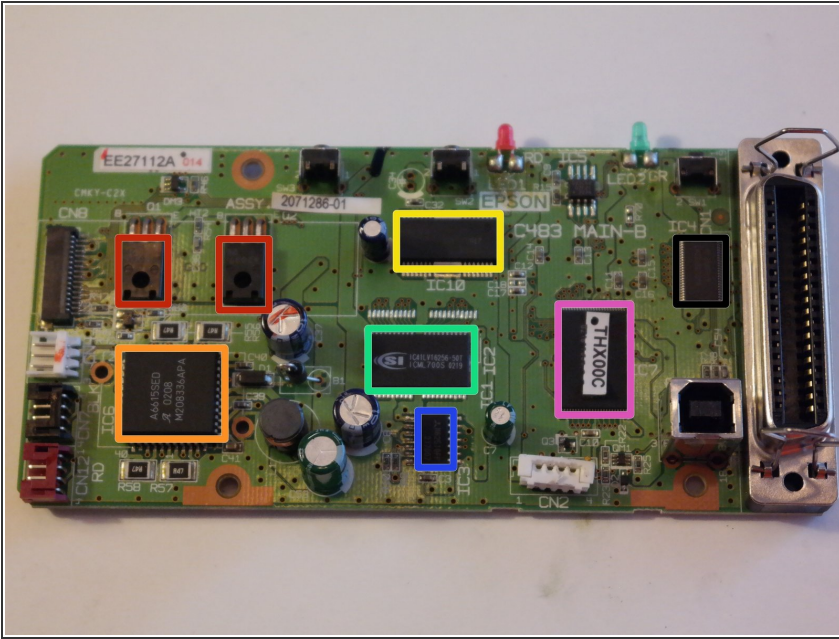
Step 21

- The chips on the logic board.
- A2037 and C5694 transistors
- A6615SED stepper motor driver
- 219A254UN proprietary EPSON chip
- IC41LV16256 256K x 16 bit dynamic RAM
- M62510FP bus termination regulator
- 29LV400TC 8 mBit CMOS flash memory
- LVCZ161284A high speed IEEE 1284 transceiver

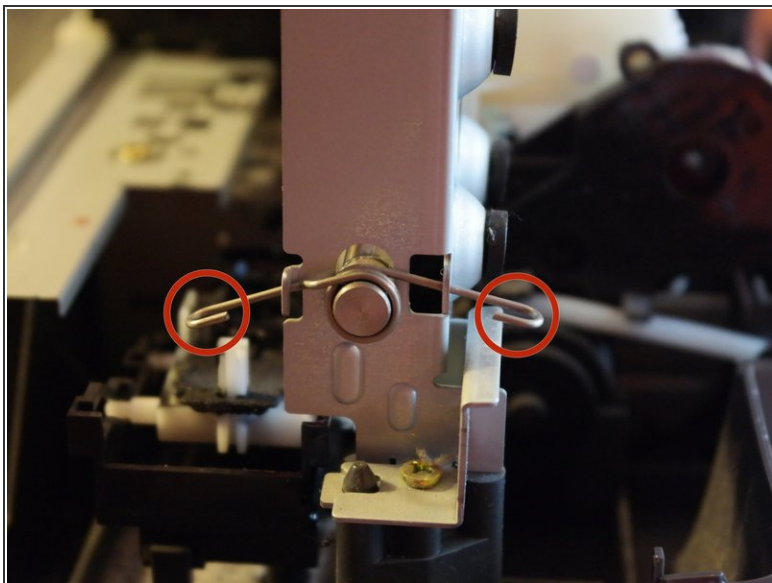
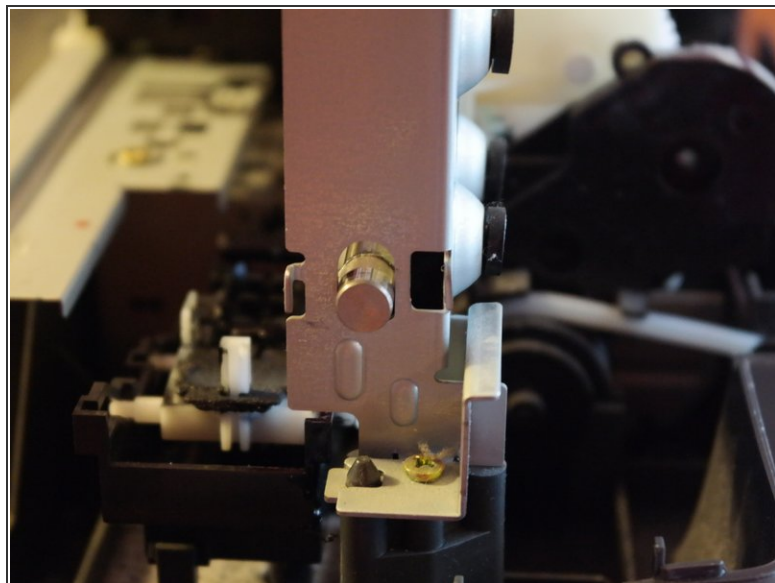
Step 23

- The main axle/rod/shaft/round metal thingy is held in by spring clips.

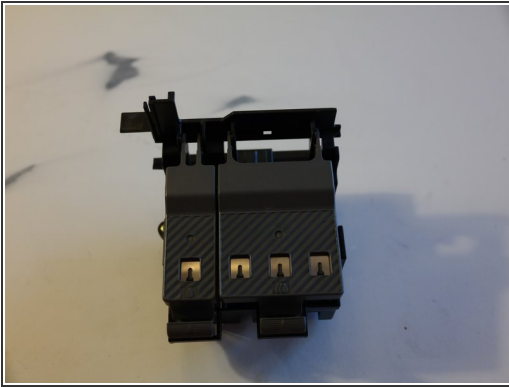
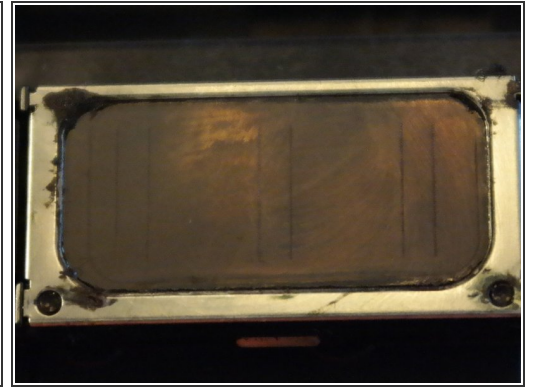
Step 27

- The print head
- The six lines on the print head visible in the second and third pictures are actually rows of microscopic ink nozzles.

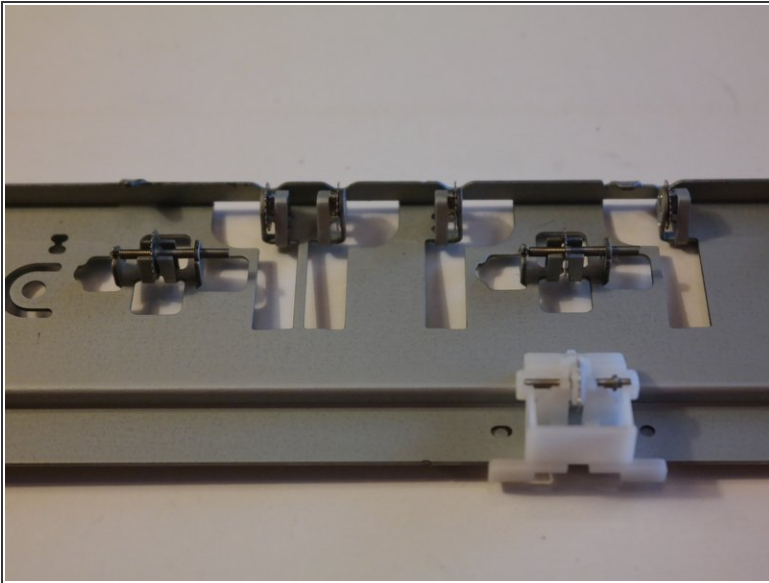
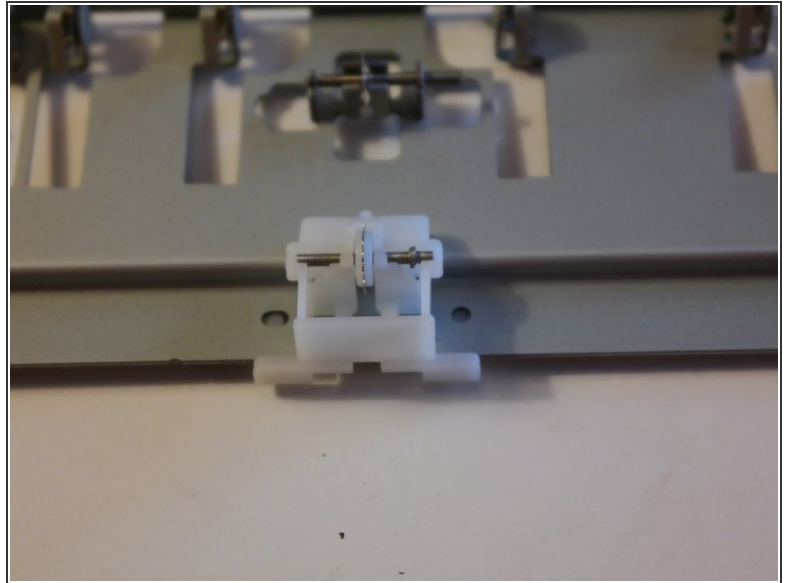
Step 29

- The metal strip contains many spoked wheels rotating on springs which allow them to be pushed out of the feed path.

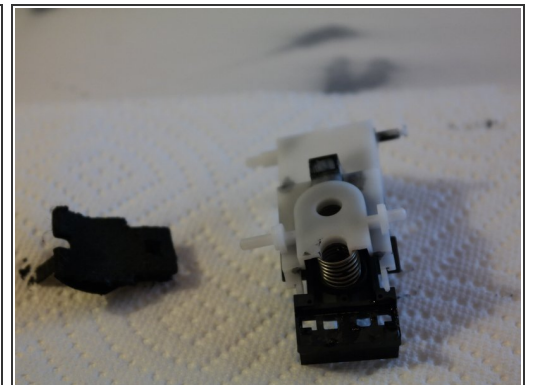
Step 30

- This inky mess is the nozzle cleaner.
- The assembly is spring loaded so the nozzles can be pushed into a pad to collect ink, which is then somehow transferred into the large absorbent ink pad.

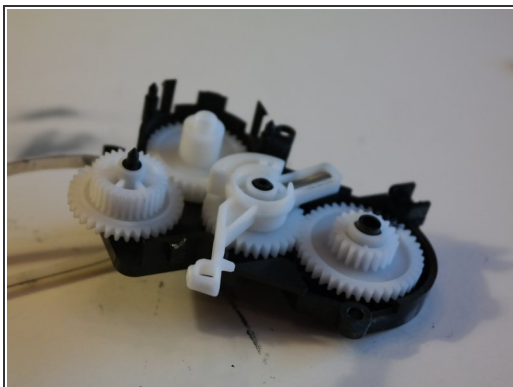
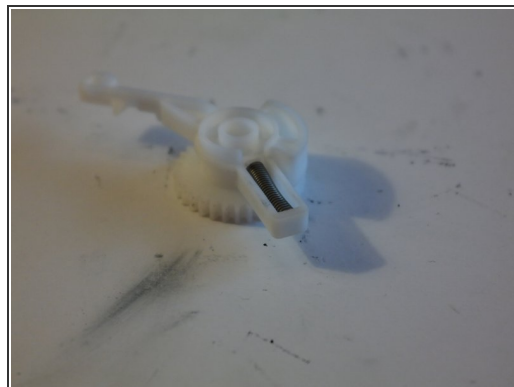
Step 37

- The gearbox drives the paper feed and the nozzle cleaning processes all from one motor.

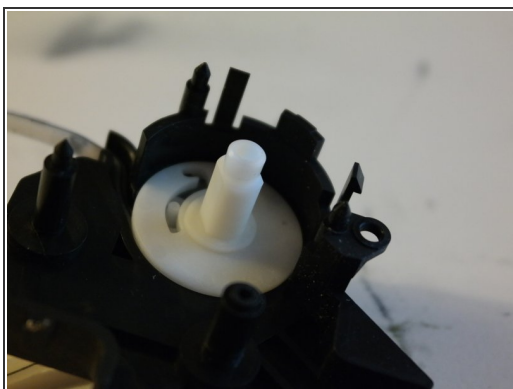
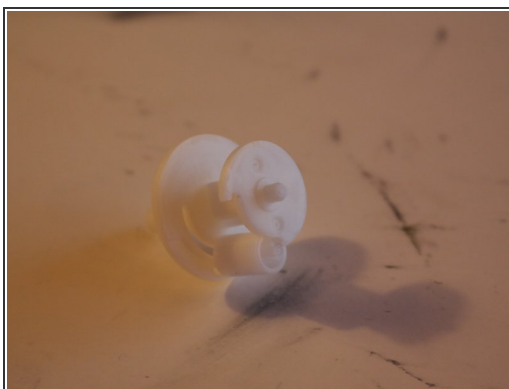
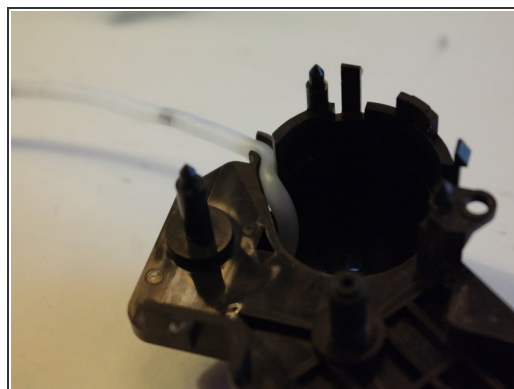
Step 38

- A close look at the peristaltic pump used to move ink from the nozzle cleaner to the large absorbent pads.

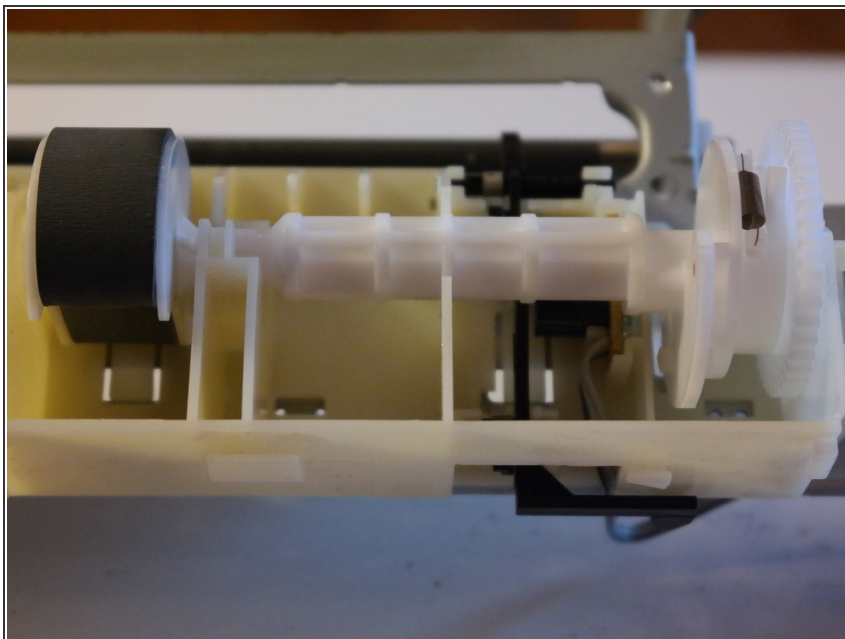
Step 39

- This is what is left of the paper feed mechanism. The circuit board contains two microswitches to detect if there is paper present.

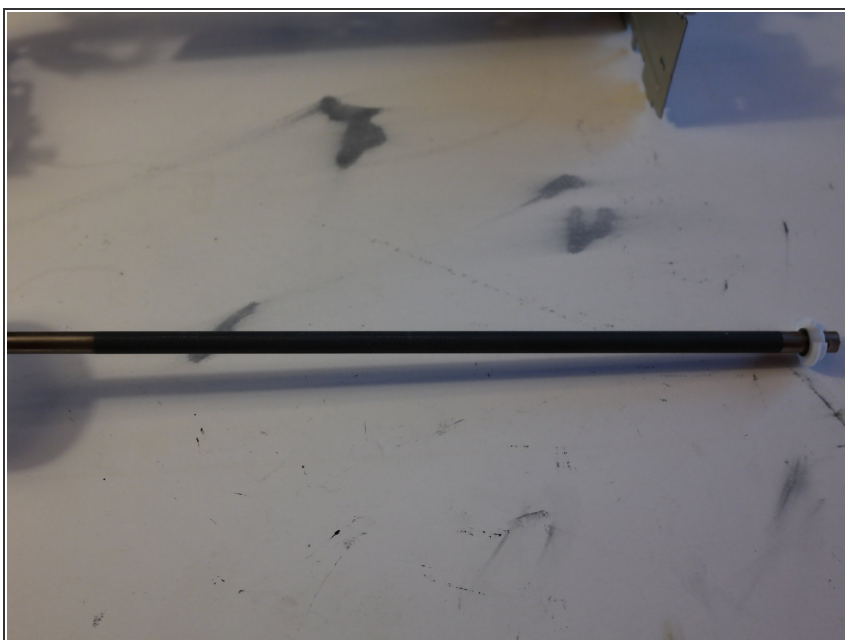
Step 40

- Another rod is removed from the printer.
- This rod is coated in something that helps it grip onto the paper better.

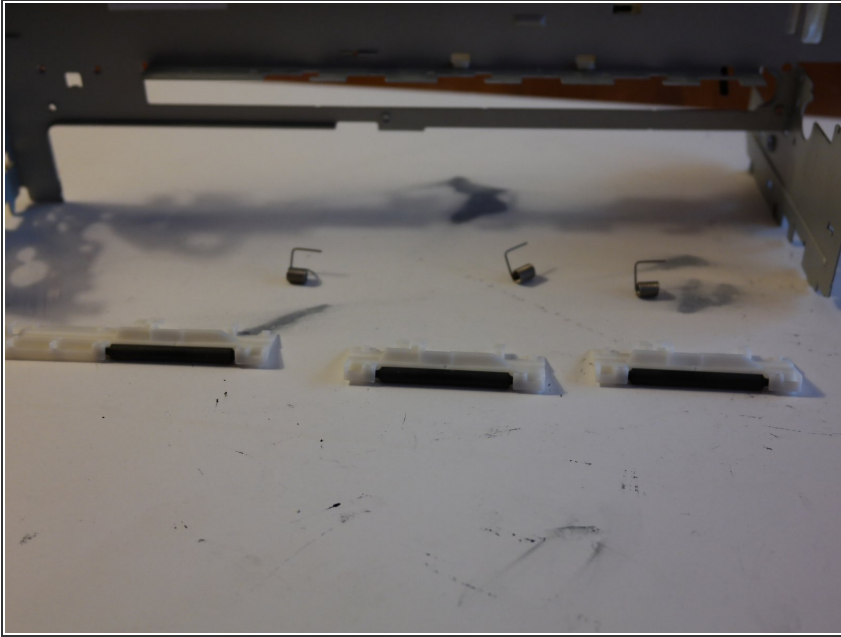
Step 41

- Lastly, here are the three spring-loaded rollers removed from the paper feed mechanism.

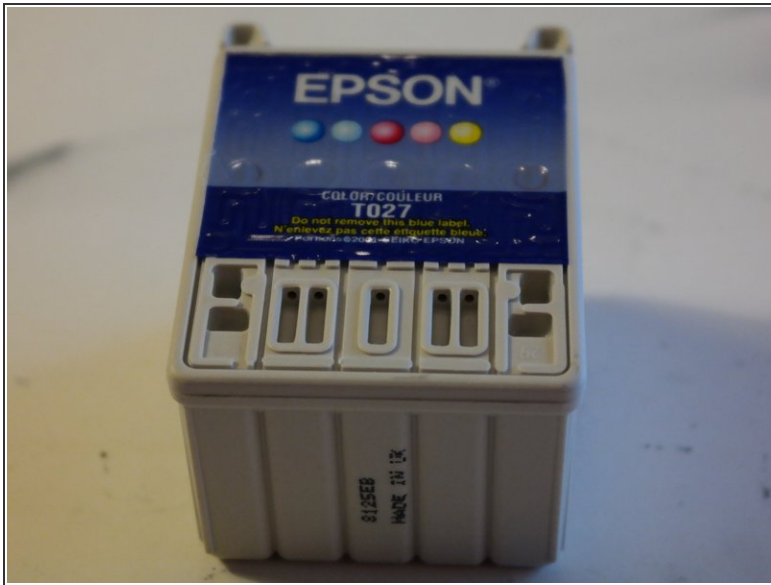
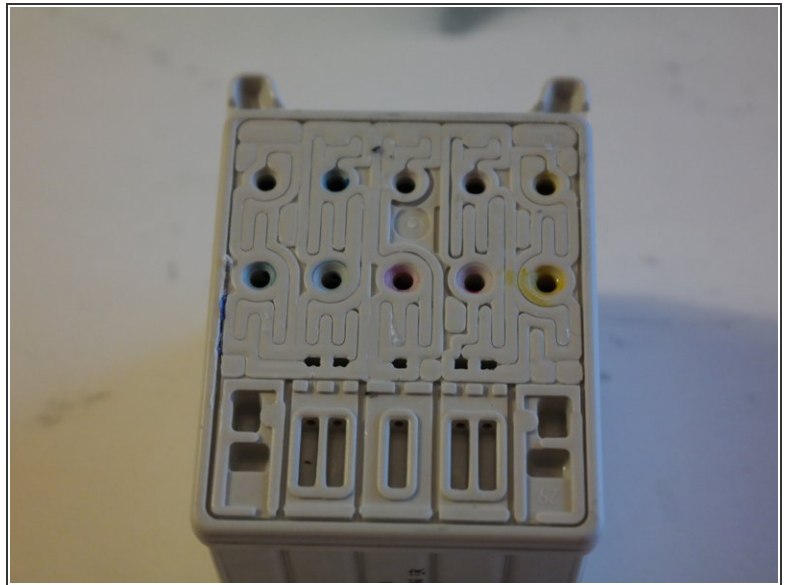
Step 43

- **Bonus Teardown Time!**
- Time to see what is underneath the 'Do not remove' sticker located on the ink cartridge.
- What is this network of labyrinthine passageways?
- The answer is a capillary tunnel to reduce ink pressure. The lower row of holes leads into the cartridge itself, while the top row leads to the ink nozzles.
