Hisense Sero 8 Charging Port Replacement

After extended use, the charging port may be worn down. If the device will not power on after charging, the charging port may be defective.

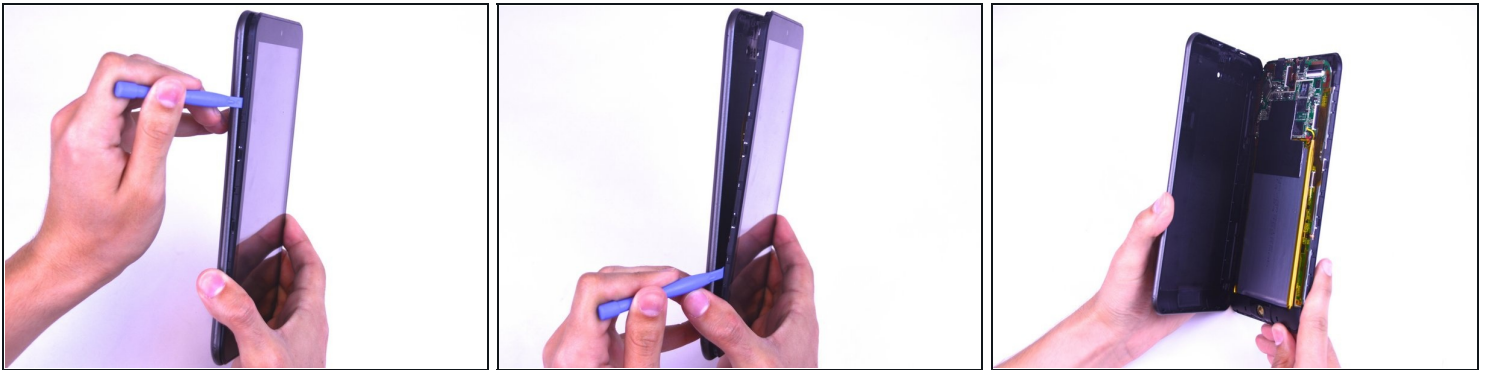
Step 1 — Charging Port

- Remove the back cover of the device using a combination of both plastic opening tools.
- Use your plastic opening tool pry open a corner of the device, then continue down the side of the device with the tool to completely open the device.

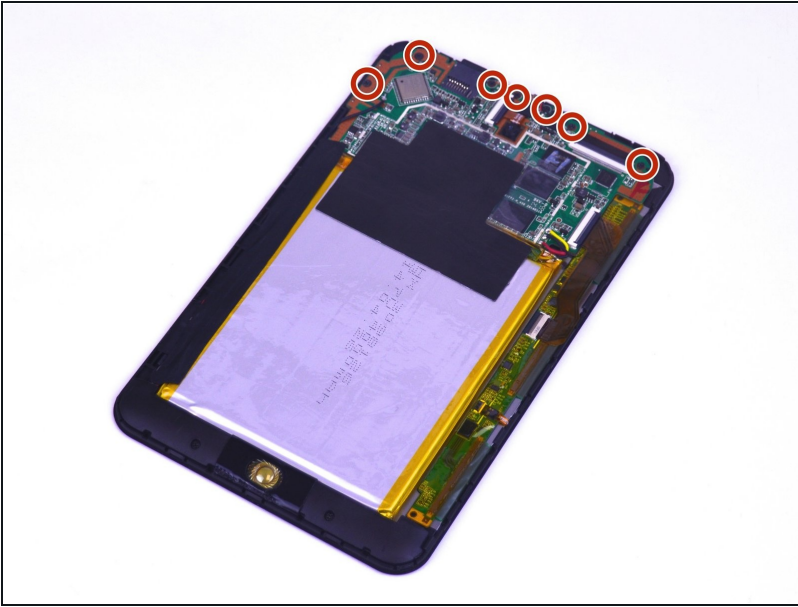
Step 2

- Remove seven of the 4.43mm screws using the Philips #00 screwdriver.
- ⓘ It is not necessary to remove the bottom two 4.43mm screws that keep the speakers in place.
