RYOBI P422 Grinding Head Assembly Replacement

This guide will show you how to remove the main cover for the driving mechanism of your grinder's blade and spindle. If the main gear is damaged, you can order a replacement head assembly component from RYOBI. [|RYOBI Parts List w/ ID #'s and Names]

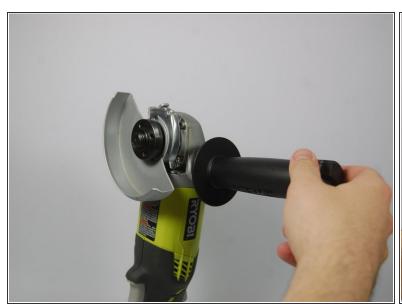
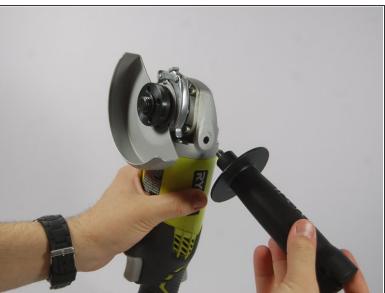
Step 1 — Battery and Handle

- To remove the battery press down on the two buttons located on each side of the battery and pull away from the body of the grinder.
- To remove the handle hold grinder with one hand and use the other hand to unscrew the handle with a counter-clockwise motion

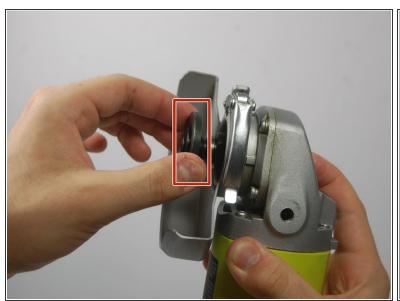
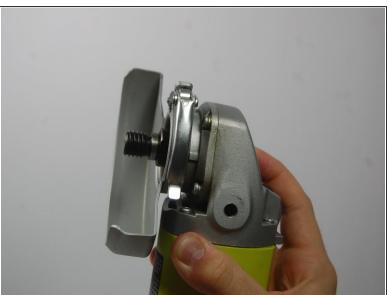
Step 3

- Remove your grinding/cutting tool by simply pulling it off the spindle.
- Next remove the disc flange (a.k.a spacer) by pulling it off of the back end of the spindle.
- (i) The disc flange has two small raised edges on its back side. These ridges need to be aligned with the two flat faces at the back of the spindle lock when reassembled. This will ensure a safe, snug fit for your grinding blades.
