Insignia NS-CLIP02 Power Auxiliary Port Replacement Replacement

Use this guide to replace the power auxiliary port in your Insignia NS-CLIP02.

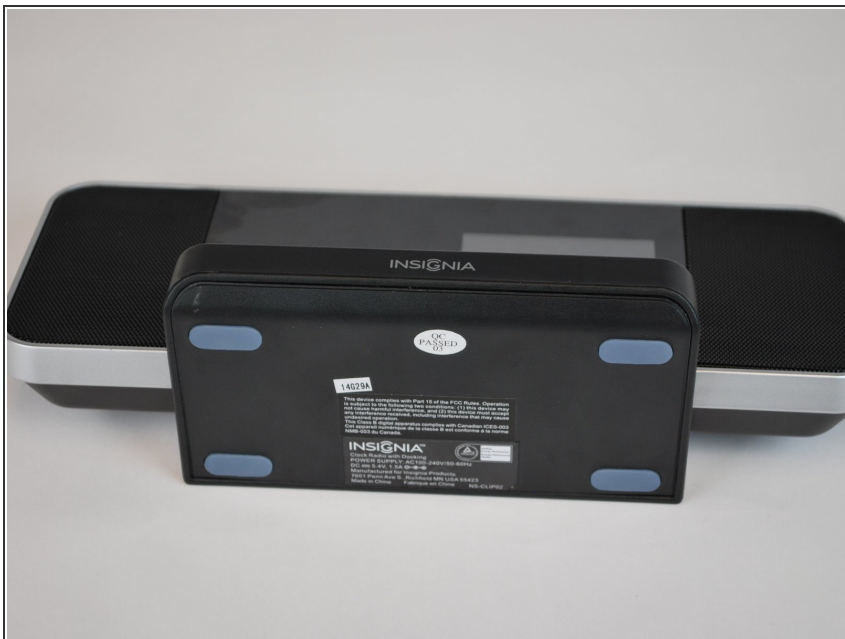
Step 1 — Power Auxiliary Port Replacement

- Locate the bottom of the device.

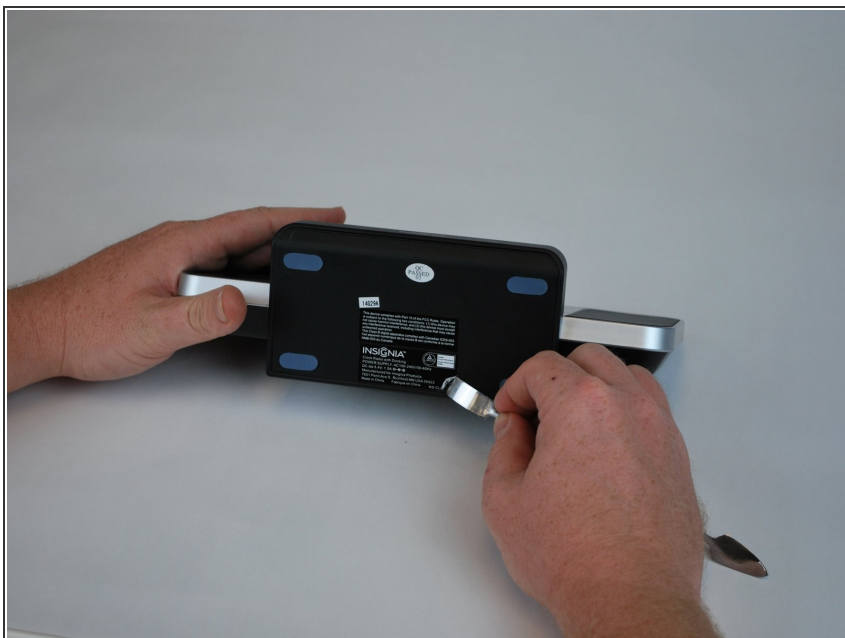
Step 2

- Peel back the adhesive sticker using a metal spudger and remove the 11mm screw beneath the sticker with a Phillips head screw driver.

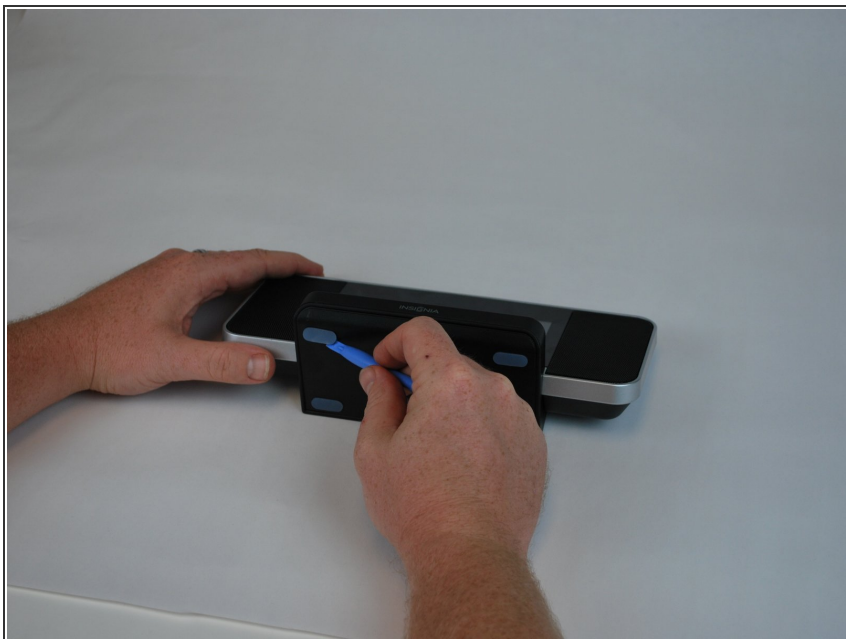
Step 3

- Using a plastic spudger, peel off the adhesive gel stoppers.

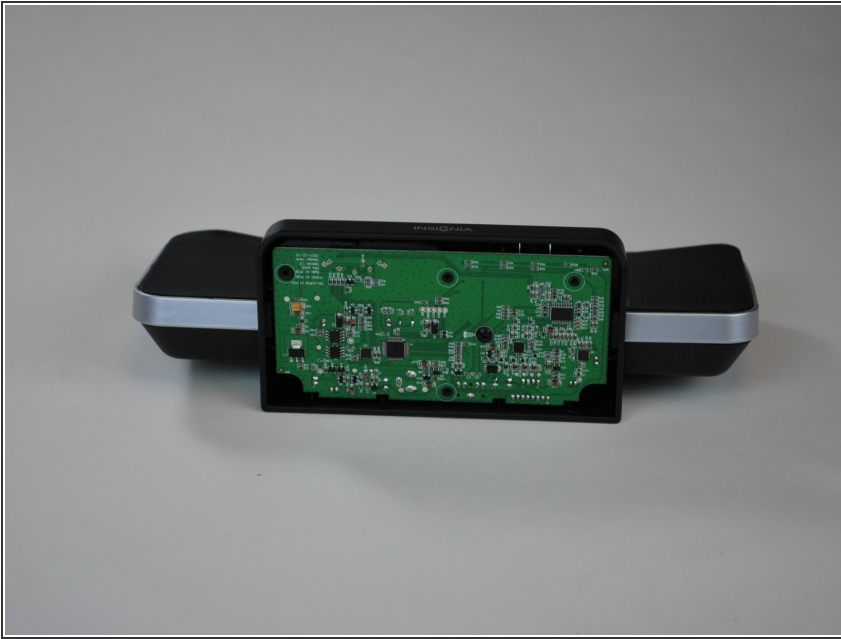
Step 5

- Remove the bottom of the device to reveal the motherboard.

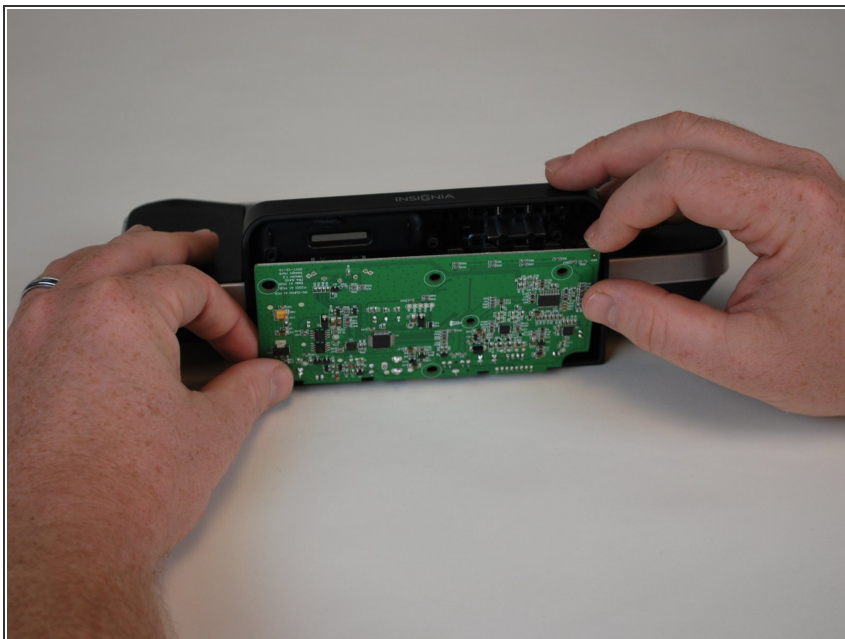
Step 7

- Lift the motherboard from the device and lie it face down. Beware of the cables plugged in on the back side

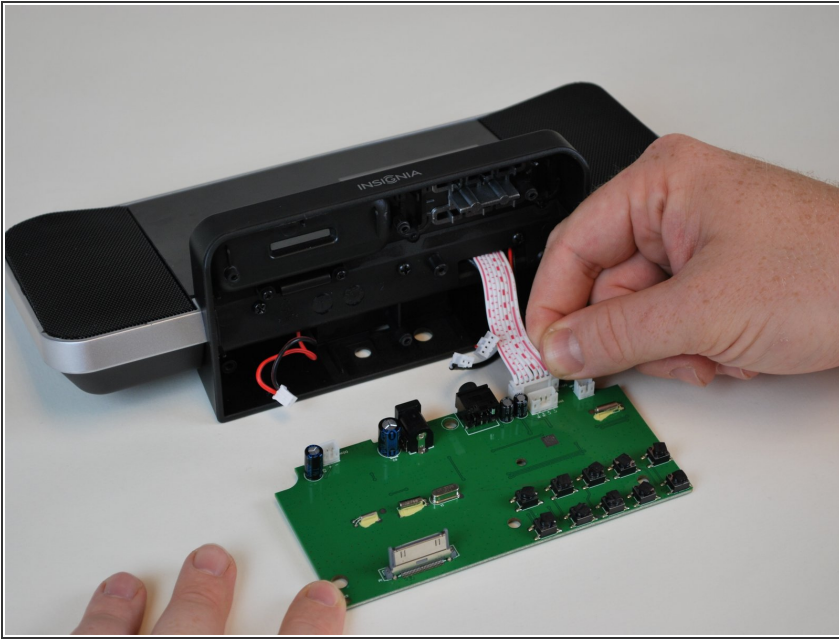
Step 11

- Remove the LCD screen plug last. For reassembly, follow the instructions in reverse order, replacing the old motherboard with the new one to fix the power auxiliary port.
