Ryobi VC120 Rubber Seal Replacement

This guide will help you replace the seal in the nose of the Ryobi VC120 vacuum cleaner.

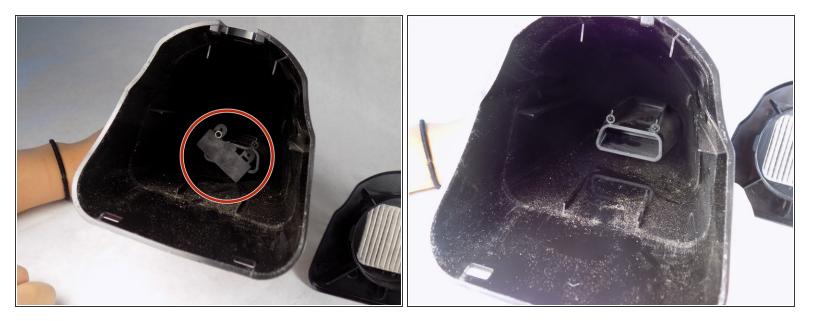
Step 1 — Rubber Seal

• Remove the nose of the vacuum and gently pull off the rubber seal by hand.

A Be careful replacing the seal on the posts, if you are too rough it may tear.
