Le Pan S Volume Rocker Replacement

A cracked or bent volume rocker may cause it to become misaligned. It may be necessary to remove and realign the rocker. If the rocker cannot be realigned, it will need to be replaced as shown.

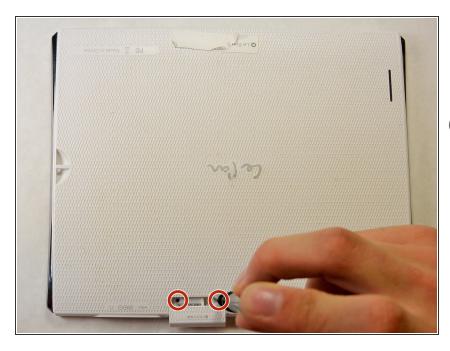
Step 1 — Battery

- Remove the two 3.5 mm Phillips #00 screws that are covered by the micro SD port.
- i This cover is adjacent to the volume button on the side of the Le Pan S.

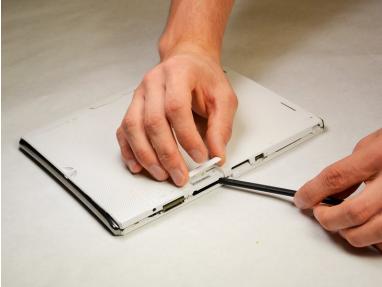
Step 2

- Insert the spudger between the front and back panel in order to pry them apart.
- (i) Do this beside the volume button and the micro SD cover.
- Pry open the rest of the Le Pan S by dragging the spudger across the side.

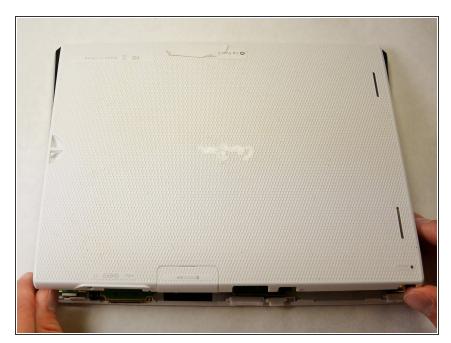
Step 3

Once the front and back faces are completely separated, remove the back cover to reveal the inside components.

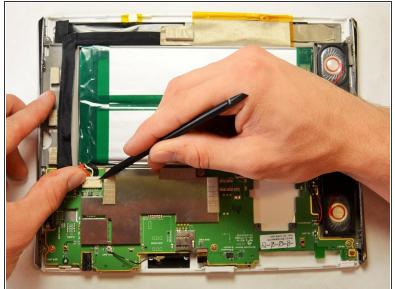
Step 4

- Disconnect the battery from the circuitry and lay it out of the way.
- The best method to complete this is to pull the bundled cable connector out with your hands. Pull towards the wires and away from the electrical board. Use the spudger to further coax the cable out.
- If you are replacing your battery, make sure to dispose of it properly.

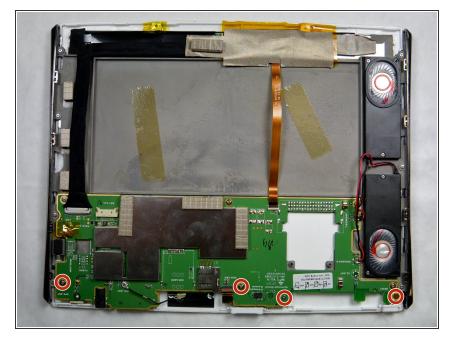
Step 5 — Volume Rocker

Remove the four 2.5 mm Phillips #00 head screws from the circuit board near the top of the tablet.

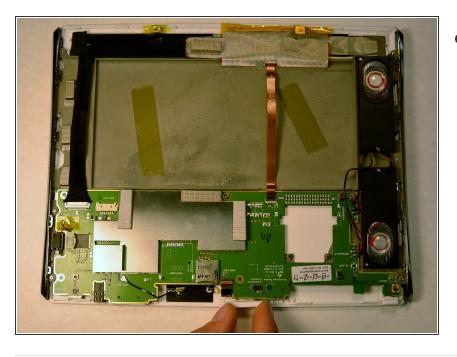
Step 6

Pull out the volume rocker by carefully moving it side to side with your fingers.
