ATT CL2940 Phone Jack Replacement

Written By: Noor Assaf

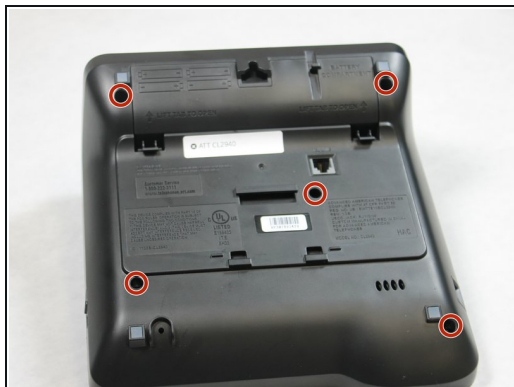
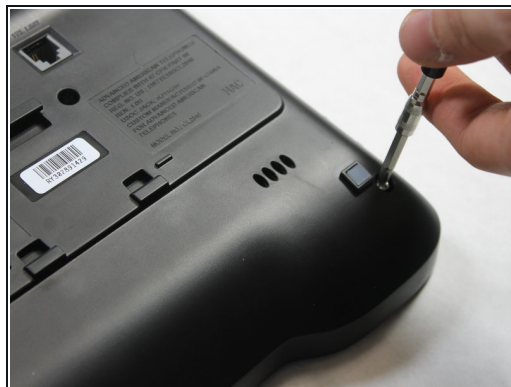
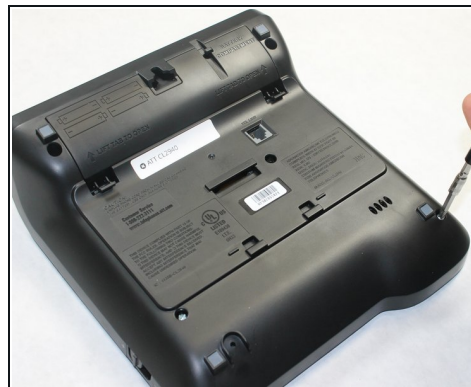
Step 1 — Back Panel

- Remove five 9.5 mm Phillips #1 screws from the back panel of the phone.

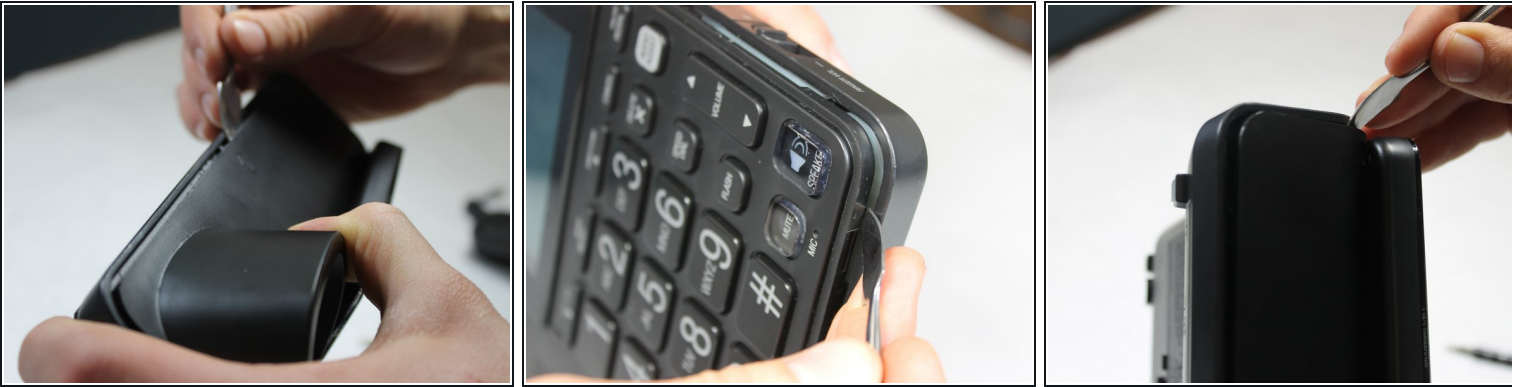
Step 2

- Slide the metal spudger into the crack and continue around to the front panel of the phone.

⚠ Be careful not to break the clips that hold the back panel to the front panel.
