Philips TT2021 Bodygroomer Series 5000 On / Off Switch Replacement

The razor can not be switched off or switched on anymore?

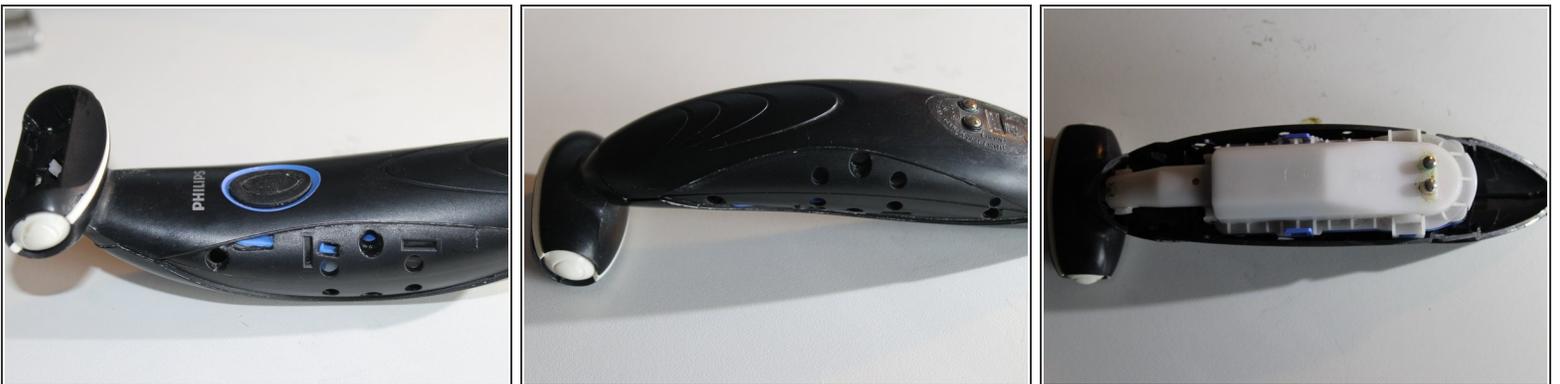
Step 2

- Next, open the black plastic case (also like the white parts with a thin slotted screwdriver)

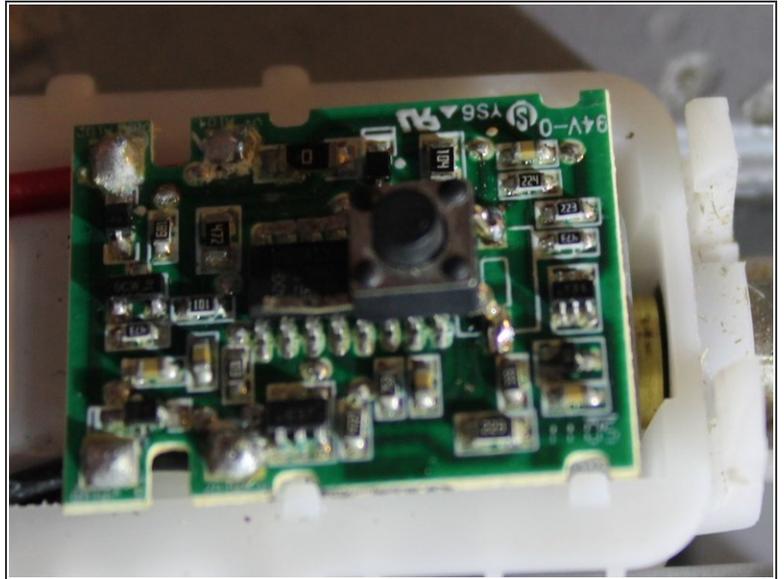
Step 5

- Now solder in the new button
- The button should rest on the IC module so as not to slip / bend
