Bissell PowerLifter Brush Belt Replacement

This is a quick repair and will ensure that your Vacuum cleaner will work as it should.

Here is a Bissell PowerLifter vacuum cleaner where the front brush did no longer turn. First thought with this problem is always the drive belt.

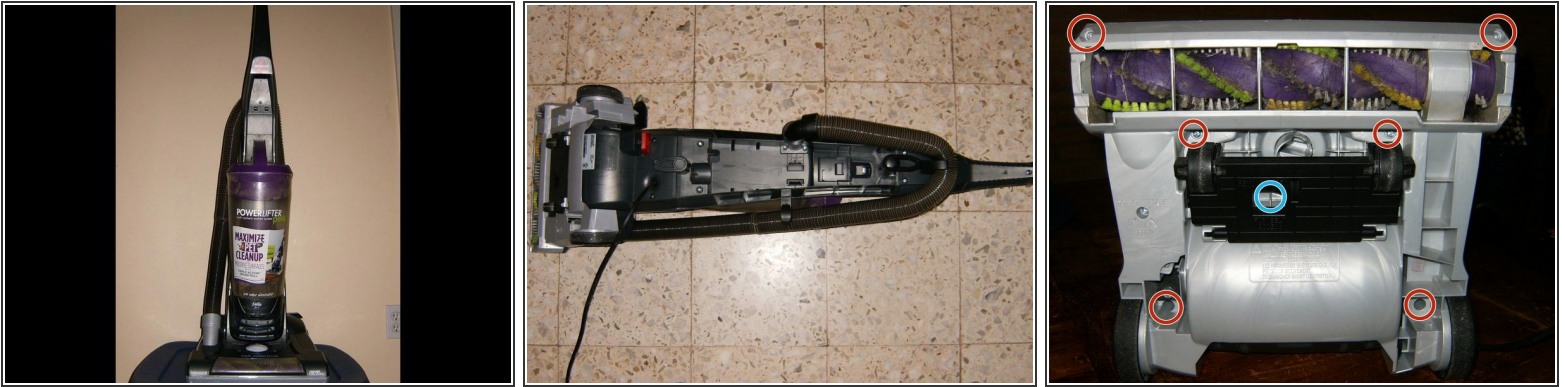
Step 1 — Brush Belt

- Here is the Bissell vacuum cleaner. The front brushes did no longer turn.
- Unplug the vacuum and turn it over so the bottom of the vacuum can be accessed
- There are a total of 7 Phillips head screws that need to be removed.
 - One of these screws is behind the height adjustment plate. It must be removed to gain access.

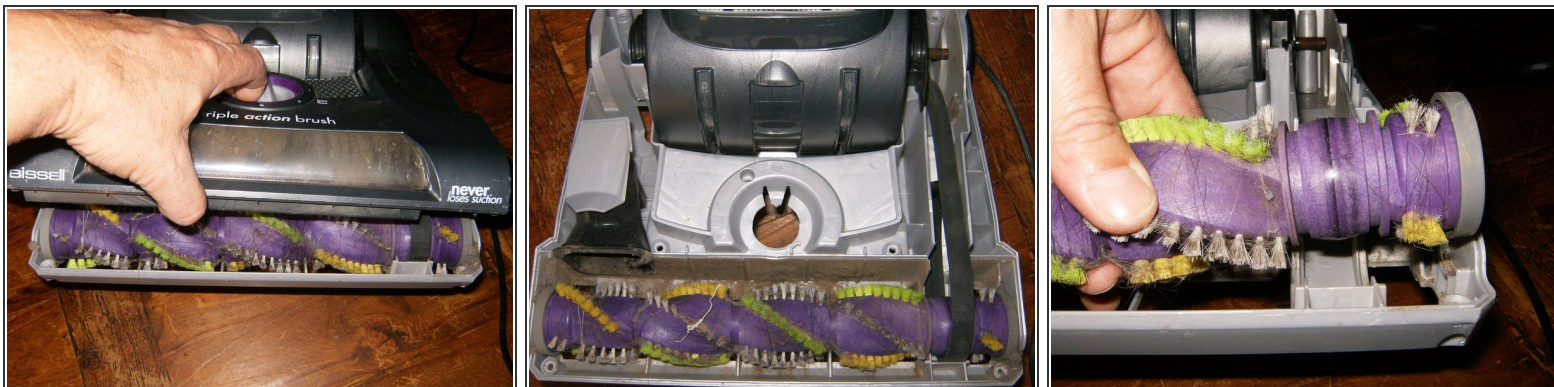
Step 3

- Turn the vacuum around and move the top cover straight up
- Here is the brush assembly with the belt on the right. This belt was definitely broken.
- Remove the brush by pulling it straight out.
