2004 Toyota Sienna Sliding Door Motor Replacement

This guide will show you how to diagnose and fix the common issue with the 2004-2010 Toyota Sienna sliding door.

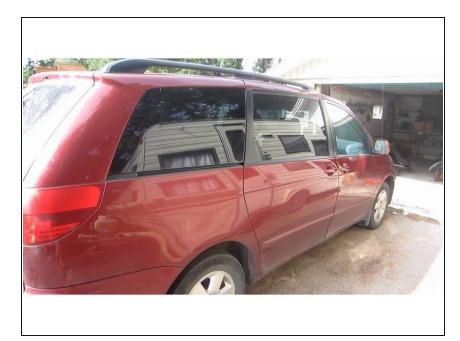
- First, test both sliding doors to identify the problem with the driver's side door
 - source.

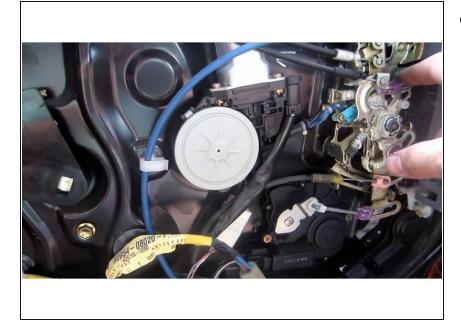
- Close the door and observe the actuator motor on the working passenger side door for comparison
 - source.

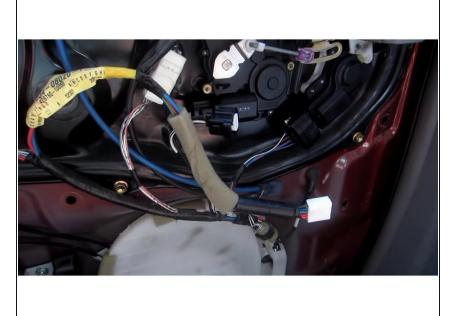
- On the driver's side door, test the voltage to confirm it's an issue with the actuator motor and not an electrical problem
 - source.
