Microsoft Band 2 Wrist Clasp Replacement

Replacing the primary spring in the small square section of the clasp in order to allow the band to lock together and be wearable.

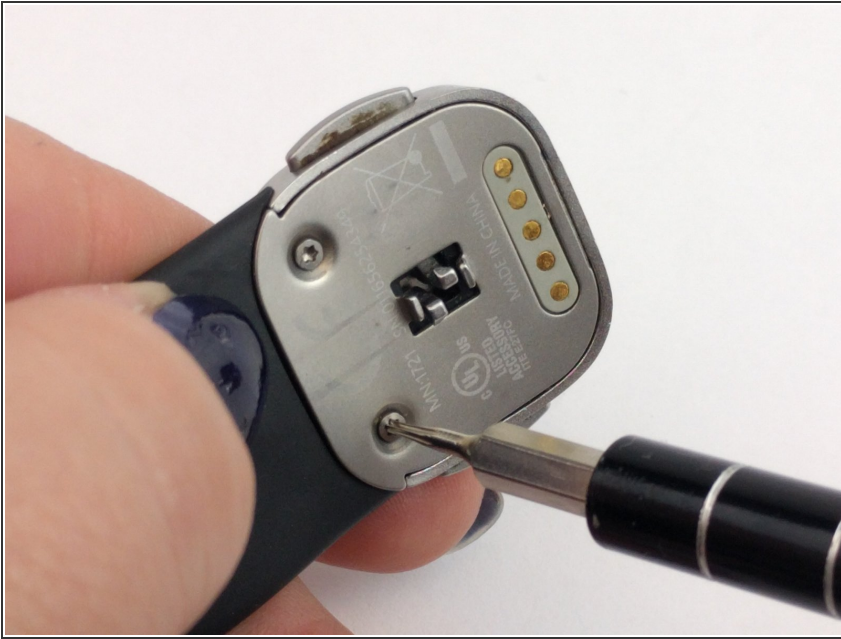
Step 1 — Wrist Clasp

- Use the T3 screwdriver to remove the two 2mm screws in the device. The top metal panel should come off with ease once the screws have been removed.

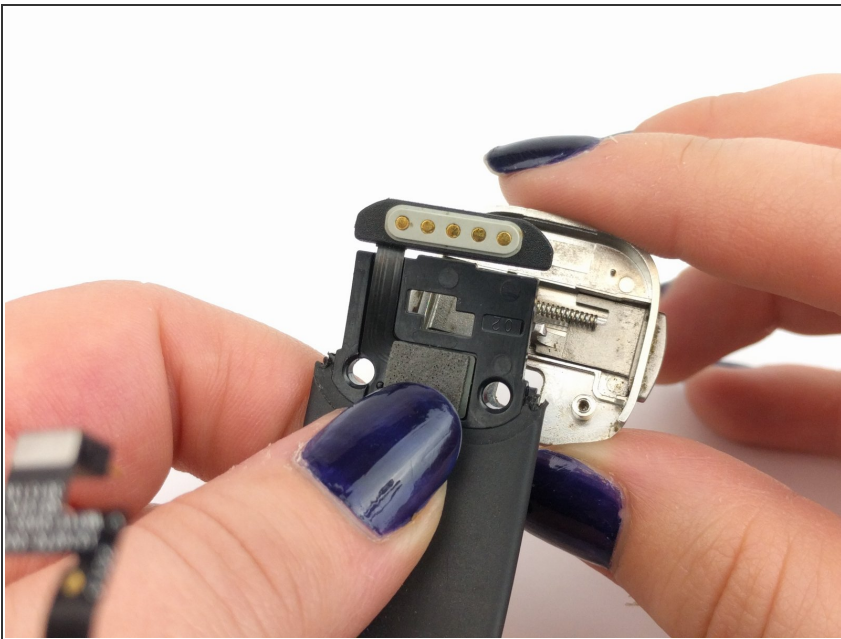
Step 2

- Separate the watch band from the bottom metal panel.
- ⓘ There is a spring underneath the watch band that may break loose.

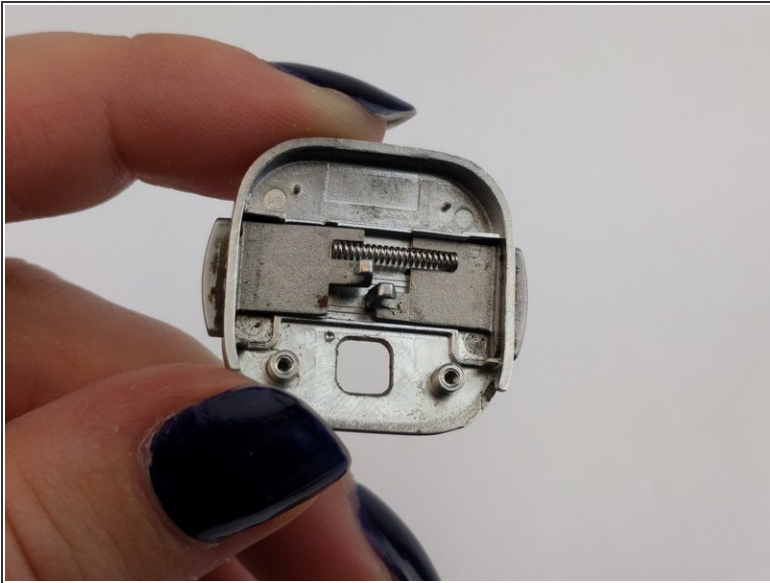
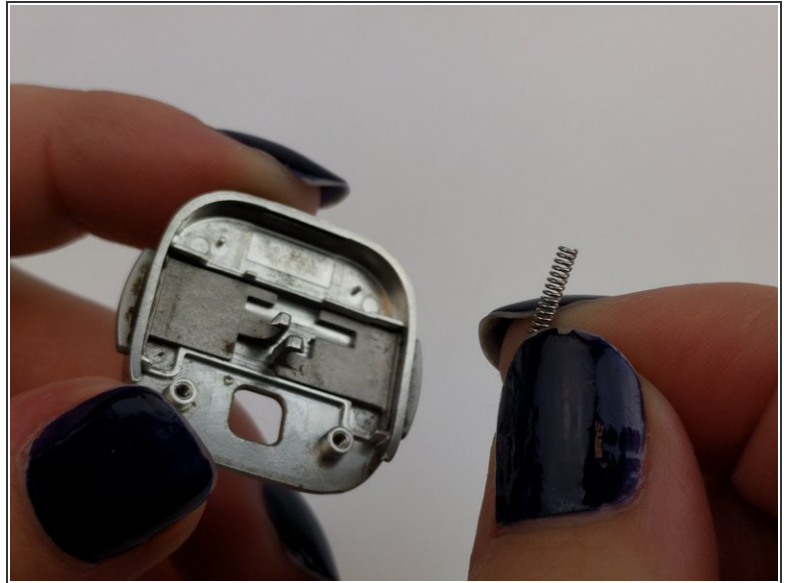
Step 3

- Remove the spring.
