# Toshiba Satellite A105-S4074 Optical Disk Drive (DVD/CD-ROM) Replacement

Replacing a non-functioning optical disk drive of the Toshiba Satellite A105-S4074. The drive door not open or read any CD's or DVD's.

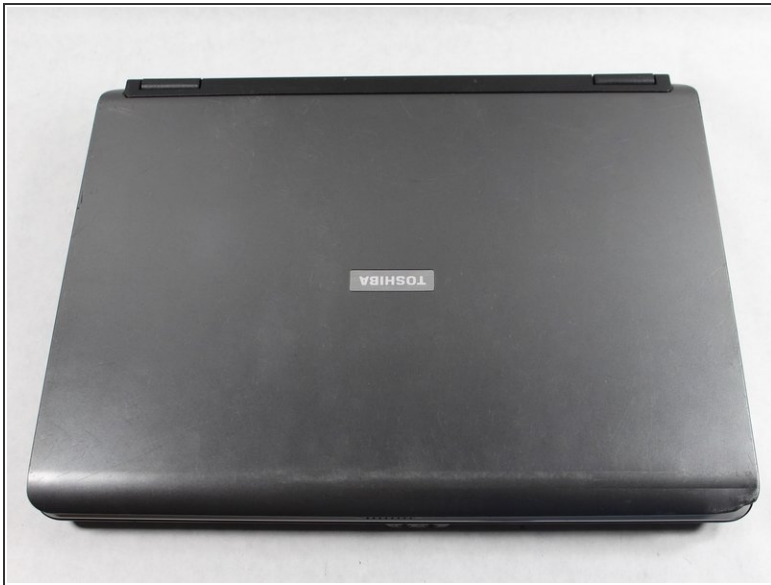
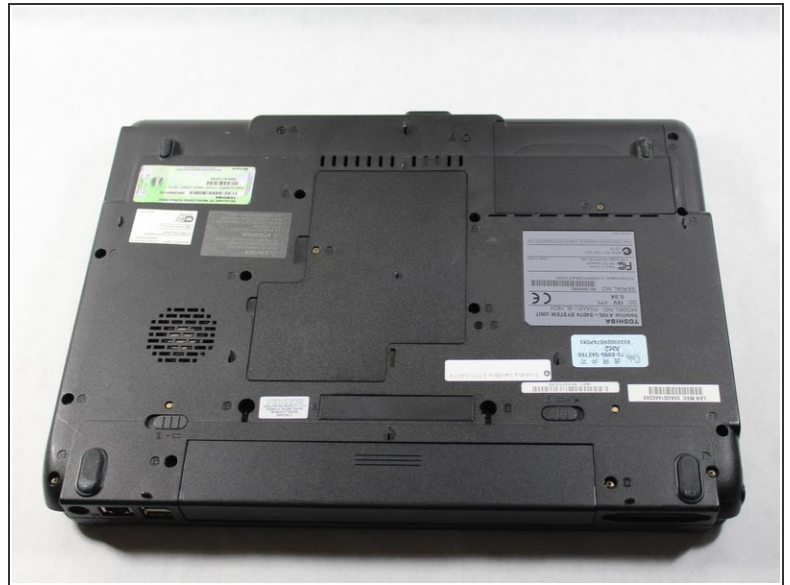
## Step 1 — Battery

To prevent electrical shock, make sure the computer is turned off; and disconnect the power adapter from the computer and electrical outlet prior to beginning any repairs on this device.

- Turn the laptop upside down with the battery facing you.

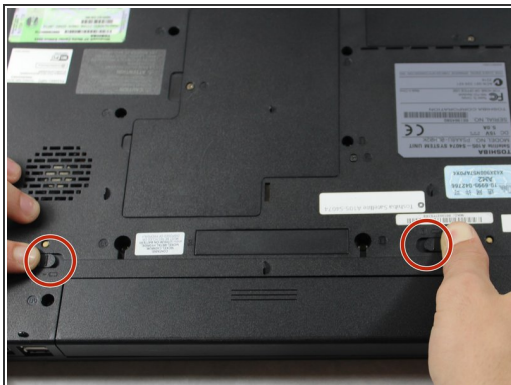
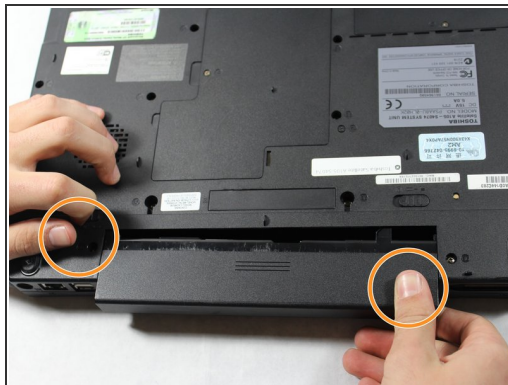
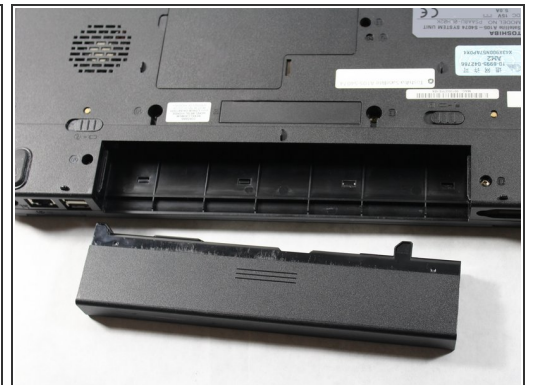
## Step 2

- Slide both the left and right battery release tabs outwards away from center of the laptop.
  - ⓘ Right release tab will remain locked in place.
- While still holding the left release tab, slide the battery towards you using your right hand.
- Fully remove the battery from the laptop.

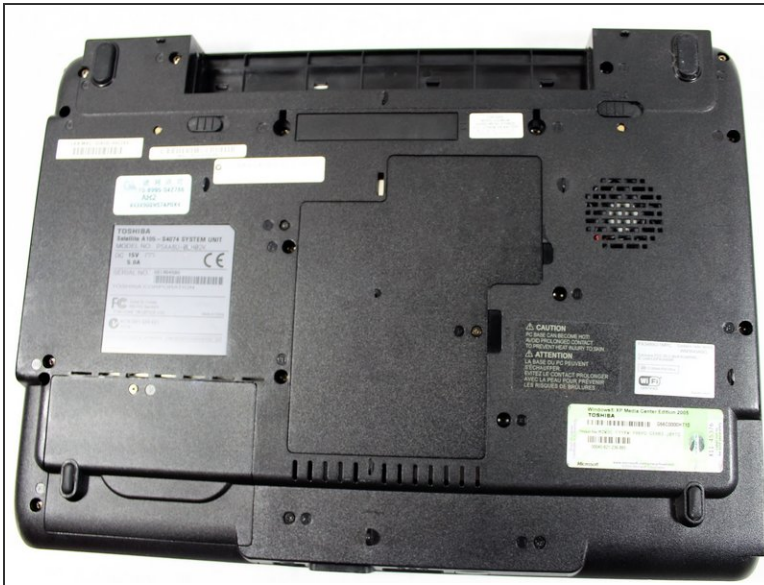
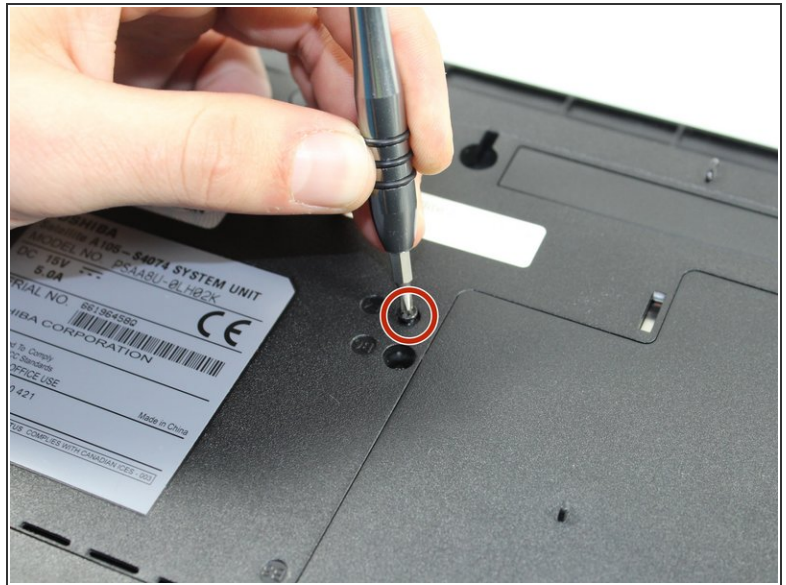
### Step 3 — Optical Disk Drive (DVD/CD-ROM)

- Turn the laptop around with the battery slot facing away from you.
- Remove the 5.0 mm screw that is holding the optical disk drive internally in place using the Phillips #1 screwdriver.

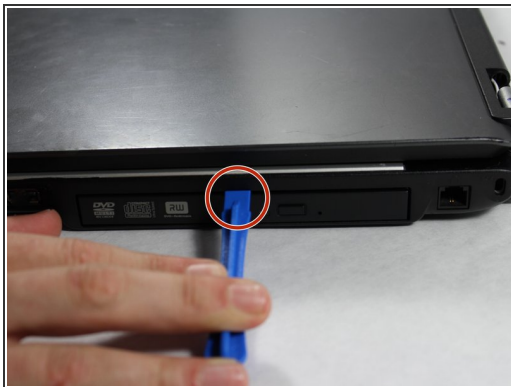
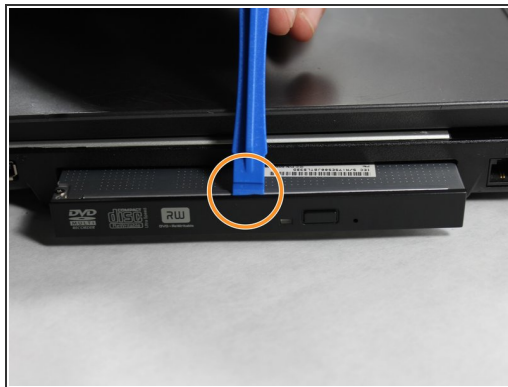
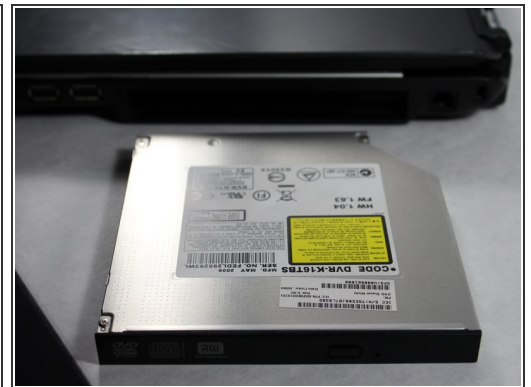
### Step 4

- Turn the laptop back over (cover-side up) with the optical disk drive on the right side.
- With the plastic opening tool, pry the drive out from the top.
- Using the opening tool, pull the drive out of the drive bay.

To reassemble your device after replacing the DVD SuperMulti drive, follow these instructions in reverse order.
