# Microsoft Band 2 Buttons Replacement

Written By: Chris Syracuse

In the event that the buttons on the side of the Microsoft Band 2 become jammed or unresponsive, follow this guide to learn how to remove them for cleaning or replacement.

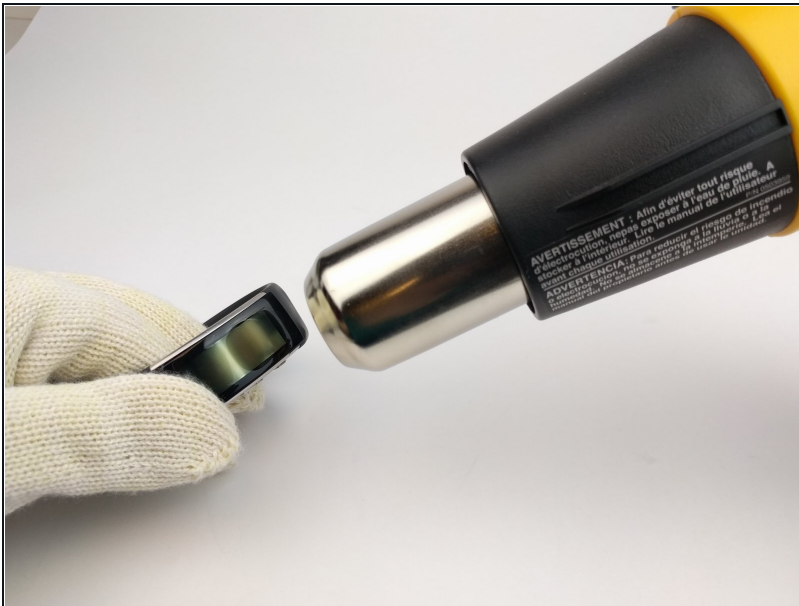
## Step 1 — Screen

- Use a heatgun to melt the adhesive beneath the screen. Heat the metal around edges of the screen.
-

Avoid heating the rubber watch band as it will quickly melt.
-

Heating the LCD screen may damage it. Avoid this procedure unless you intend to replace the screen.

**Wear proper gloves when using a heatgun.**

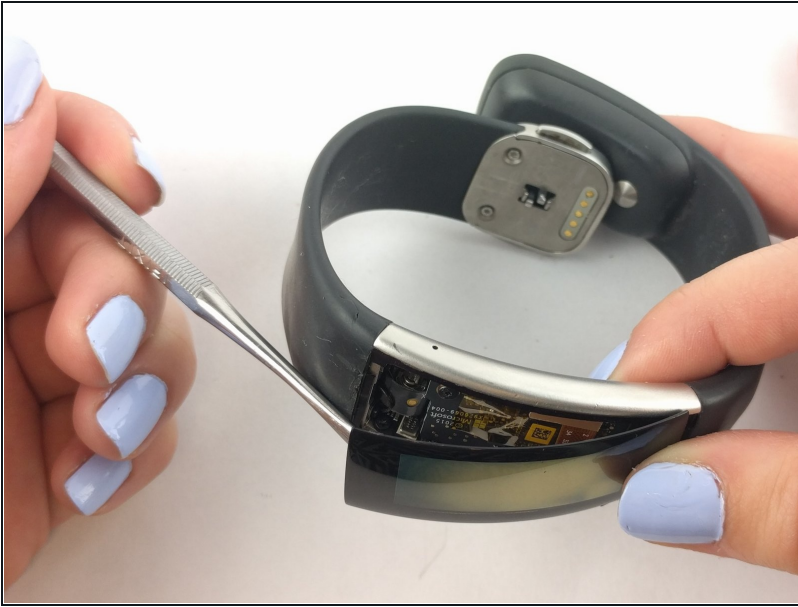
## Step 2

- Use a [spudger](#) and plastic [opening picks](#) to pry the screen away from the Band 2.

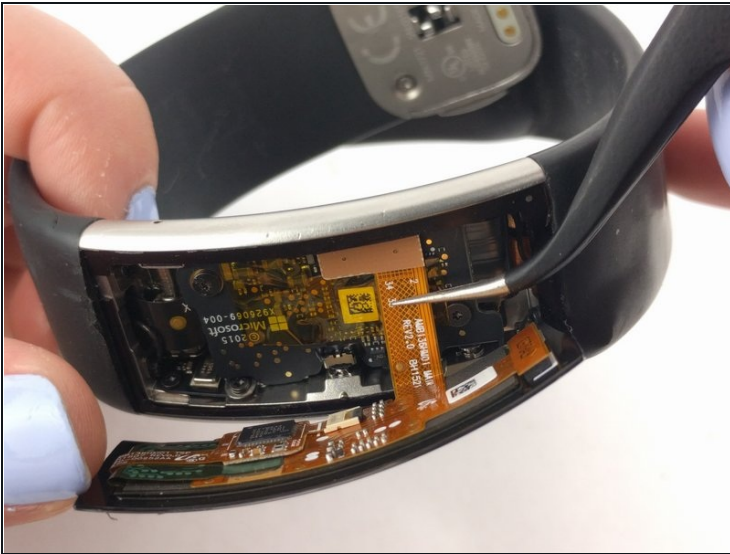
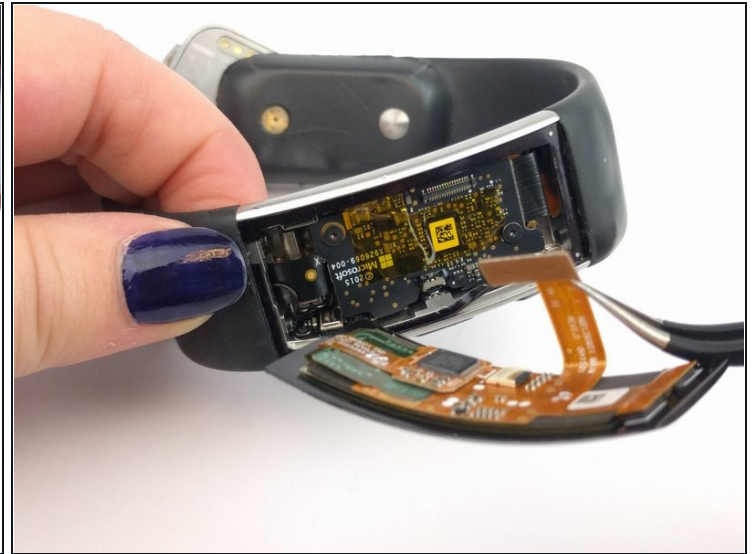
## Step 3

- Use metal [tweezers](#) to gently detach the orange press-fit (or "pop") connector.

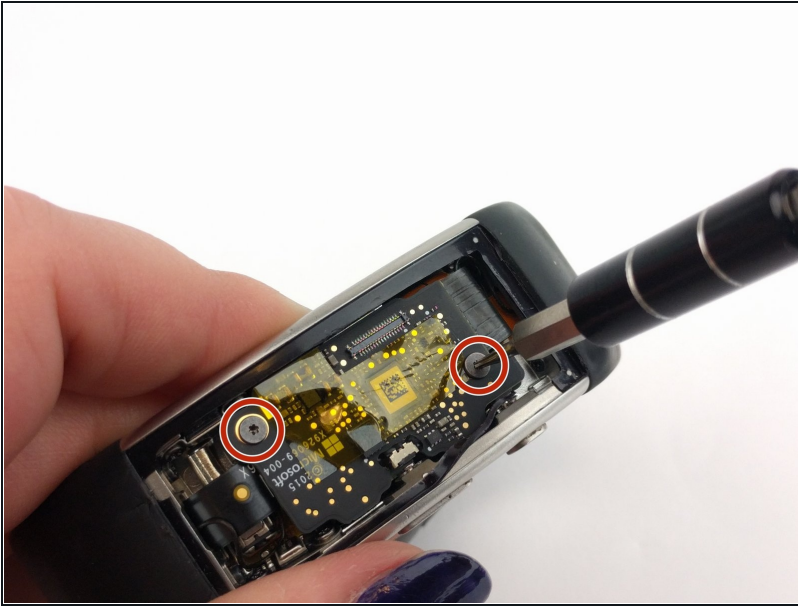
## Step 4 — Buttons

- Use the T3 Torx Screwdriver to remove the two 2.7 mm screws
