MSI GT72 2QE Dominator Pro CD Drive Replacement

Removing the CD drive from the MSI GT72 2QE Dominator Pro.

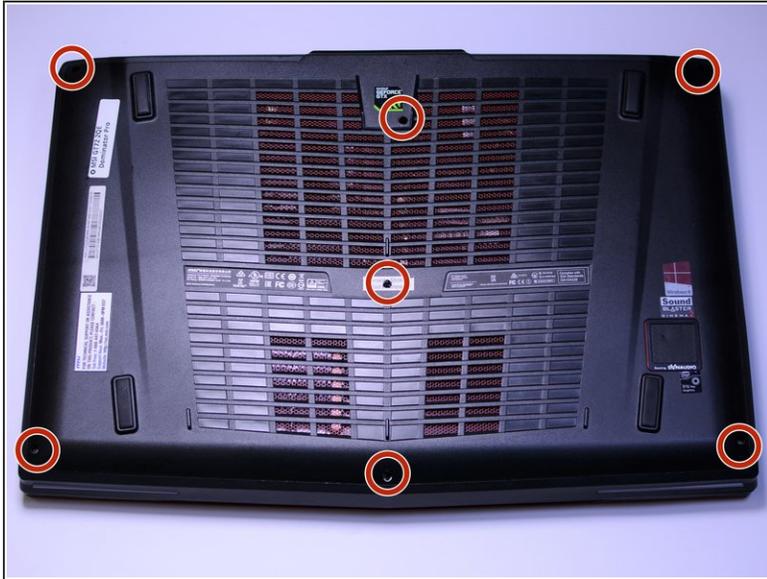
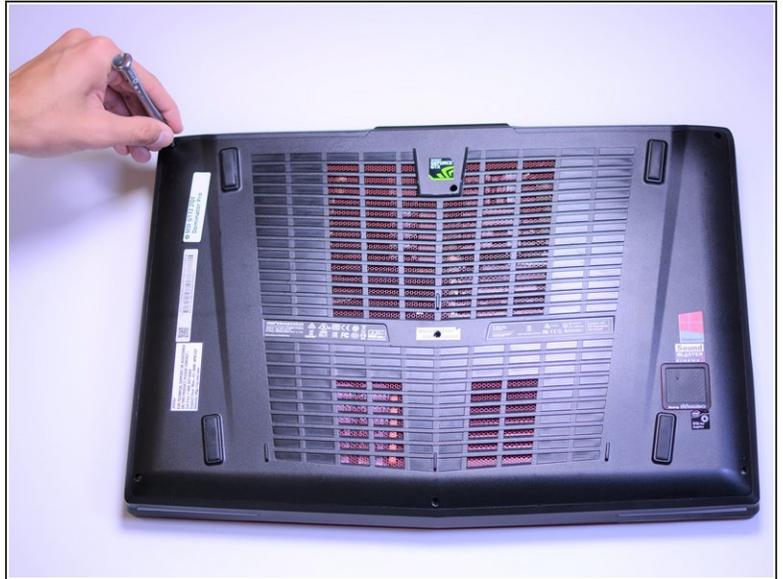
Step 1 — CD Drive

- Remove the indicated seven (7) 6 mm Phillips #0 screws for the back cover.

i The same PH0 screwdriver bit can be used throughout all the steps.

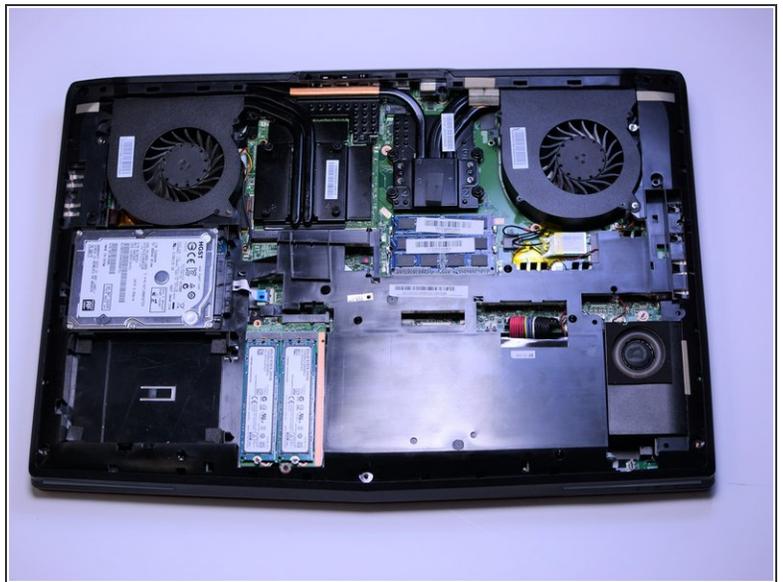
Step 2

- Lift the back cover using the tab to expose the hardware beneath.

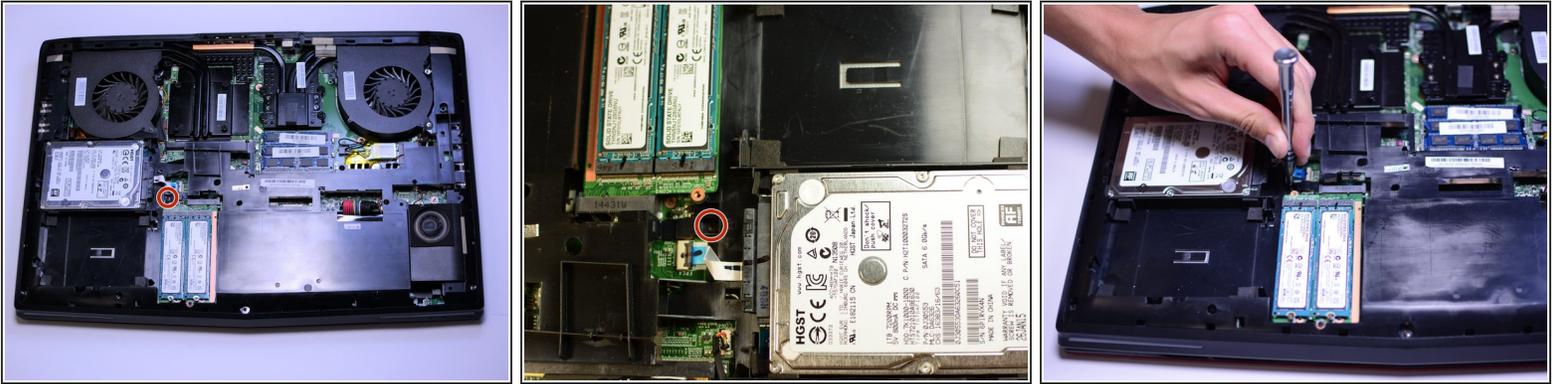
Step 3

- Remove the indicated 5mm Phillips #0 screw.

⚠ This is the only screw holding the CD drive in place. Do not lose it.

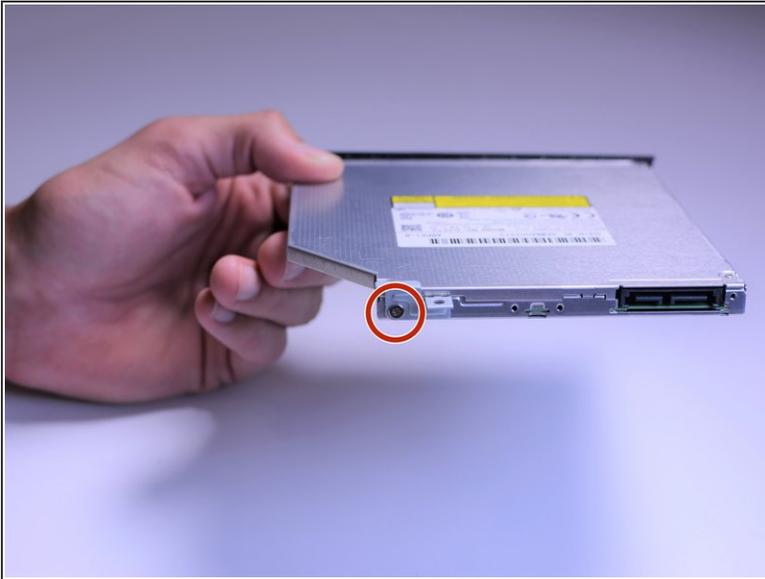
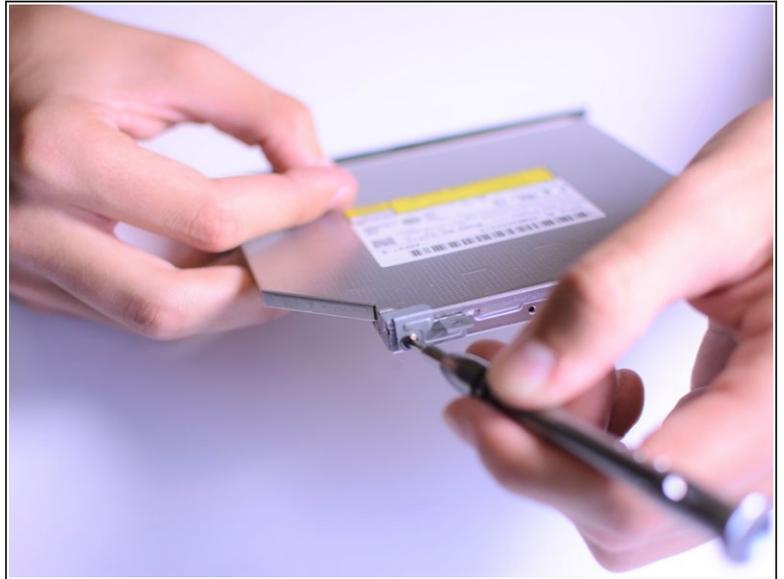
Step 5

- Remove the indicated 4mm Phillips #0 screw and metal hinge.

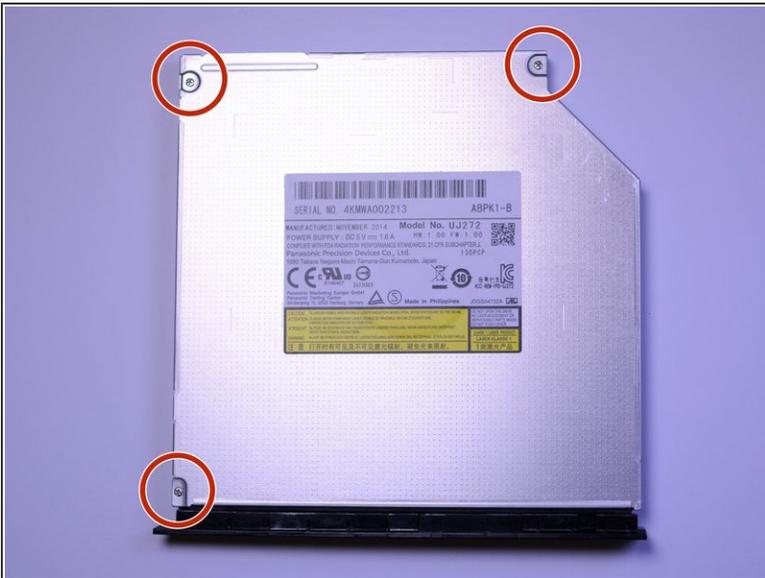
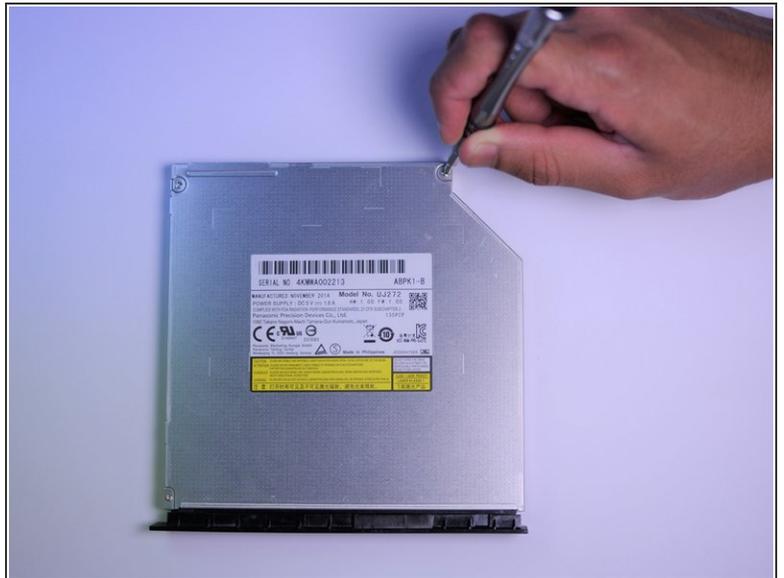
Step 6

- Remove the three (3) indicated 2mm Phillips #0 screws.

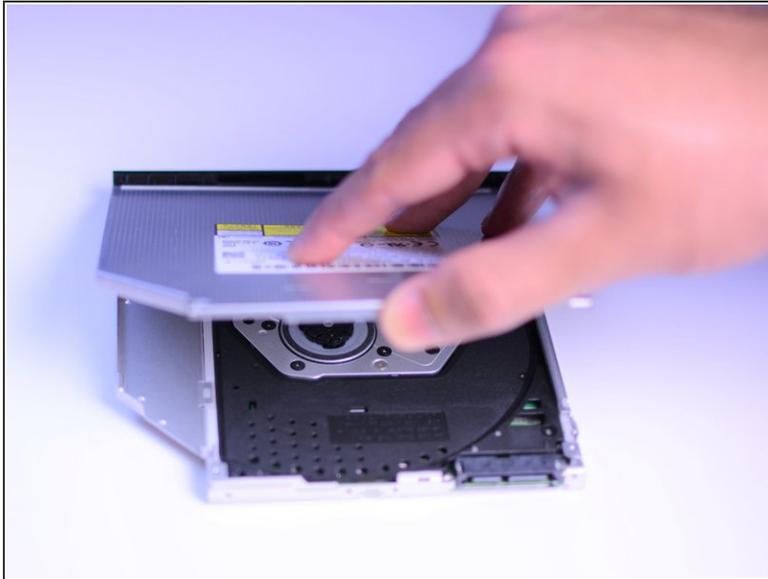
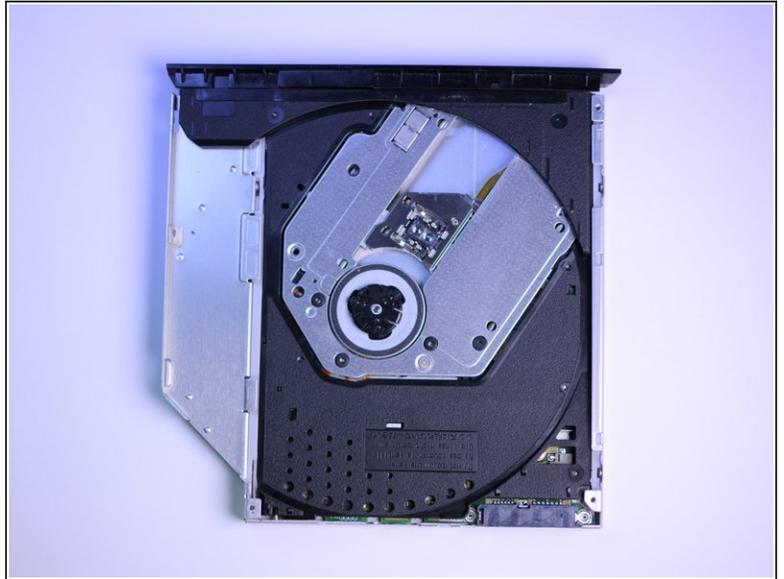
Step 7

- Lift metal cover gently, using the tab like indent located where the arrow is pointed.
- This should expose the inside of the CD drive.
