Altec Lansing BoomJacket Bluetooth Board Replacement

This replacement guide for the Altec Lansing BoomJacket will give step by step information about how to repair the Bluetooth Board in your device.

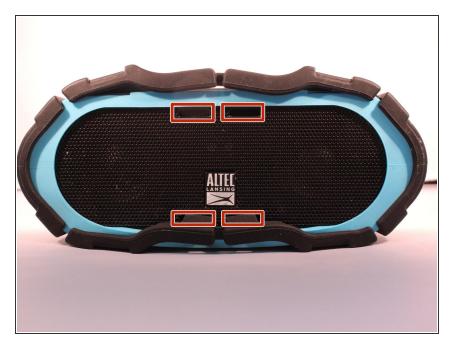
Step 1 — Case Removal

Using your hands, remove the pegs (4+4) from the front and back of the speaker.

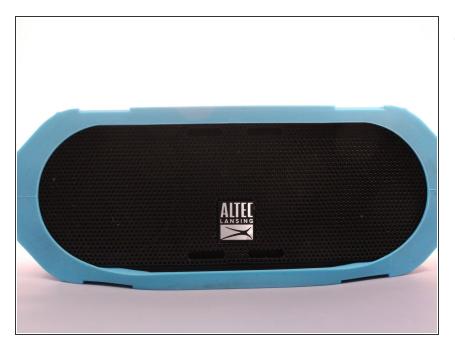
Step 2

Remove the outer black rubber housing of the speaker.

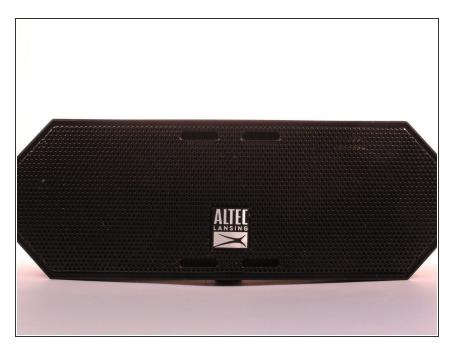
Remove the inner blue rubber housing from the speaker.

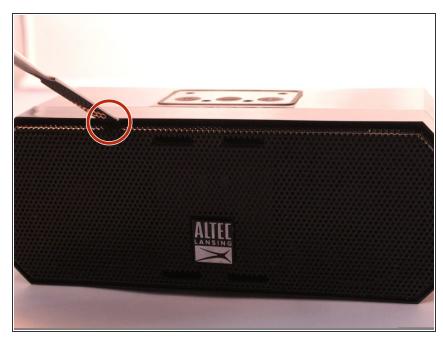
Step 4

- Pull out the two black wire meshes using a metal spudger.
- A Be careful not to damage the metal casing.

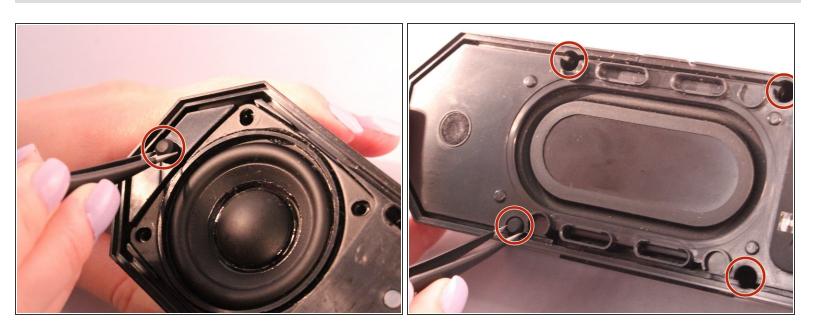
Using tweezers remove the rubber stoppers (4 at the back + 2 at the front).

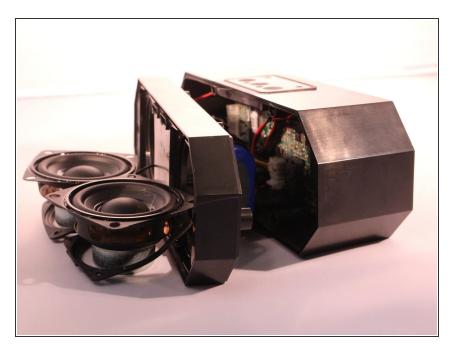
Pull the case apart and you will be able to see all the components inside the speaker.

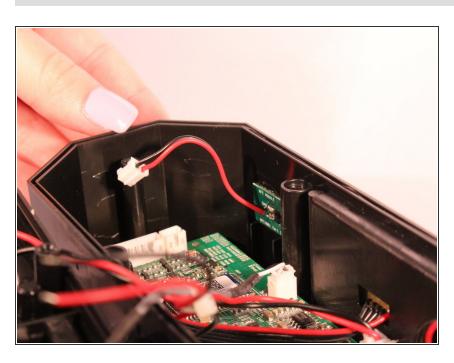
Disconnect the Bluetooth (NFC) chip from the motherboard.

To reassemble your device, follow these instructions in reverse order.
