iRobot Roomba 630 Top Bumper Infrared Sensor Replacement

This guide will demonstrate in detail how to remove and replace the Top Bumper Infrared Sensor from the iRobot Roomba 630. The front sensor could become damaged or potentially wear out over time and need to be replaced to ensure the Roomba operates correctly. Without the front sensor, the Roomba won't dock itself correctly nor sense incoming objects as it's vacuuming, causing it to crash around your home or office.

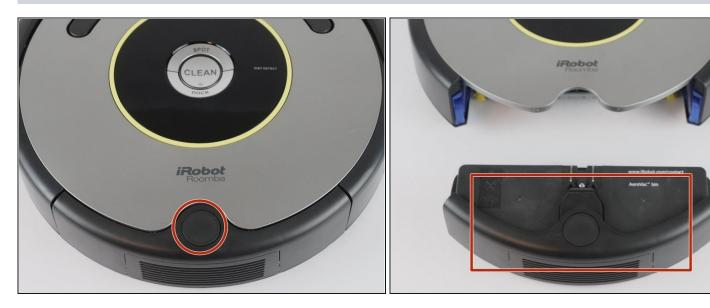
Step 1 — Front Sensor

Press the bin button and pull the bin out.

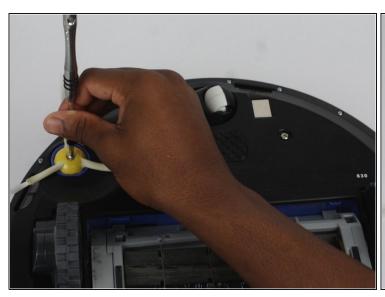
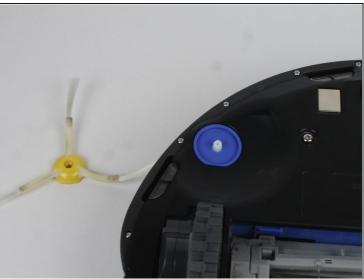
• Flip the device over and unscrew the side brush screw using the Phillips #2 screwdriver.

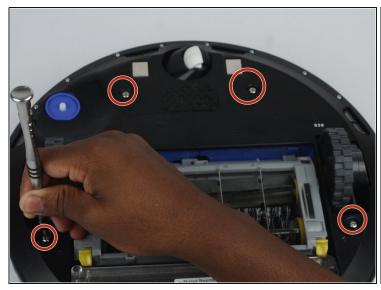
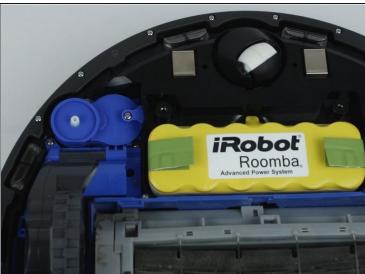
Step 3

- Unscrew the (4) four back plate screws using the Phillips #2 screwdriver.
- Lift the back plate off of the device.

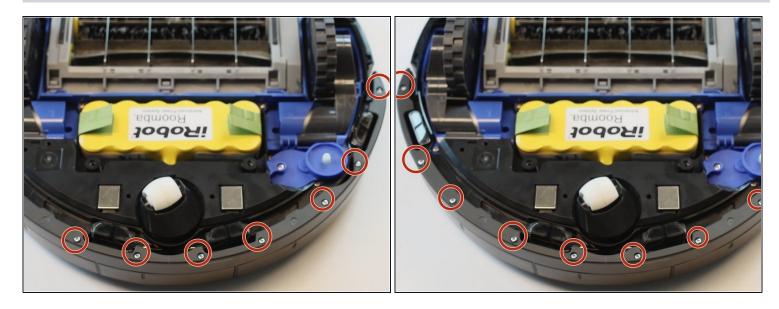
Unscrew the screws on the bottom of the front bumper.

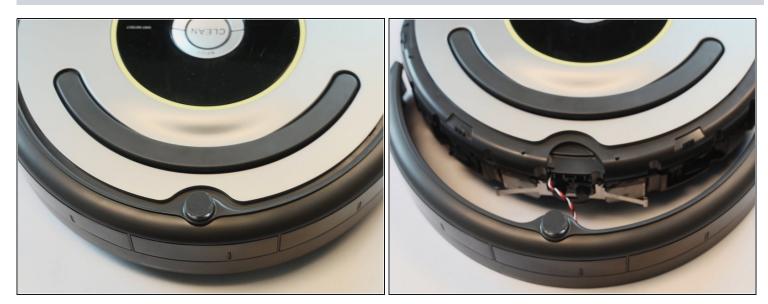
Step 5

- Flip the device over and lift the front bumper up and off.
- *i* Lift with care so the sensor wires aren't damaged.

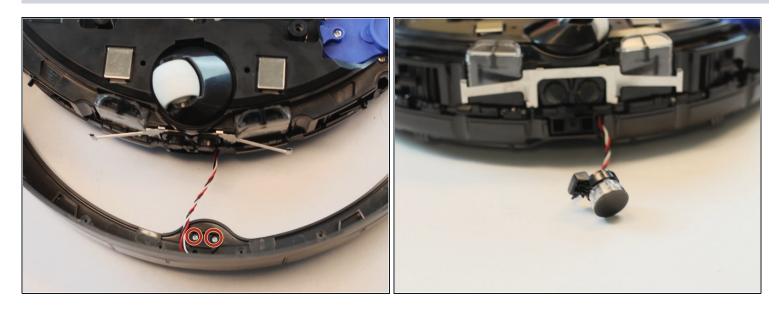
• Flip the Roomba back over and unscrew the 2 screws that connect the sensor to the bumper.

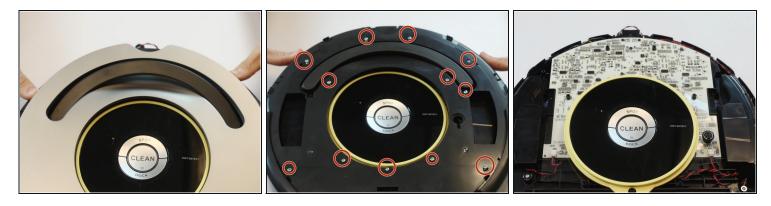
Step 7

- Flip Roomba back over and pry the top cover off.
- Unscrew the screws to the top plate and lift off.
