iRobot Roomba 595 Pet Series Side Brush Motor Replacement

This tutorial will show users how to properly change the side motor on their iRobot Roomba 595 Pet Series

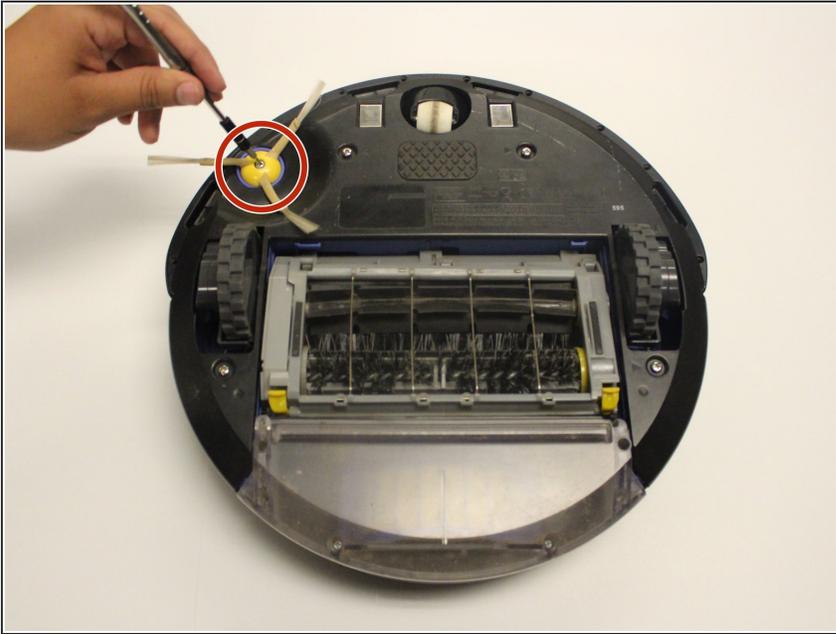
Step 1 — Secondary Brush

- Flip the Roomba upside down. Using the Phillips #0 screwdriver, carefully remove the 5 mm screw holding the brush in place.

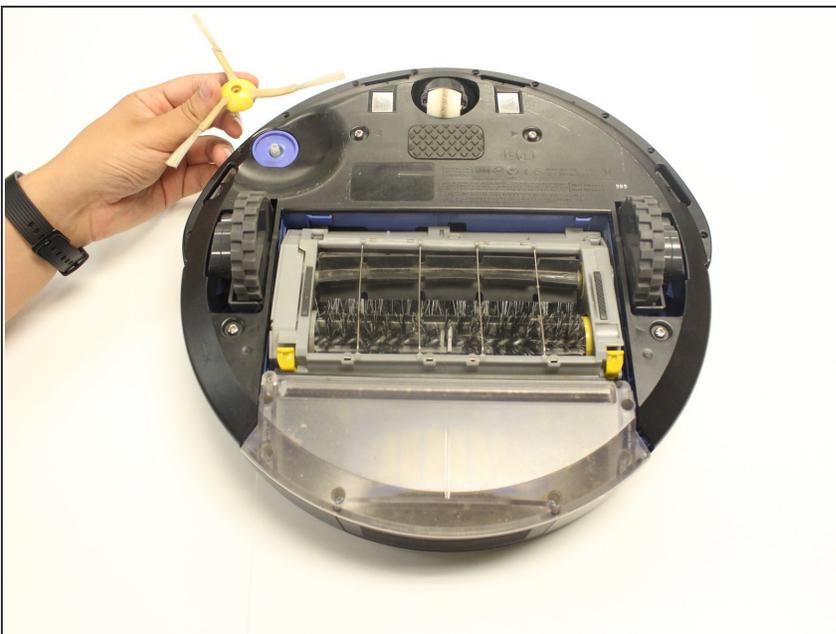
Step 2

- Gently pull the brush up and remove it from the device.

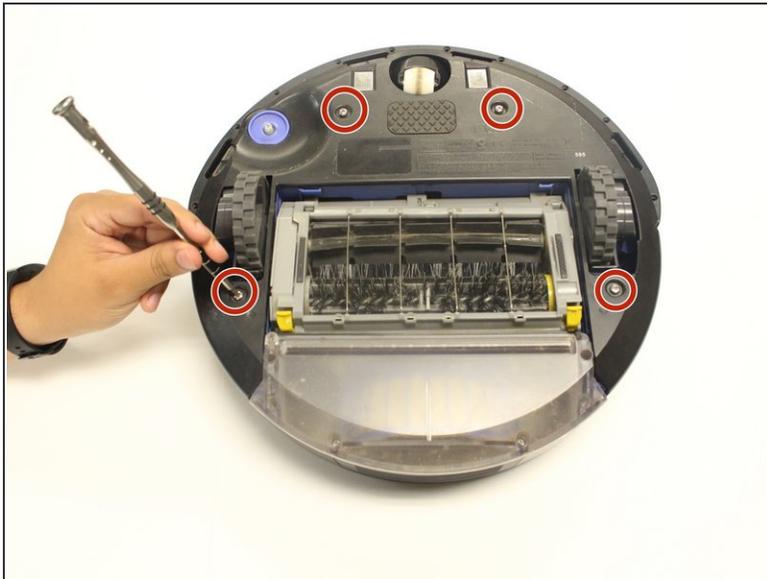
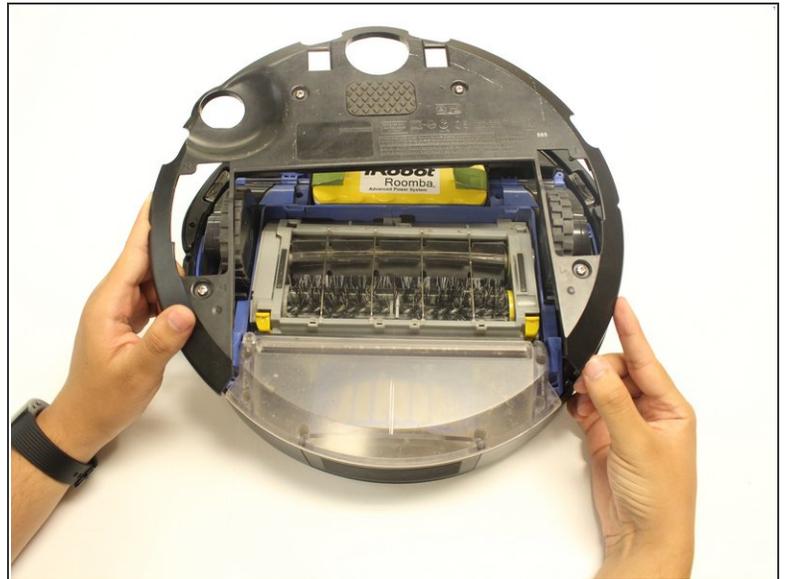
Step 3 — Side Brush Motor

- Unscrew the four 10mm screws on the underside of the Roomba with a Phillips #1 screwdriver.
- Lift the external underside cover accordingly.

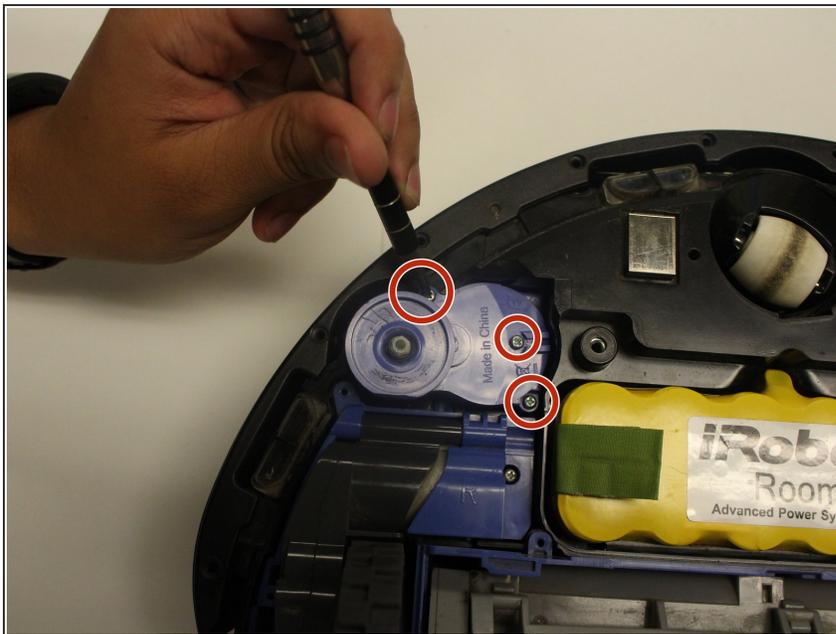
Step 4

- Use the Phillips #0 screwdriver bit to remove the three 15mm screws.

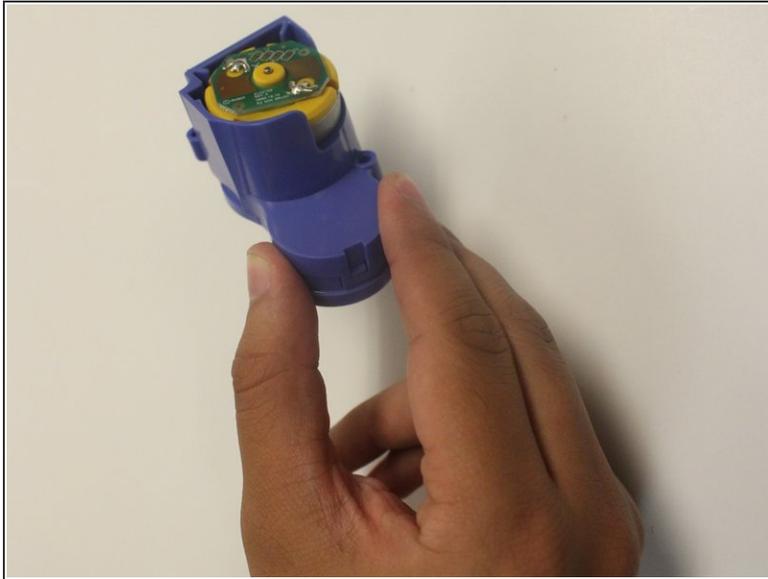
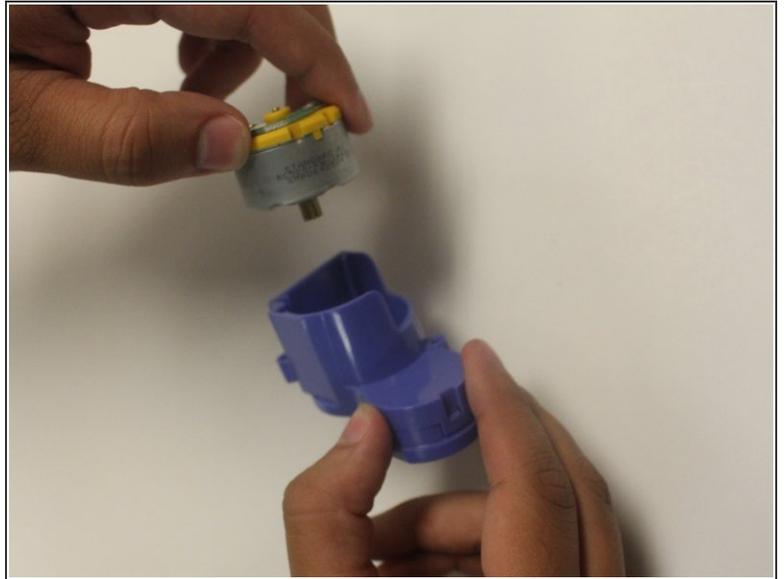
Step 5

- Remove the motor from the blue casing.

To reassemble your device, follow these instructions in reverse order.
