# Navi Falk Neo550 Battery Replacement

Replacing the battery with the Navi Falk Neo550

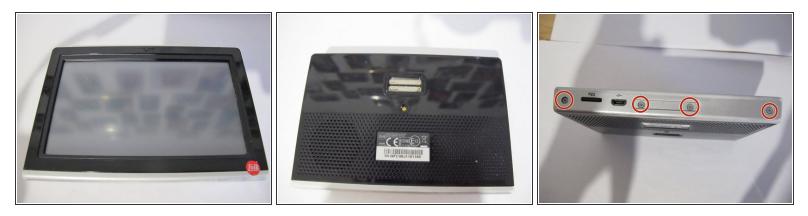
# Step 1 — Unscrew lower edge cover

• Using a PH 0 screwdriver, loosen the four screws on the underside of the device.

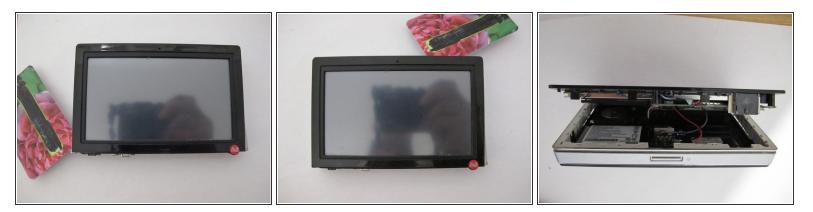
# Step 2 — Release the screen

• Pull the plastic card at the lower corners, starting at the bottom of the screen.

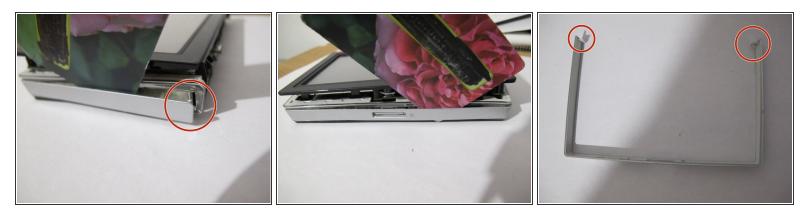
#### Step 3 — Remove the edge cover

- At one of the bottom corners, remove the edge cover by sliding a plastic card from the front of the navigation system under the edge.
- The edge strip is attached with double-sided tape, the plastic card can be pushed with a sawing movement gradually under the side cover

A Caution: At the two lower corners, the cover strip is inserted into the housing with a latching lug.

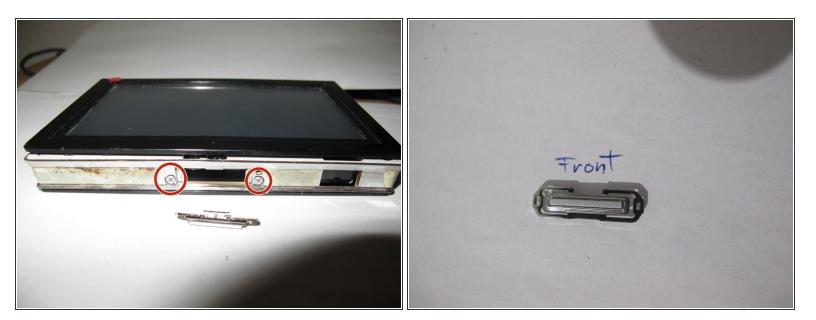
#### Step 4 — remove inner edge cover

• Use the screwdriver PH 0 to remove the two screws at the upper edge.

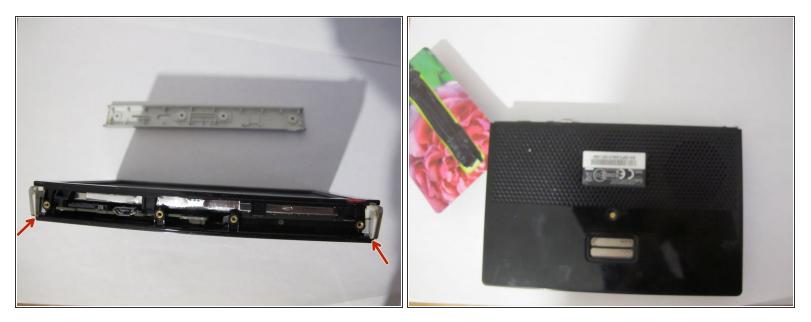
# Step 5 — Separate wall

Pull a plastic card between the wall and the side panel to separate them. After the sides also separate the upper edge.

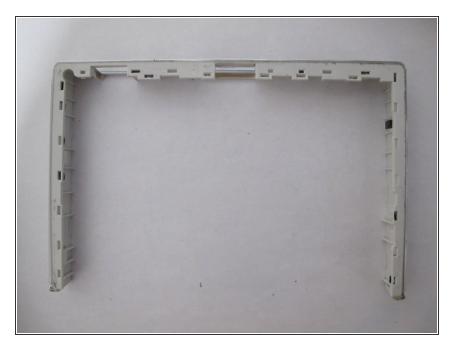
# Step 6 — remove inner edge cover

• Pull out the inner edge cover between the screen and the rear panel.

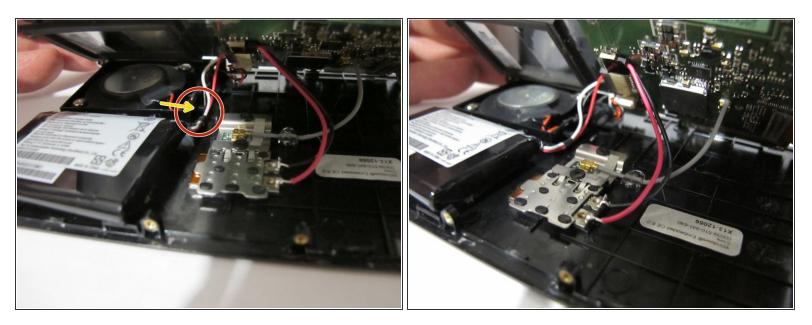
# Step 7 — Disconnect the battery cable

• Pull the battery cable downwards, then out from the guide nose.

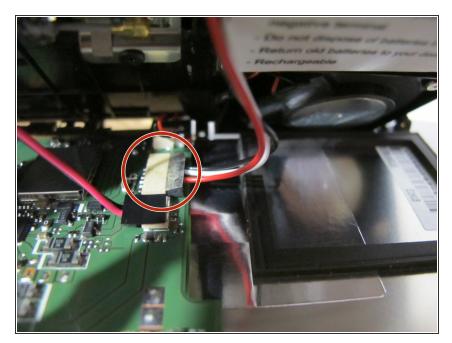
# Step 8 — Disconnect the battery cable

- Remove the adhesive tape from the battery.
- Pull plug out of socket.

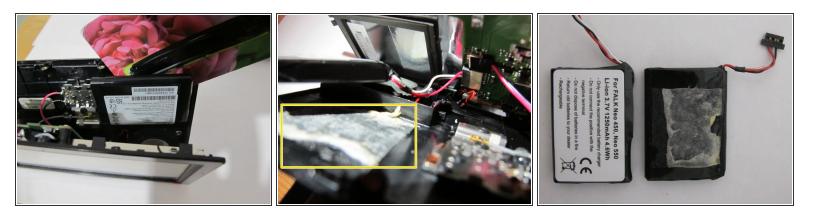
# Step 9

The battery is glued to the housing with a very tough adhesive tape. "Carefully" pry out. (You can probably solve this with isopropyl alcohol - I read later).
