Microsoft Surface Go Teardown

Written By: Jeff Suovanen

INTRODUCTION

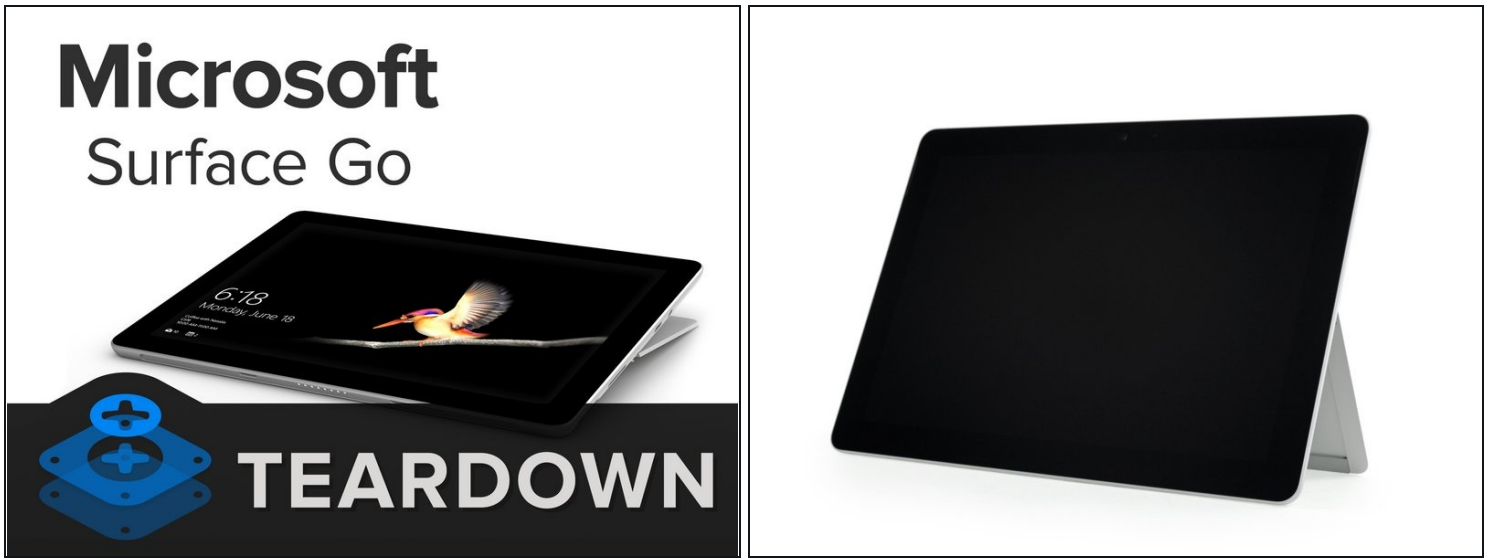
Step 1 — Microsoft Surface Go Teardown

- As always, our teardown begins with a cursory *in-spec-tion*:
 - 10" IPS multi-touch display with 3:2 aspect ratio and 1800 × 1200 resolution (217 ppi)
 - Dual-core 1.6 GHz Intel Pentium Gold 4415Y processor with integrated Intel HD Graphics 615
 - 4 GB RAM (8 GB optional)
 - 64 GB eMMC storage (128 GB NVMe SSD optional), with additional storage via microSDXC
 - 8 MP primary camera with 1080p video; 5 MP / 1080p selfie camera

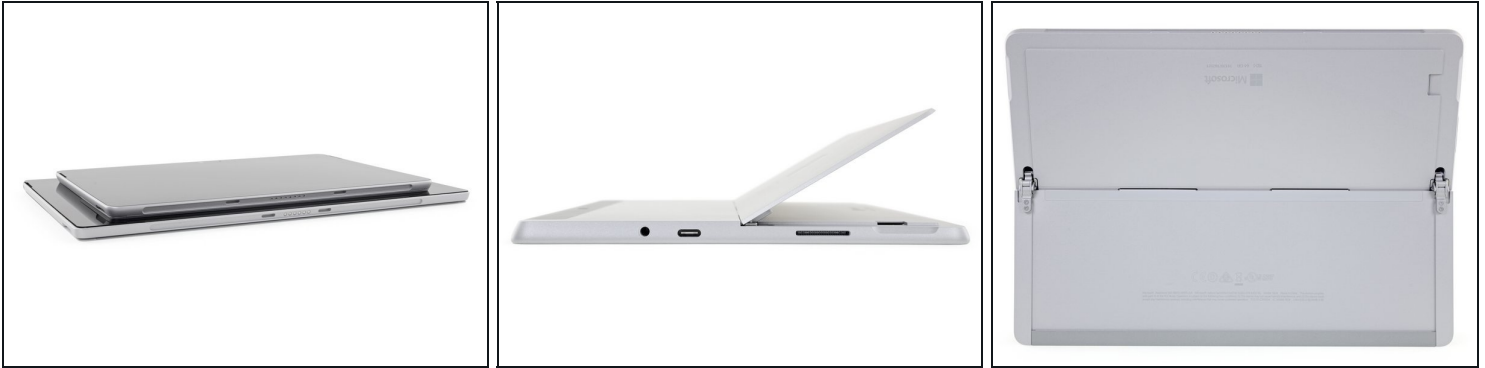
Step 2

- Compared to the Pro, the Go looks to have smoother curves, rounder edges, and a vaguely more iPad-y aesthetic.
- The Surface Go doesn't believe in the [fewer-ports-is-more-ports](#) trend. This tablet packs a USB-C port, headphone jack, a couple proprietary connectors, *and* an SD card reader.
 - ① Hunting for that SD port, we accidentally [woke](#) the sleeping Go—presumably a magnetometer notices when the magnet-toting kickstand moves.
- Peeking between the [slightly redesigned hinges](#), we spy FCC info, the model number (1824), and storage and memory specifications.

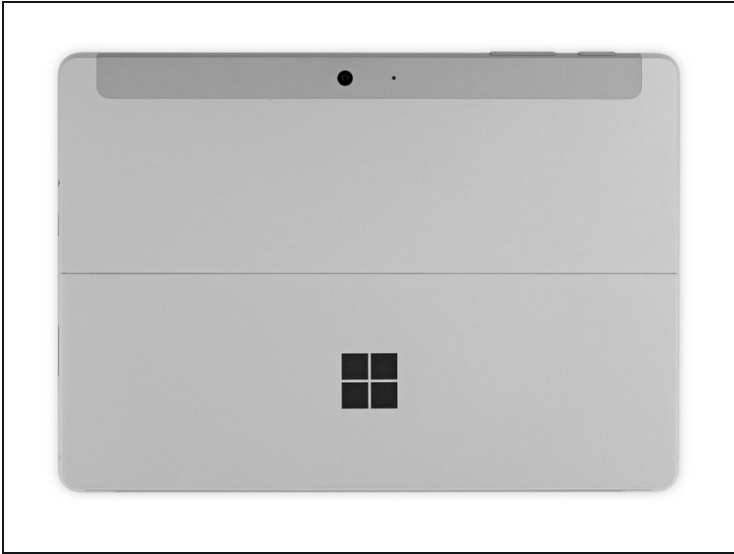
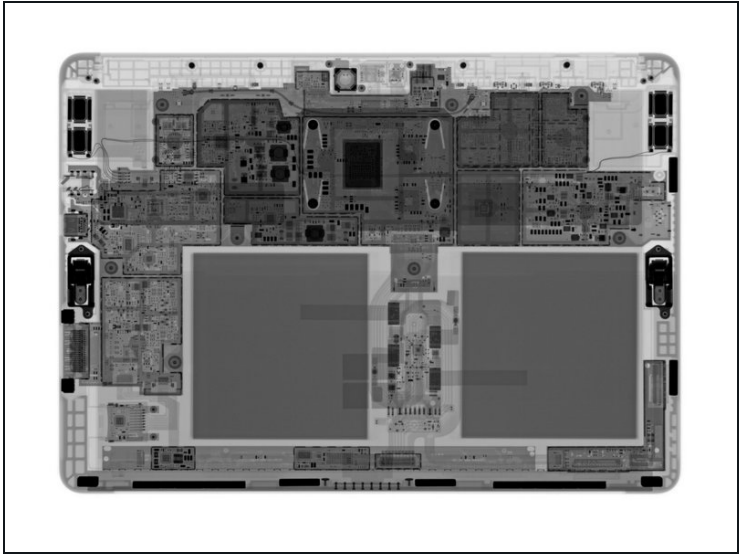
Step 3

- There's more than one way to teardown. Our way takes a while, so our friends at [Creative Electron](#) give us the X-ray version.
- Preliminary intel: two battery cells, lots of circuit board—and no visible heat pipes! Looks like the Surface has been on a low-copper diet.

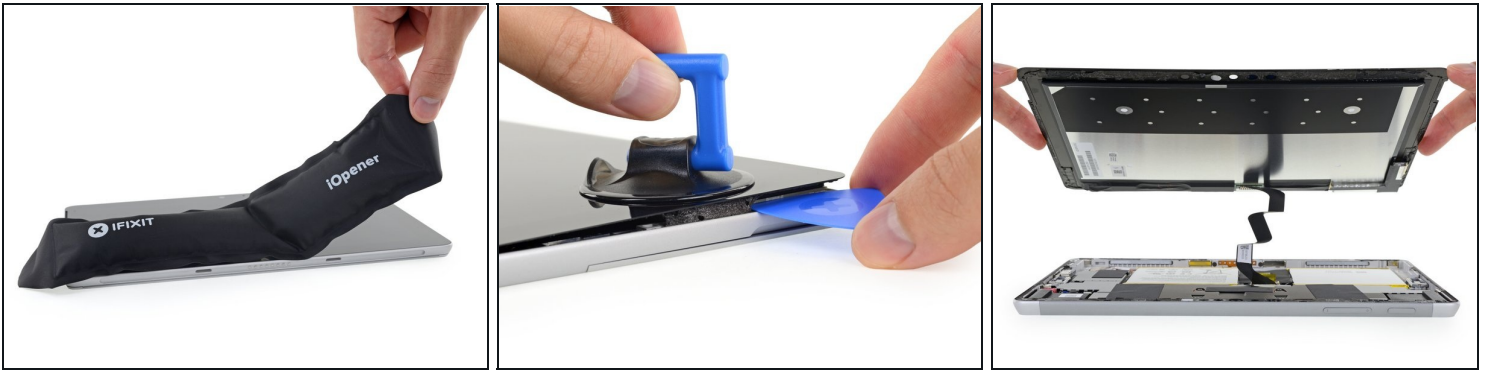
Step 4

- If we've learned one thing after five years of Surfacing, it's how to open these things.
- Our well-used [iOpener](#) brings the heat, then a [suction handle](#) and [opening picks](#) ([just a few this time](#)) attack the ample adhesive.
 - ① We encounter the same kind of goopy glue as before, but the smaller, sturdier display makes the opening procedure seem a little less [scary](#).
- The display's off, and we're pleased to see that Microsoft allowed it a fairly long leash.
 - ① A long display cable makes it easier to disconnect the display without damaging the cable, for safer and easier display removal.

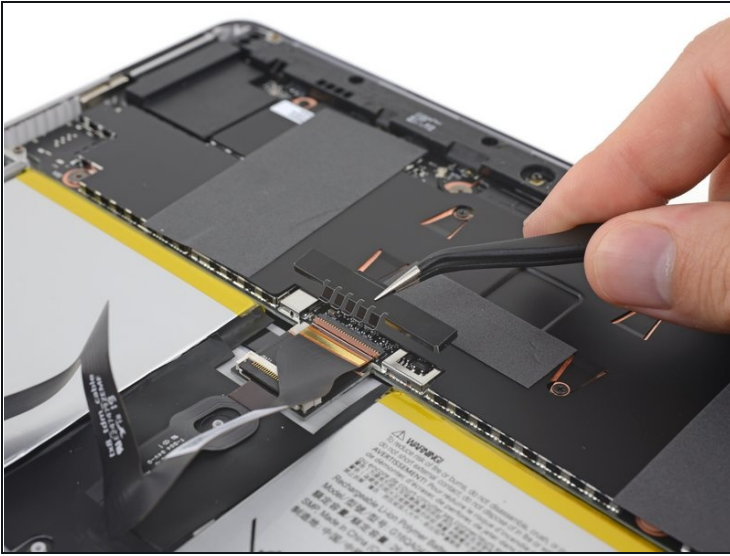
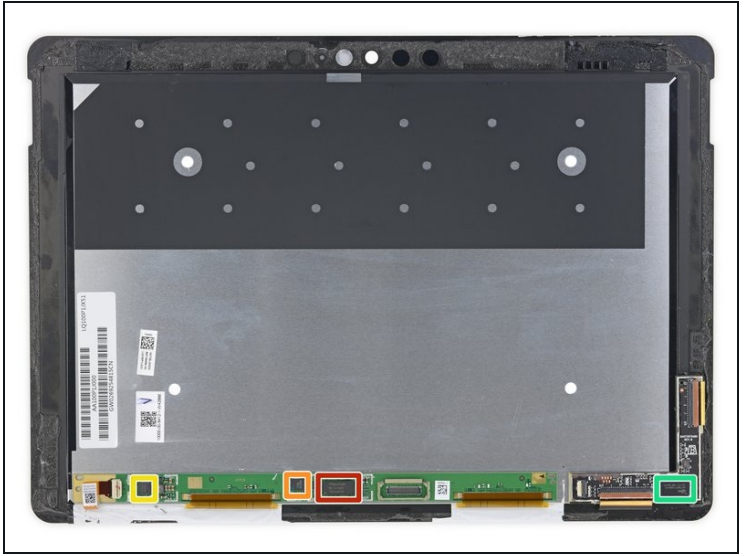
Step 5

- One last obstacle before the display is free—an EMI ~~claw~~ shield guarding the display ZIF connector.
- With the display free, we turn our attention toward the bottom edge, and discover a few display chips in their natural environment:
 - Likely MegaChips [S15 series LCD timing controller](#)
 - i7248 H717690
 - 18996MB N746547
 - KTH6212MAYS

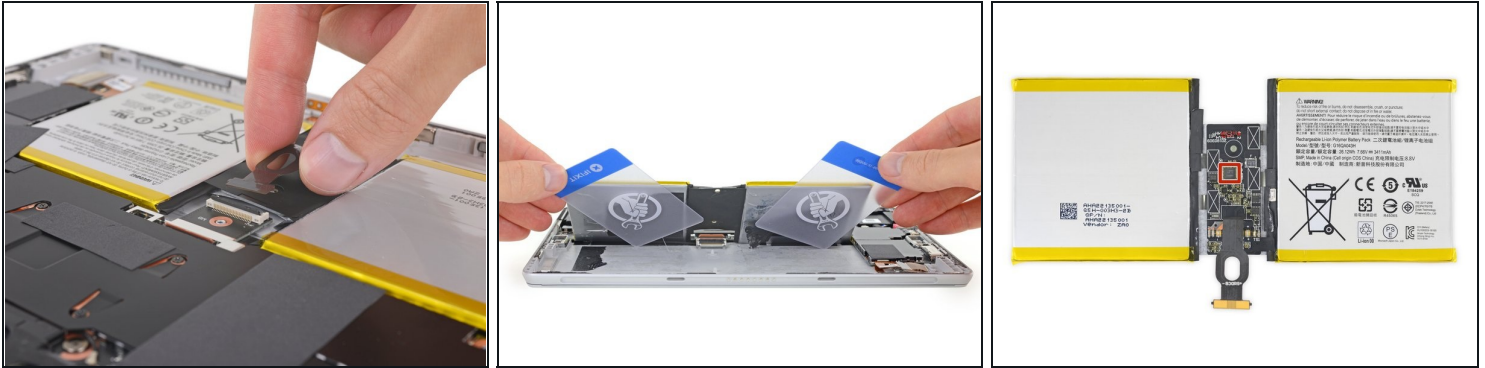
Step 6

- To our great surprise, the Surface Go has an immediately disconnectable battery! With no need to fully remove the motherboard, repairability is looking up.
- Or is it? Removing the battery is just like [the bad ol' days](#)—two giant pads of adhesive put up a staunch fight against our [adhesive remover](#) and [plastic cards](#).
- ① Glued-in batteries prevent consumers from easily extending the life of their device, and they increase costs for recyclers at the end of the device's life.
- The battery in the Go is a lot smaller, at 26.12 Wh, than any [of its pro-level predecessors](#)—even the similarly sized [iPad 6](#) packs a 32.9 Wh powerbank.
- A Texas Instruments [BQ40Z50](#) series Li-ion battery pack manager is the brains of this operation.

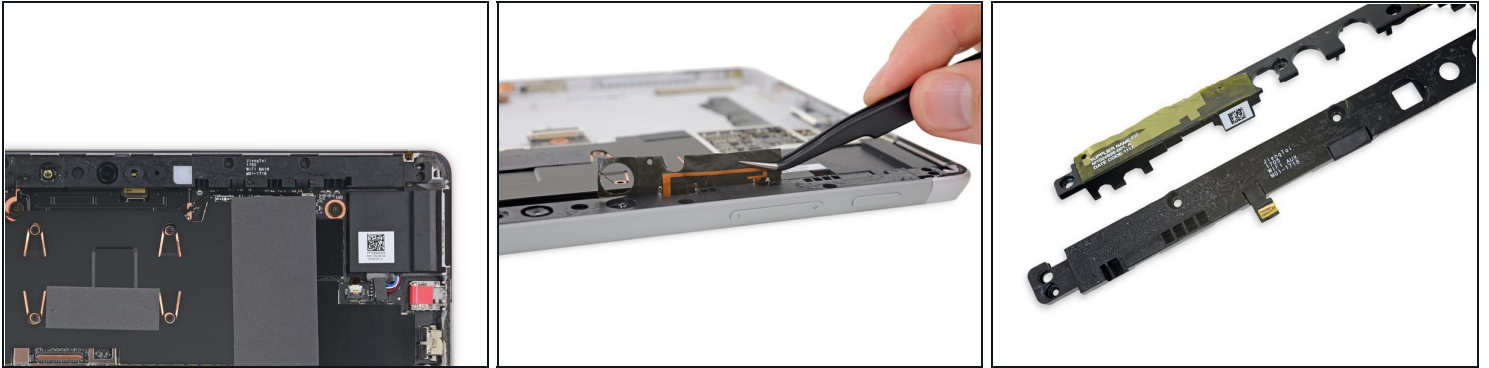
Step 7

- Turning our attention to the Wi-Fi antennas, we fully expect to find them mangled after that hack-and-slash display separation.
- Having the display cover glass [glued right over the top](#) of the Wi-Fi antennas has wreaked havoc on many a Surface Pro repair attempt. Most times, the antennas don't survive display removal.
- This time, we have to keep looking... and looking.
- These antennas are actually tough to spot, and seem miraculously unscathed. That's one of our poor [5th-gen Surface Pro antennas](#) up top, for comparison.
- They've definitely been redesigned—perhaps with slightly less of a nail-biting repair experience in mind?

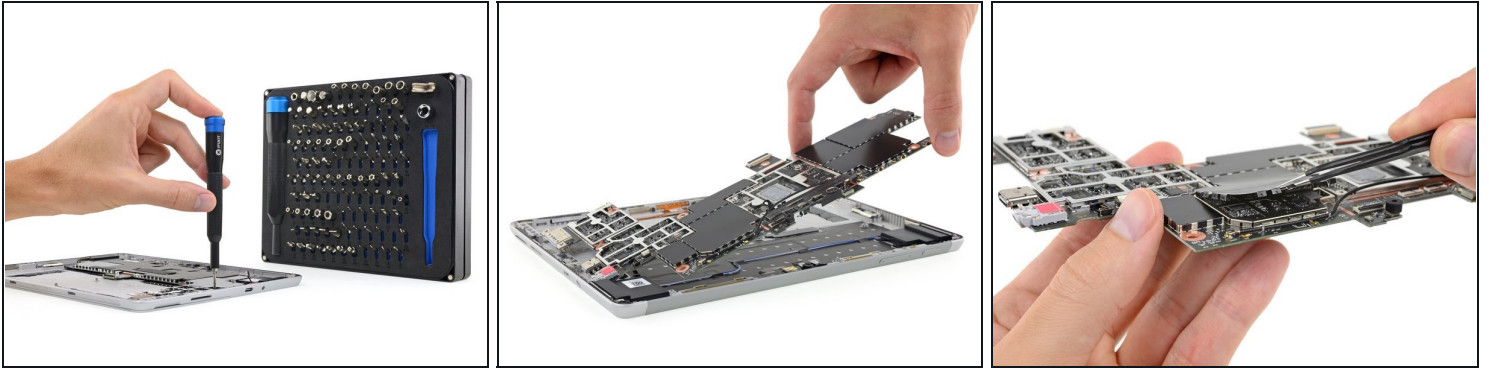
Step 8

- Our journey beneath the Surface doesn't get any easier as we move on to the motherboard.
- Thankfully there's no glue here, but we're forced to excavate our way through seemingly endless layers of shields, tape, and hidden screws in order to unearth the board.
 - ① Luckily, we have our [Manta Driver Kit](#) to keep us company, and to deal with any fasteners we find.
- Finally, we relieve the motherboard of the last of its restraints, and free it from its metal and plastic prison.
- Even with the motherboard free, we keep digging, through shielding and fabric stickers, to find the silicon that lies hidden underneath.

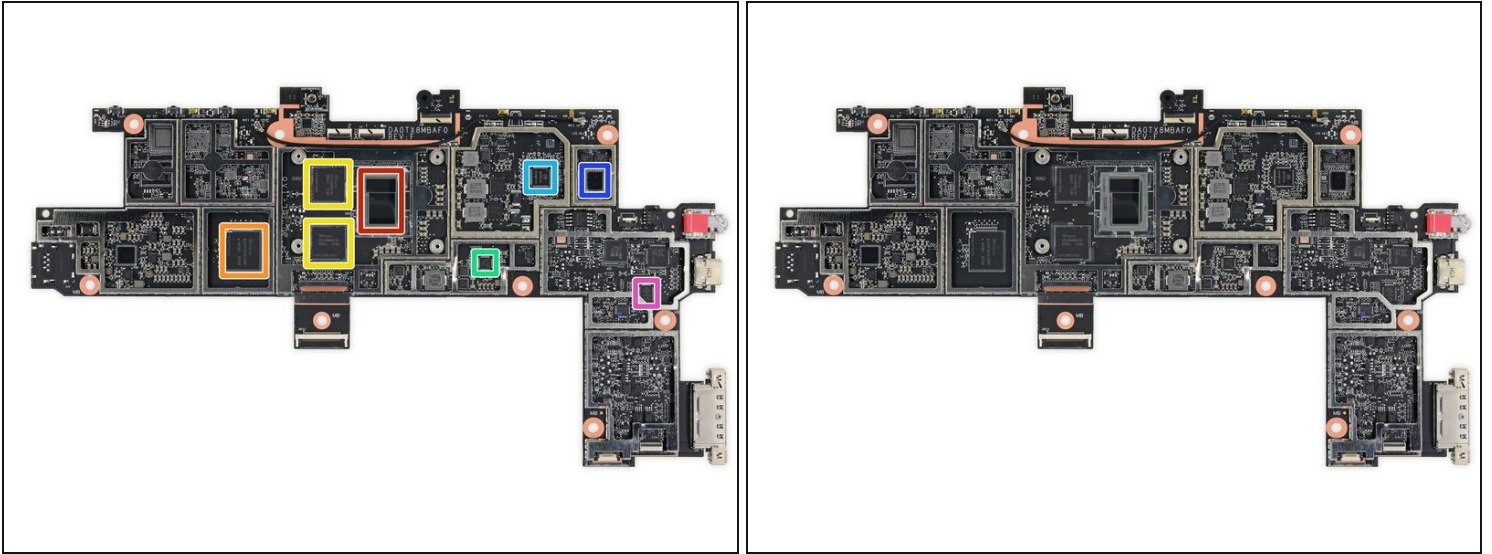
Step 9

- At last, we're rewarded for our hard work with a treasure trove of silicon:
 - Intel Pentium [4415Y](#) processor
 - SK Hynix [H26M74002HMR](#) 64 GB eMMC5.1 NAND flash memory
 - 2x SK Hynix H9CCNNNBKTAL 16 Gb LPDDR3 SDRAM (4 GB total)
 - Texas Instruments [BQ25700A](#) battery buck-boost charge controller
 - ON Semiconductor [NCP81216](#) phase controller
 - Qualcomm [QCA6174A](#) Wi-Fi/Bluetooth SoC
 - Parade Technologies PS87430 (likely [USB host switch](#))

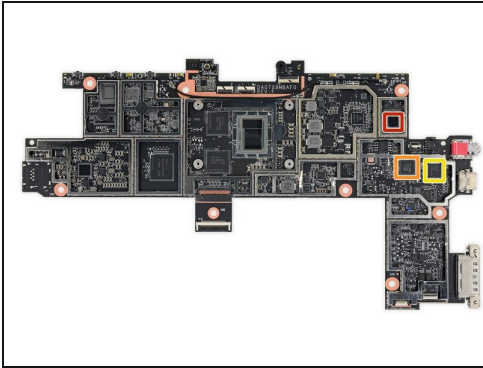
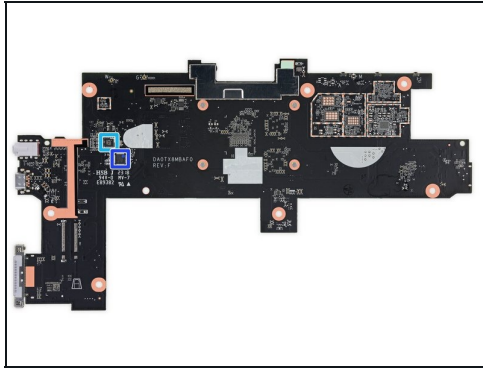
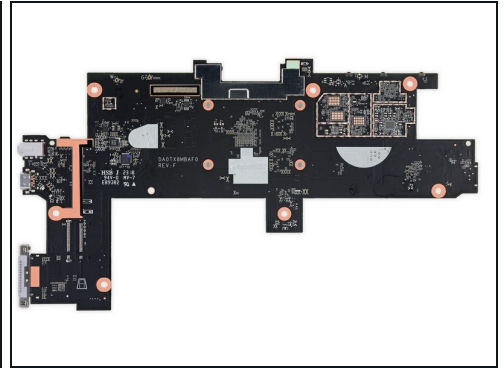
Step 10

- More front-side chips:
 - Qualcomm [QCA6174A](#) Wi-Fi/Bluetooth SoC
 - ITE Tech Inc. [IT8987](#) LPC bus controller
 - Realtek [ALC298](#) audio codec
- Back-side chips:
 - NXP P3003
 - Atmel [ATSAMD20E](#) ARM microcontroller

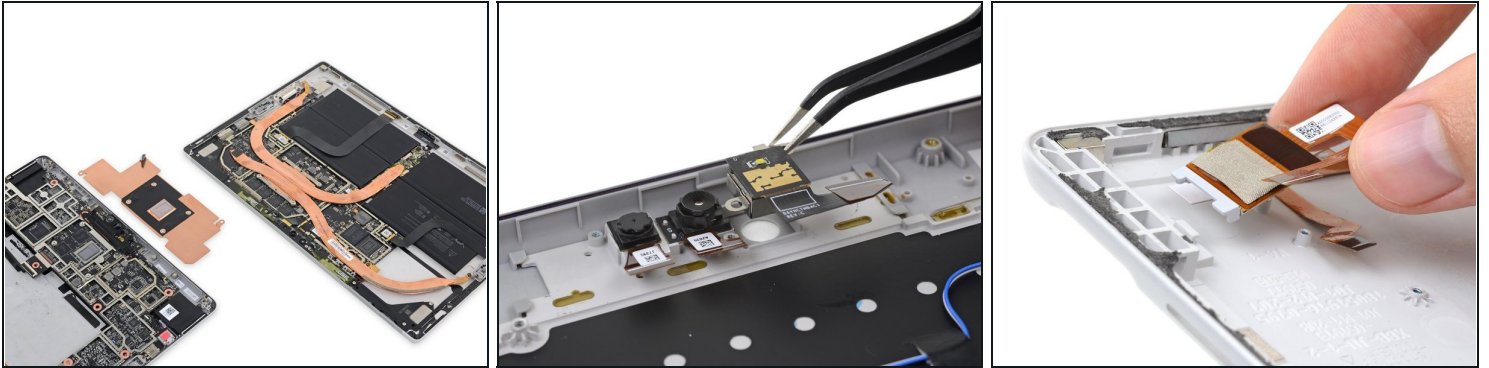
Step 11

- All that silicon, and yet this Go is fan-less and heatpipe-less. This thin copper shield and some thermal paste will have to do the heat sinking for this would-be PC. (Then again, you can always [run it in a freezer...](#))
- It's certainly a radical departure from those thick copper tentacles we found on the 5th-gen Pro, on the right. Hopefully it'll be enough for the Go's power-sipping, non-Turbo'd processor.
- Now to pluck the final strings of this teardown. Such as: the Windows Hello camera, the 5 MP front-facing camera, and the 8 MP rear-facing camera (complete with piggybacked LED) all sitting in a row.
- Finally, the modular microSDXC port with Realtek 5227S [card reader controller](#)—which is *technically* upgradable storage!
 - ① Not exactly the kind of upgradability we were hoping for, but we'll take what we can get.

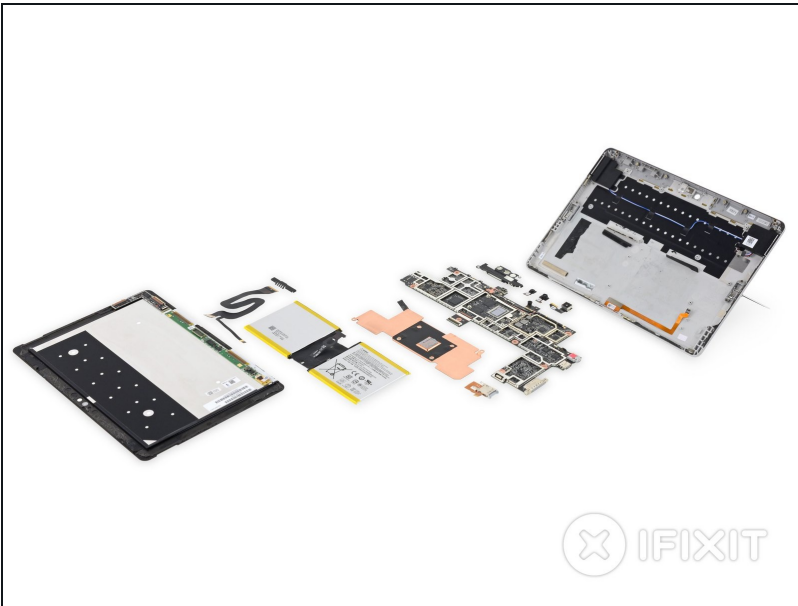
Step 12

- Here are all the bits lurking beneath the Surface. Thanks for joining us!

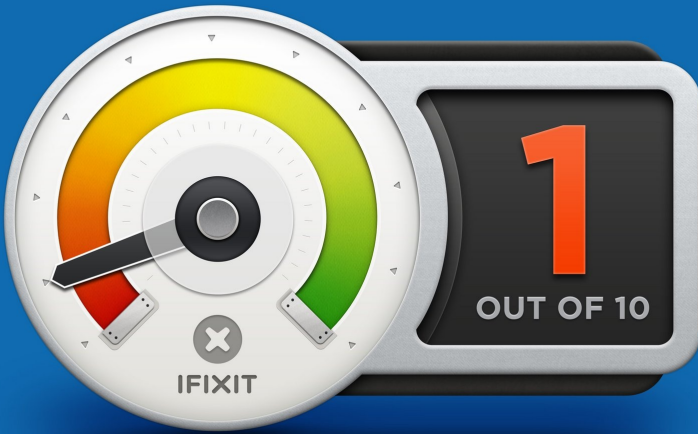
REPAIRABILITY SCORE:

- The Microsoft Surface Go earns a **1 out of 10** on our repairability scale (10 is the easiest to repair):
 - The smaller form factor seems to make the glass easier to remove without breaking, but it's still terrifyingly hard.
- If this is expected to replace a PC, the lack of upgradability will severely limit the device's lifespan.
- The lack of modularity, especially on high-wear ports, makes repairs unnecessarily expensive.
- Adhesive holds many components in place, including the display and battery.
- Replacement of any part requires removal of the display assembly, an easy (and expensive) part to damage.
