Ridgid Angle Grinder R10202 Motor Housing Replacement

How to replace a Ridgid Angle Grinder R10202 motor housing.

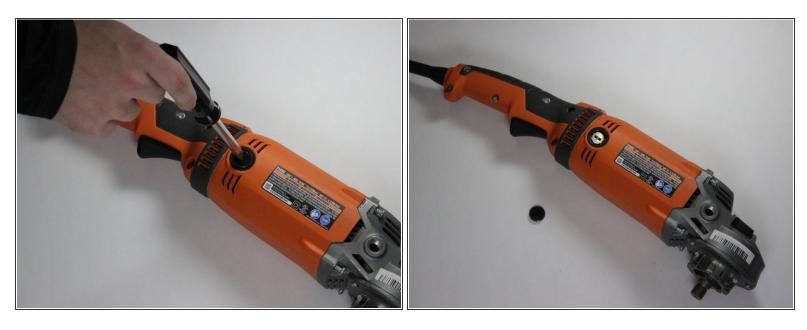
Step 1 — Carbon Brush

Use a flathead screwdriver to unscrew the brush holder cap.

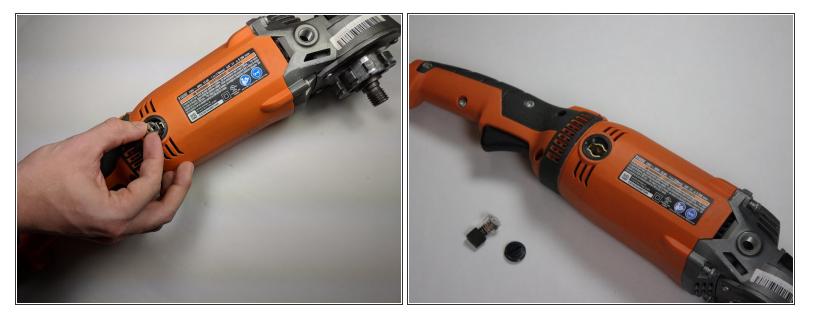
Step 2

- Using your fingers, gently lift the carbon brush up and out of its housing.
- Repeat these steps to remove the other carbon brush on the opposing side.

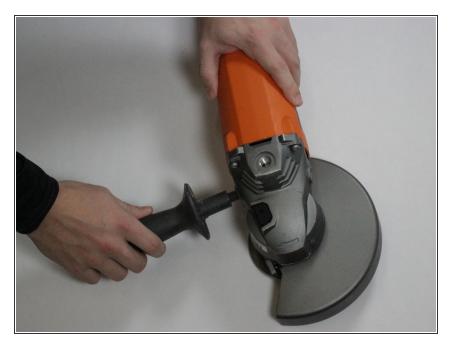
Step 3 — **Motor Housing**

Unscrew the side handle assembly from the gear housing assembly by hand.

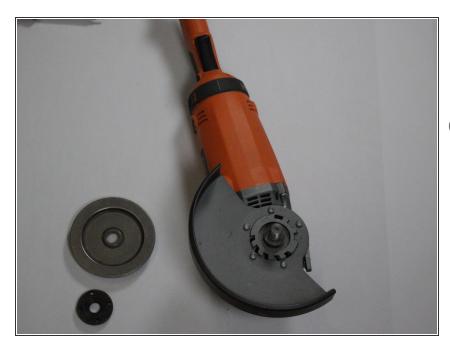
Step 4

- Unscrew the clamp nut and the backing flange from the output shaft assembly.
- You can do this by hand or use a spanner wrench which should be provided in the manufacturers box.

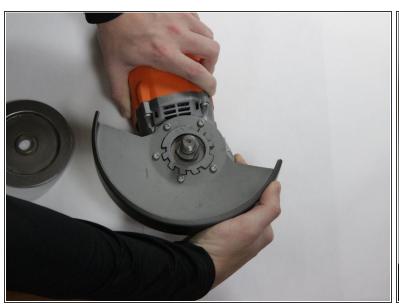
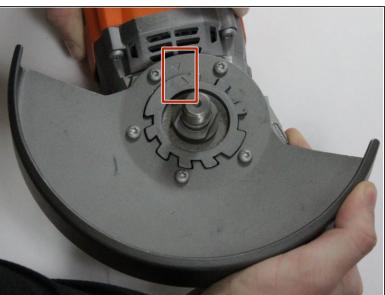
Step 5

- Push in the guard lever and twist the guard until it aligns with the slots on the output shaft assembly.
- There are two arrows that should align before you attempt to pull the pieces apart.

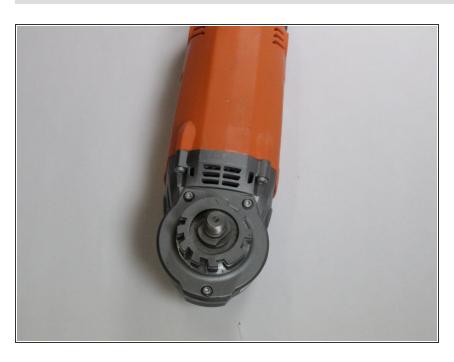
Step 6

Lift the guard away from the output shaft assembly.

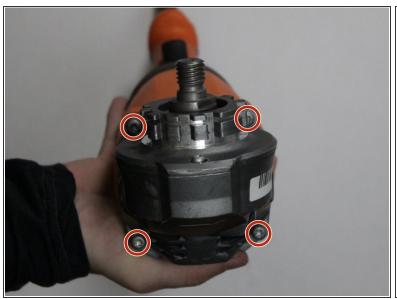
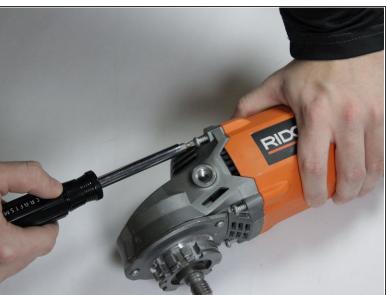
Step 7

Using a T25 Torx screwdriver, unscrew the four M5 X 28mm Torx screws.
