Logitech MBJ58 Mouse Support Spring Replacement

This guide demonstrates how to replace a missing or broken scroll wheel support spring in the Logitech MBJ58 Mouse.

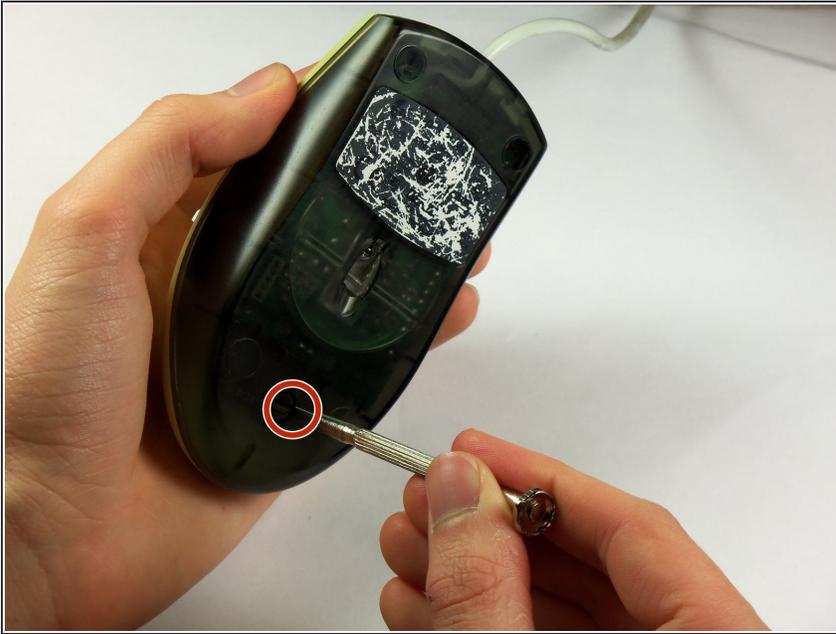
Step 1 — Top cover

- Hold the mouse so that the bottom is facing up.
- Remove the single Phillips #1 screw from the bottom half of the mouse.

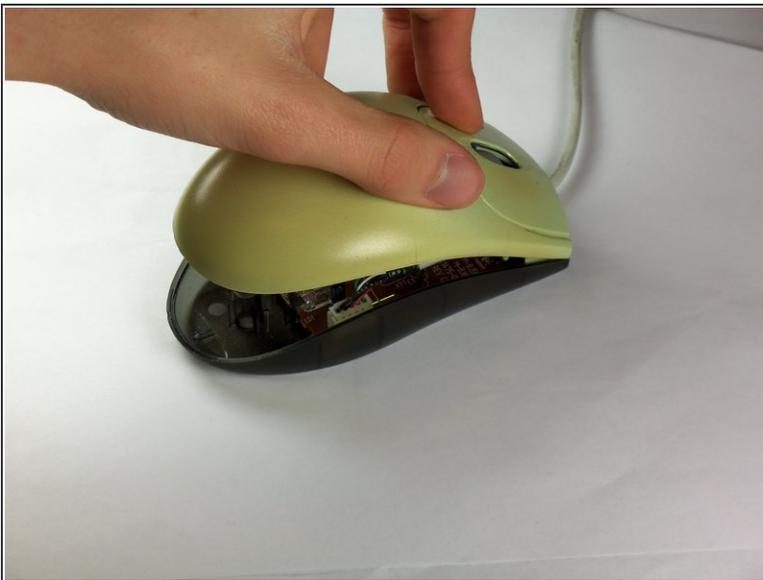
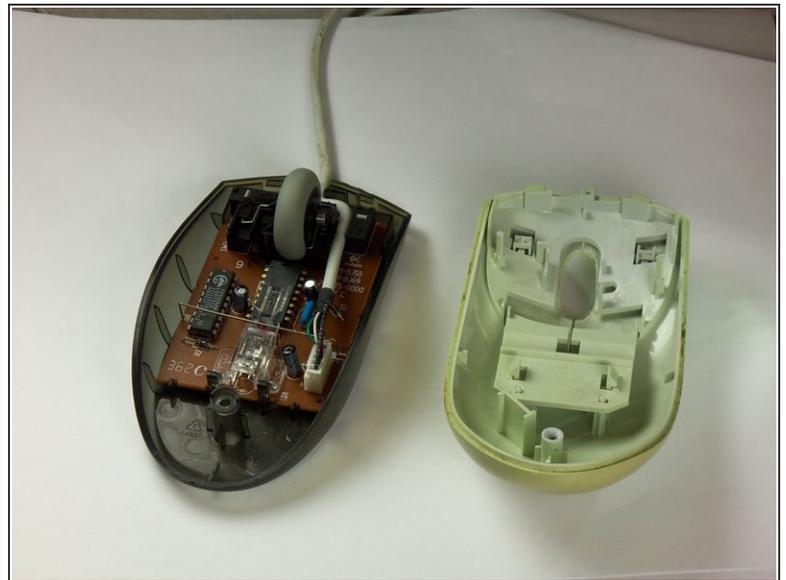
Step 2

- Place the mouse so that the bottom is resting against a hard surface.
- Lift the top cover of the mouse gently, and remove it.

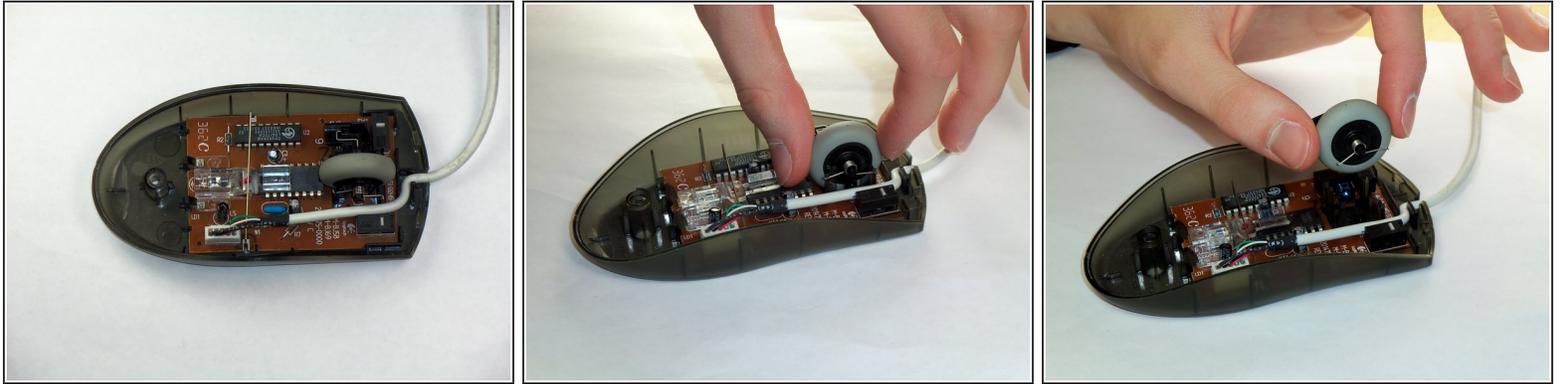
Step 3 — Removing the Logitech MBJ58 Mouse Scroll Wheel

- Locate the scroll wheel on the mouse.
- Grab the scroll wheel with your thumb and index finger.
- Gently lift up, to remove the scroll wheel from the mouse.

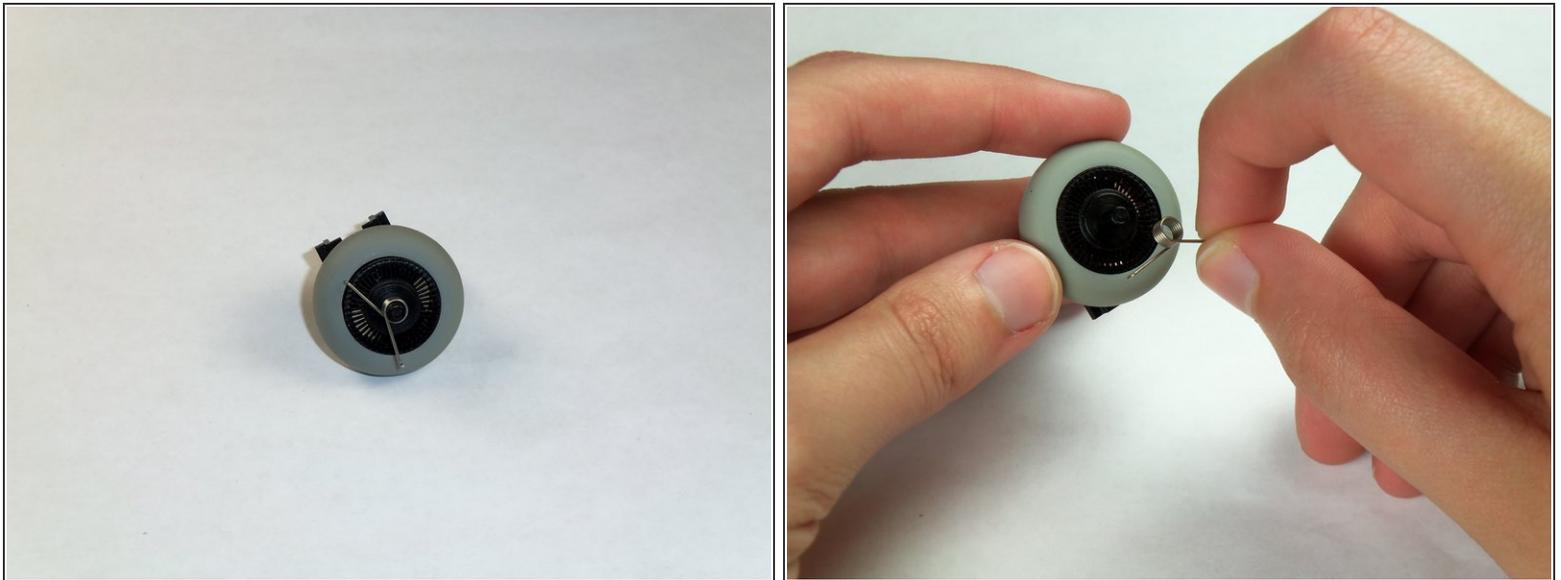
Step 4 — Support Spring

- Locate the spring on the scroll wheel, and carefully remove the spring.

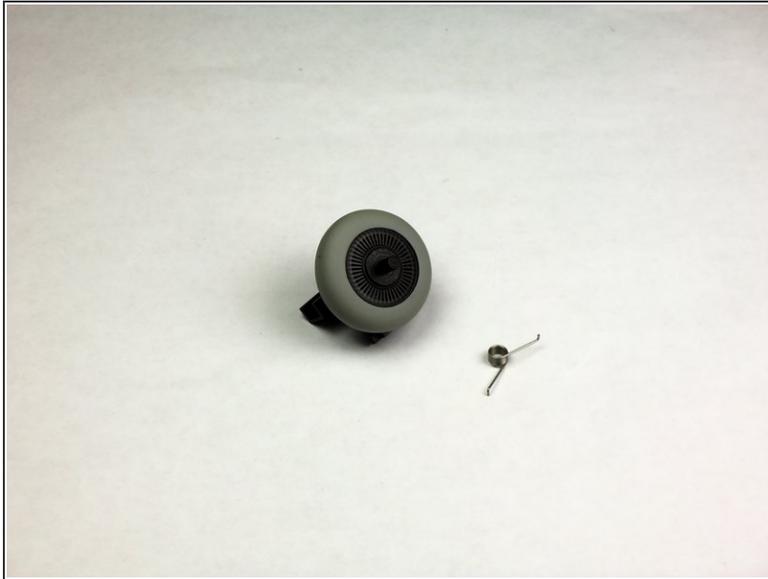
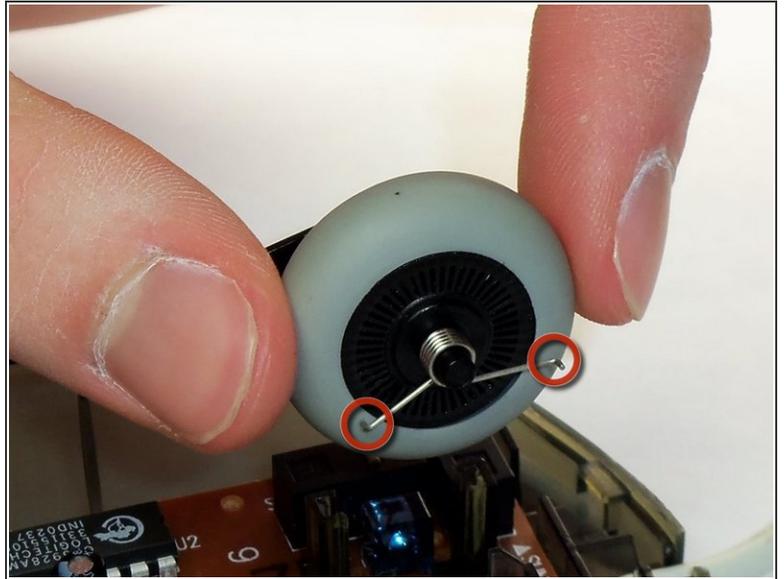
Step 5 — Attaching the New Spring

- Place the replacement spring on the correct side of the wheel (shown in the images) with the prongs pointing down.

To reassemble your device, follow these instructions in reverse order.
