# Acer Chromebook Spin 15 CP315-1H-P1K8

## USB-C Port Replacement

This guide will help you successfully replace your USB-C port in the Acer Chromebook Spin 15 CP315-1H-P1K8 laptop.

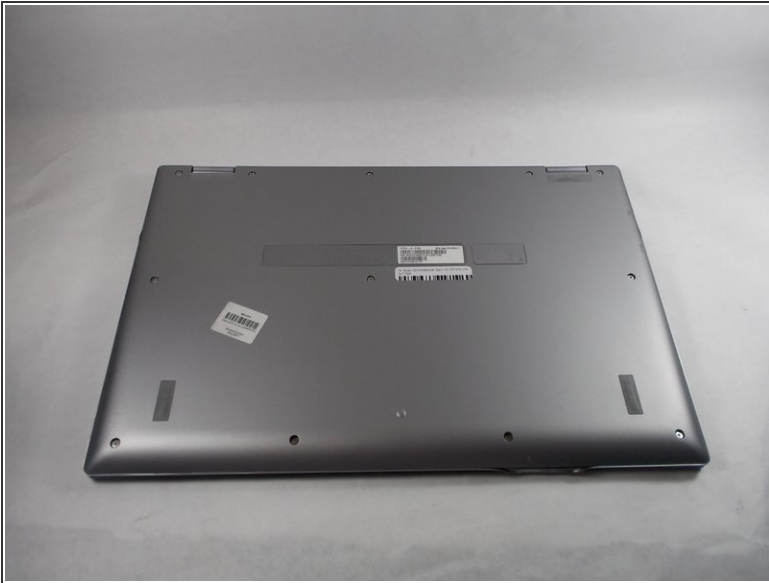
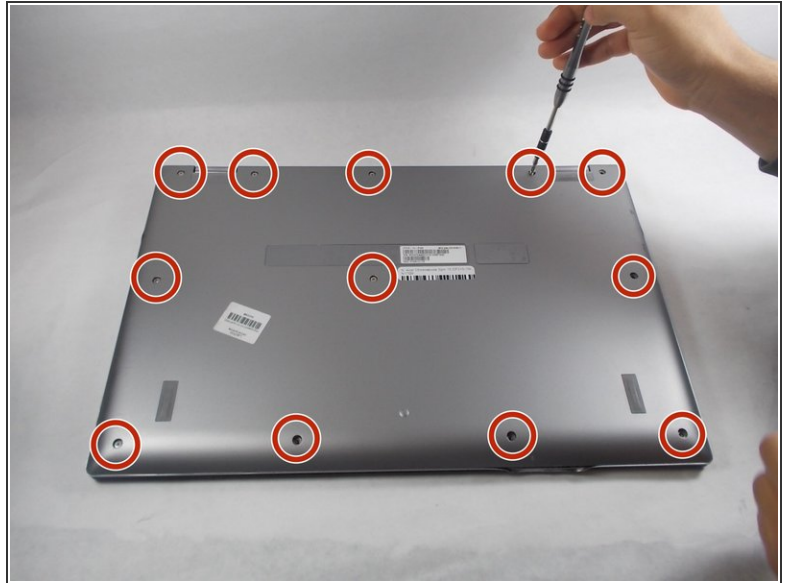
## Step 1 — Back Cover

⚠ Make sure the device is fully powered off.

- Flip the computer over so that the back is facing up.
- Remove the twelve 6mm Phillips #1 screws from the bottom of the laptop.

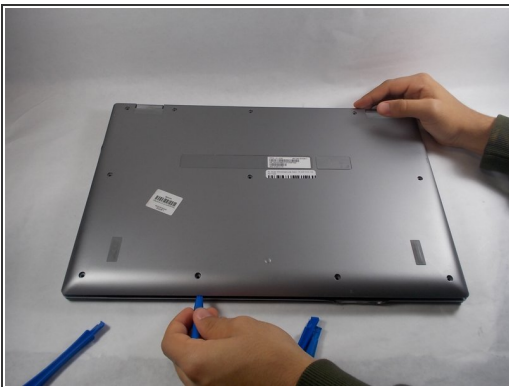
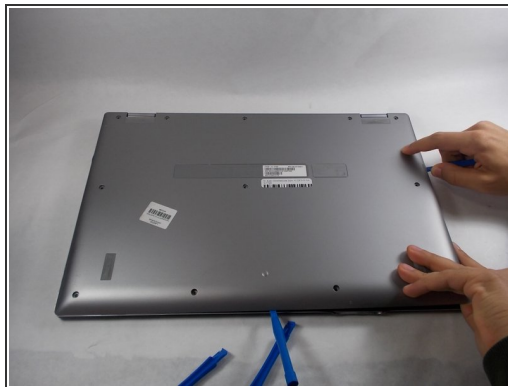
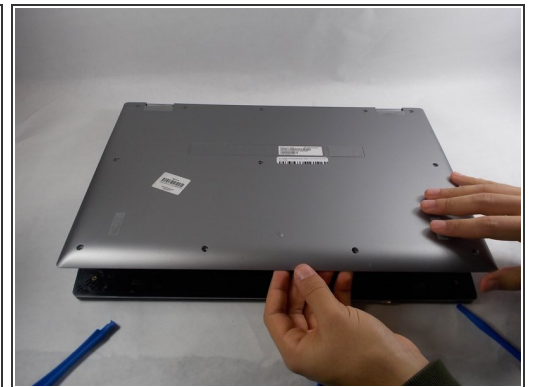
## Step 2

- Use the iFixit opening tools as wedges to pry the back of the laptop off.

⚠ Go slow, making sure not to snap the plastic. With enough of a gap made, you can use your hand to finish taking off the back.

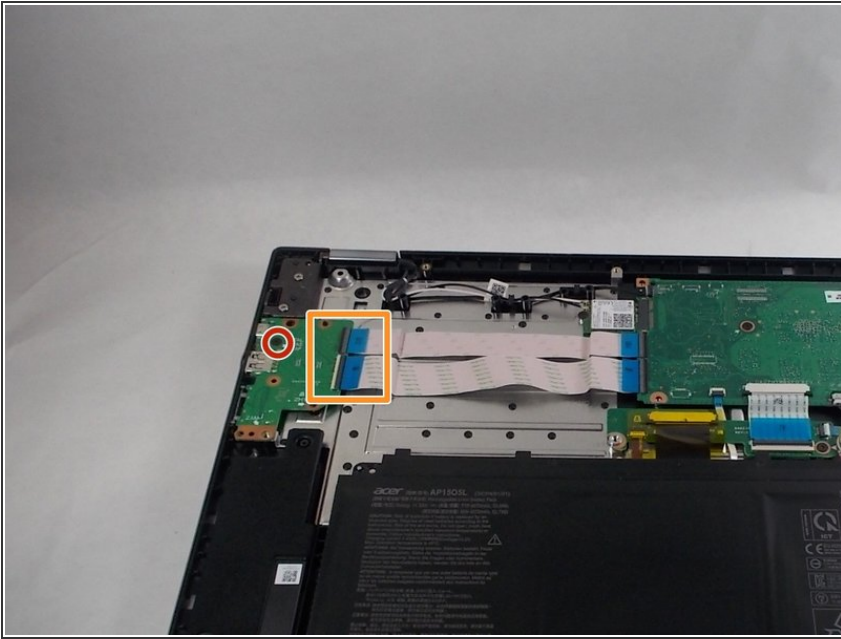
## Step 3 — USB-C Port

- Remove the single 3mm Phillips #1 screw from the circuit board.
- Remove the two ribbon cables from the circuit board.
- Remove the USB-C port from the laptop.
