# Surface Go 2 Teardown

A Teardown of the Surface Go 2 performed on May 14, 2020.

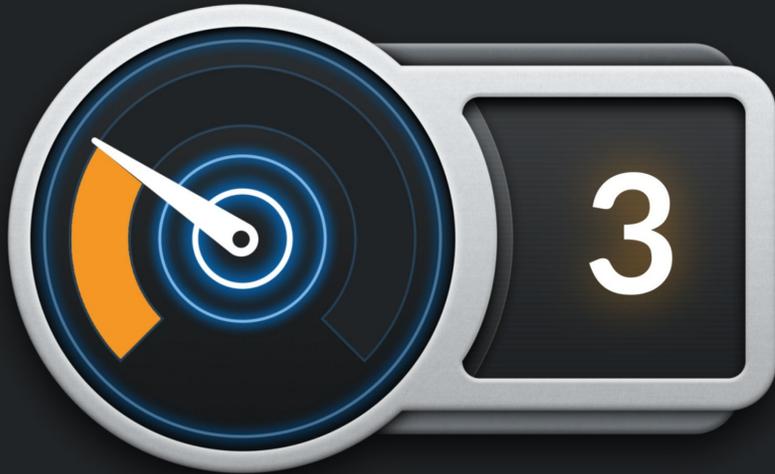
### Repairability Score

- This version of the Surface Go is significantly easier to open thanks to the new display adhesive and redesigned interior shields.
- The use of only one type of screw simplifies repair.
- The lack of modularity, especially on high-wear ports, makes repairs unnecessarily expensive.
- Replacement of any part requires removal of the display assembly, an easy (and expensive) part to damage.
