FLORABEST Cordless Grass & Shrub Trimmer FGS 3.6 A1 Oxidized Safety Key Repair

Safety key no longer working, oxidized/rusted. Grinding helped.

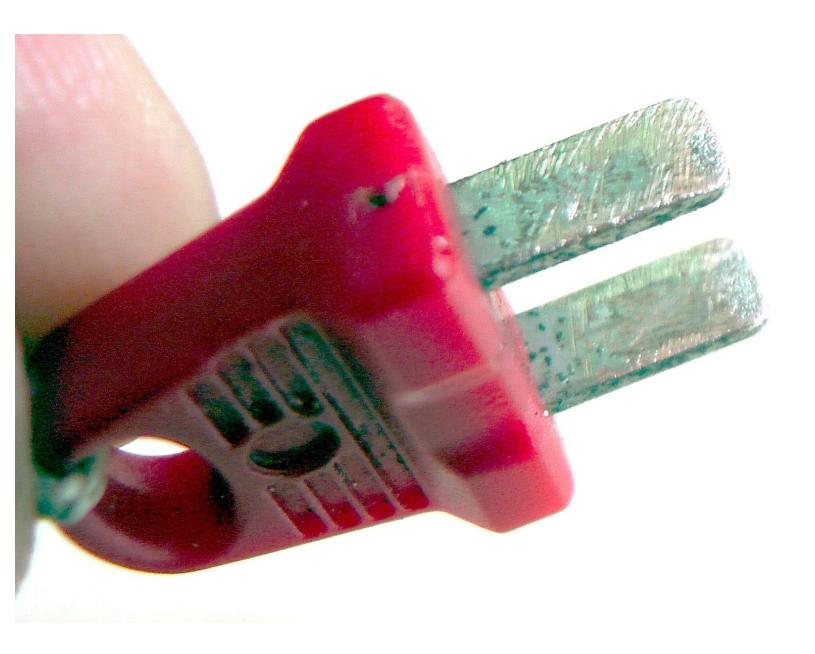
If the device does not work despite a fully charged battery, then it may help to briefly grind the contacts of the safety key (safety pin/plug) with sandpaper.

Grind until the contacts are glossy again.

All done! Hopefully it works now. Make sure to not grind off too much of the key, or it won't work.
