MacBook Pro 15" Retina Display Late 2013 Teardown

Written By: Sam Goldheart

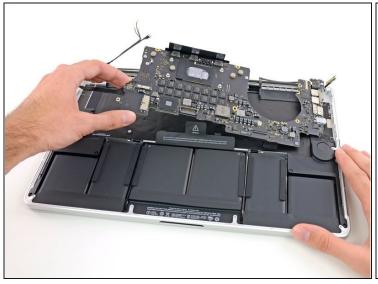
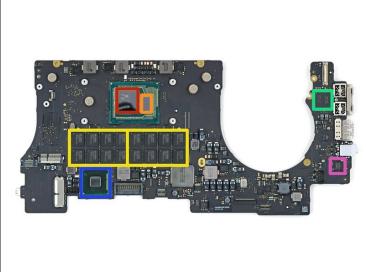
- One of the few differences: The 15" MBP now has a sleekified heat sink with just a single thermal pad, thanks to the more closely integrated GPU—which we attribute to the "Haswellification" process, as we call it.
- (i) Another effect of Haswelling your MacBook: This model claims to deliver an extra hour of battery life with the same capacity cells. The more efficient processor likely contributes much to that extra hour of looking at <u>pictures of cats</u> on the internet.

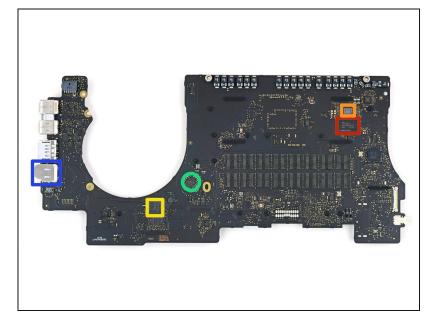
- The most noteworthy revisions come on the logic board, including the all-new Haswell Core i7 processor, Iris Pro Graphics, and Thunderbolt 2 support:
 - 2.0 GHz quad-core Intel Core i7 processor (Turbo Boost up to 3.2 GHz) with 6 MB shared L3 cache and Iris Pro graphics
 - 128MB eDRAM cache
 - Elpida <u>J4208EFBG</u> 512 MB DDR3 SDRAM (16 chips for 8 GB total)
 - Intel <u>DSL5520</u> Thunderbolt 2 Controller
 - Intel Platform Controller Hub
 - Cirrus 4208-CRZ Audio Codec, similar to Cirrus <u>CS4207</u>
