Microsoft Band Battery Replacement

You will be replacing one or both batteries located in the side panels.

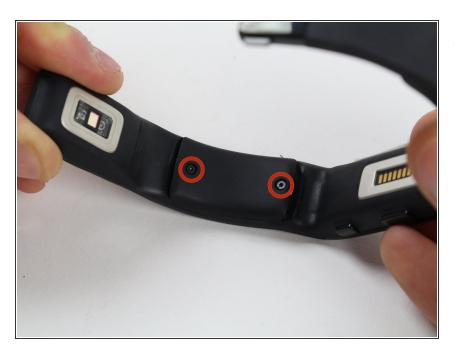
Step 1 — Battery

Unscrew both side panel 2mm screws using the T3 Torx screwdriver.

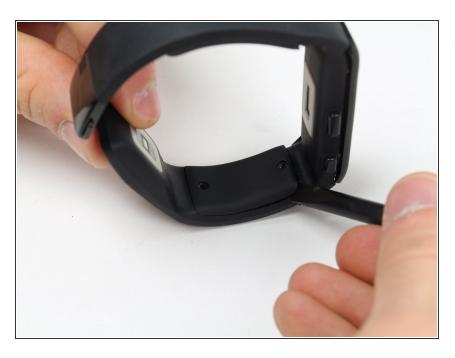
Step 2

Firmly pry up the side panel using the plastic spudger to break the waterproof seal and lift the battery panel.

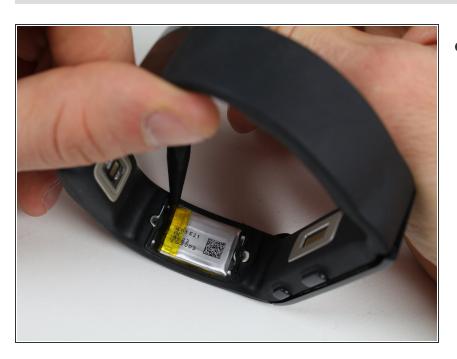
Step 3

Gently pry up one edge of the battery with the plastic spudger.

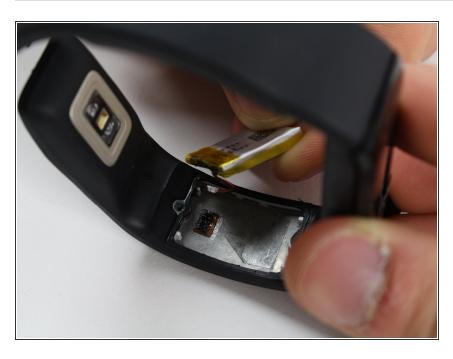
Step 4

Remove battery from its compartment with your fingers.

To reassemble your device, follow these instructions in reverse order. Replace the vibrator in its original compartment.
