Minolta Maxxum STsi Tripod Socket Replacement

Replace the tripod socket for your Minolta Maxxum STsi.

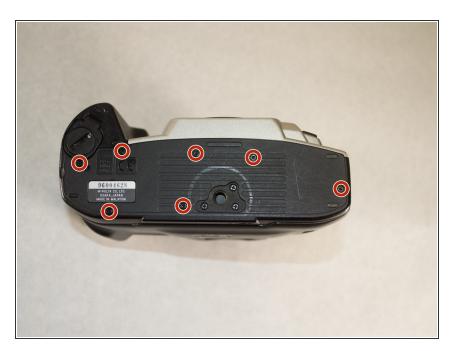
Step 1 — Bottom Panel

Remove the seven black Phillips #00
5.0 mm screws.

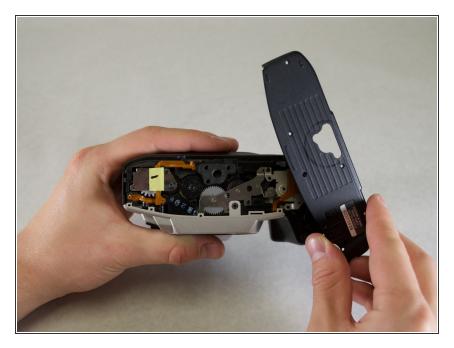
Step 2

Gently remove the bottom panel using your fingers.

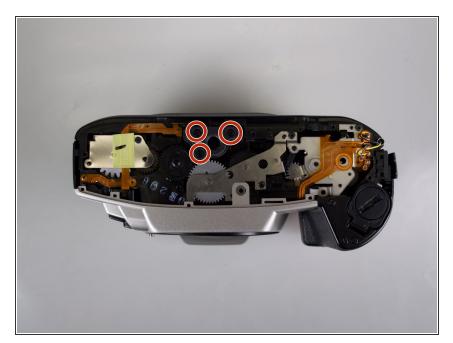
Step 3 — Tripod Socket

Remove the three black Phillips #00
6.25 mm screws from the tripod socket to remove the tripod socket.

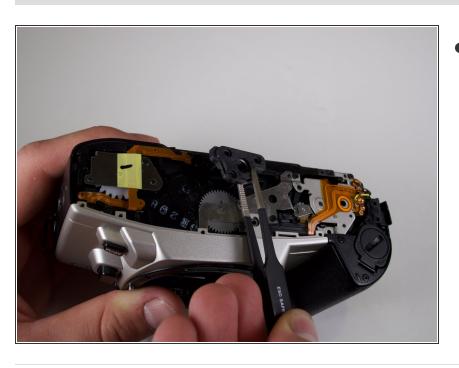
Step 4

Use tweezers to gently remove the tripod socket.

To reassemble your device, follow these instructions in reverse order.
