# Minolta Maxxum STsi Back Clock Button Replacement

This guide consists of removing the back clock button.

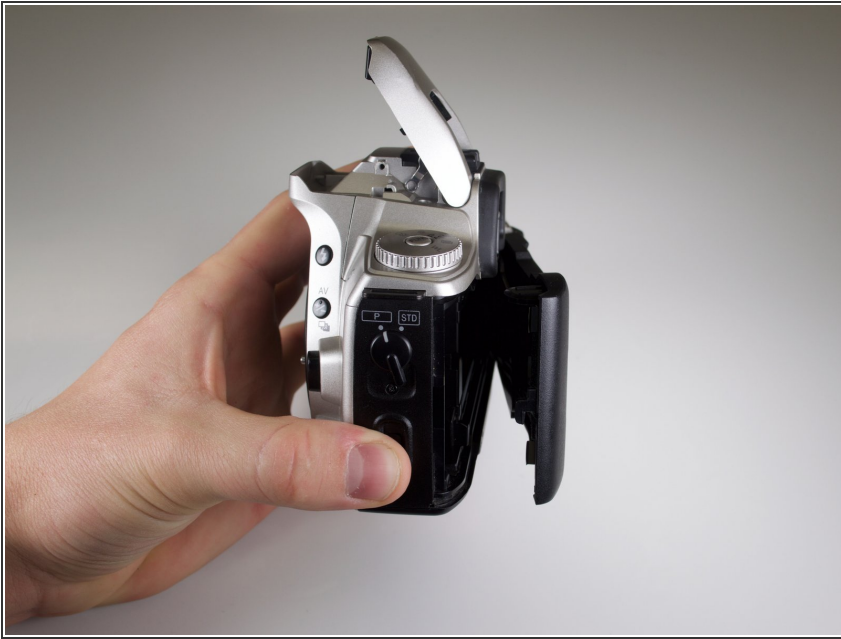
## Step 1 — Back Clock Button

- Open the back panel by firmly pressing up on the back-cover release on the lower right side of the camera.

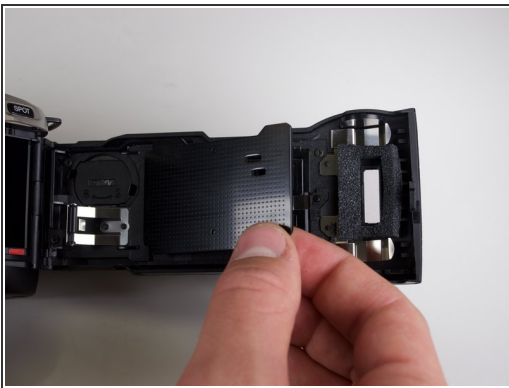
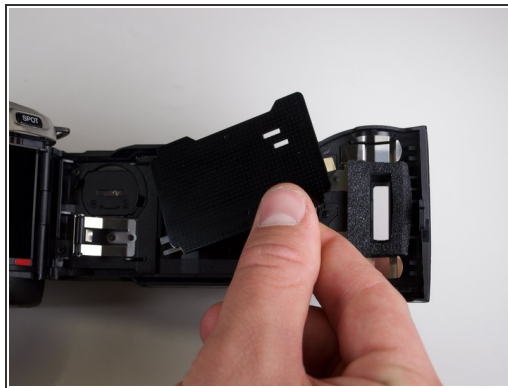
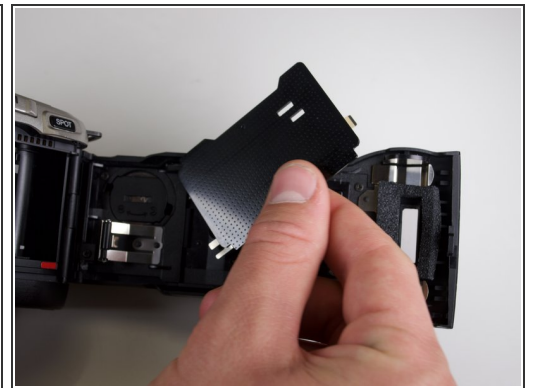
## Step 2

- Remove the black case by gently lifting it with your fingers and rotating counterclockwise.

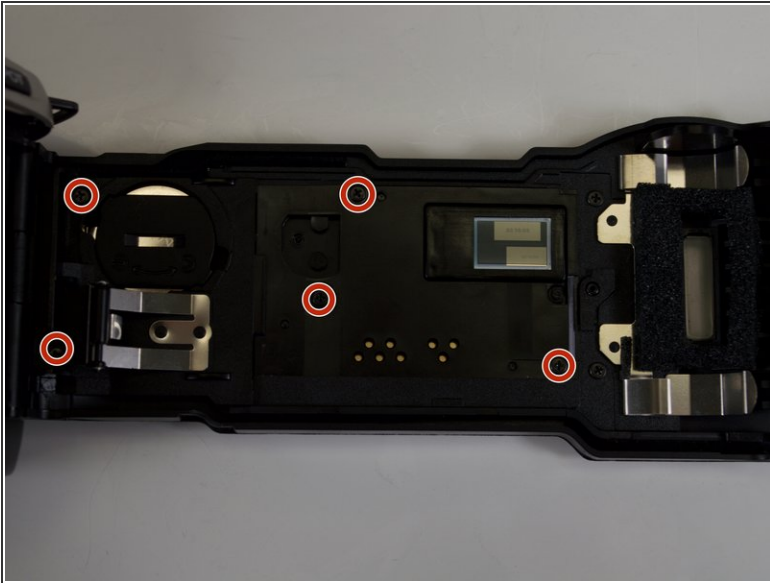
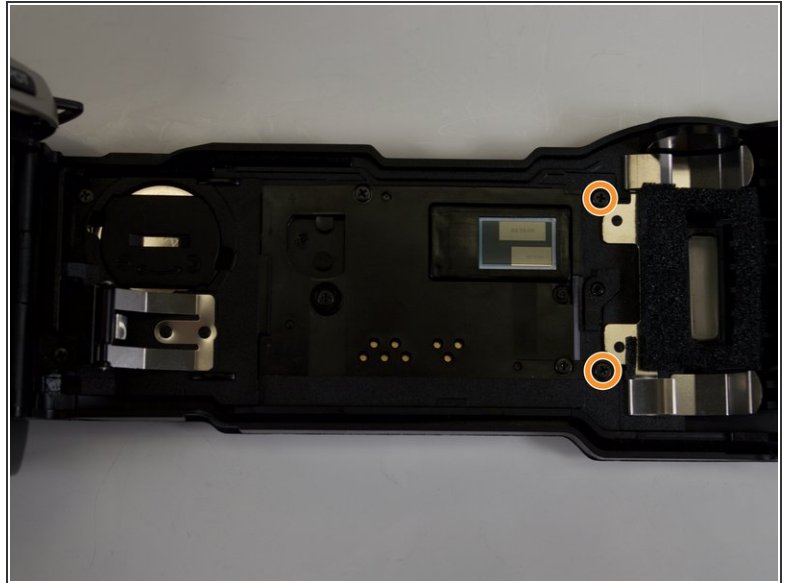
### Step 3

- Remove the five black Phillips #00 2.5 mm screws from the back panel.
- Also remove the two black Phillips #00 5.0 mm screws from the back panel.

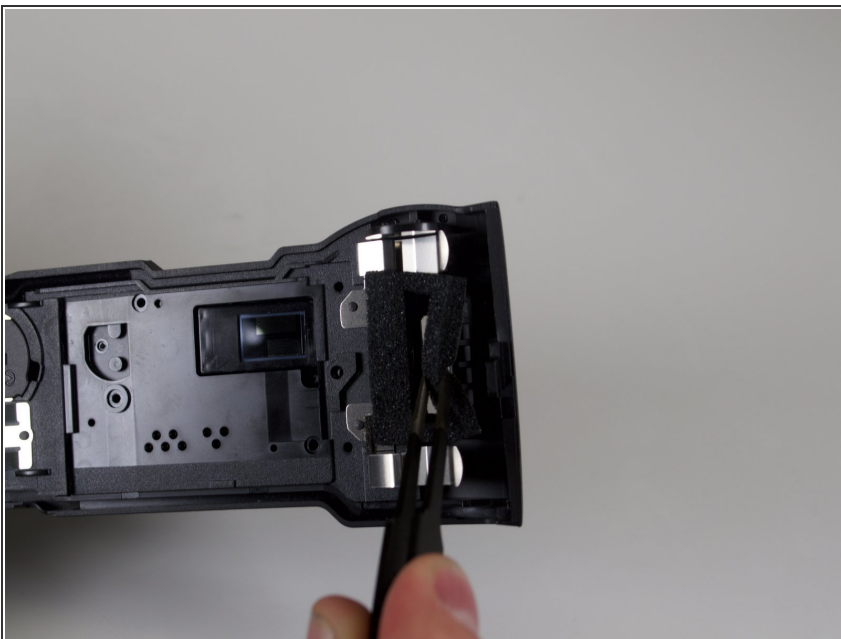
### Step 4

- Use the tweezers to carefully peel back the adhesive foam connecting the back panel to the case and remove the panel.

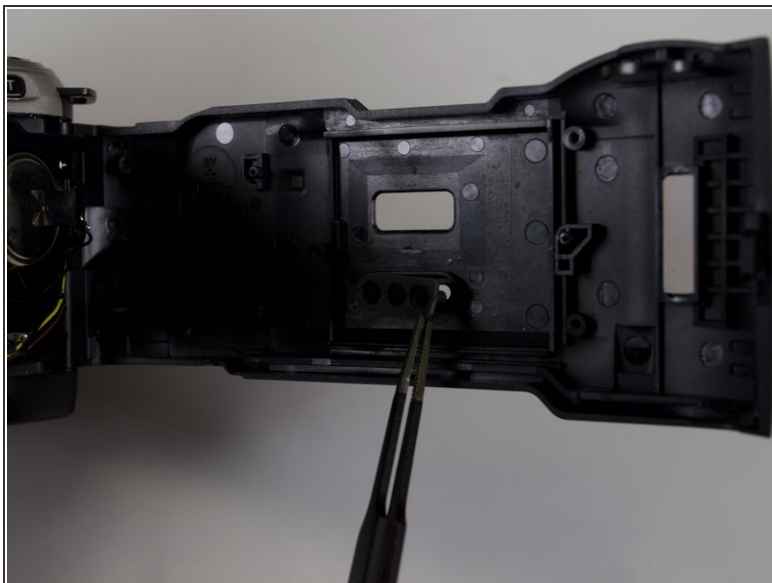
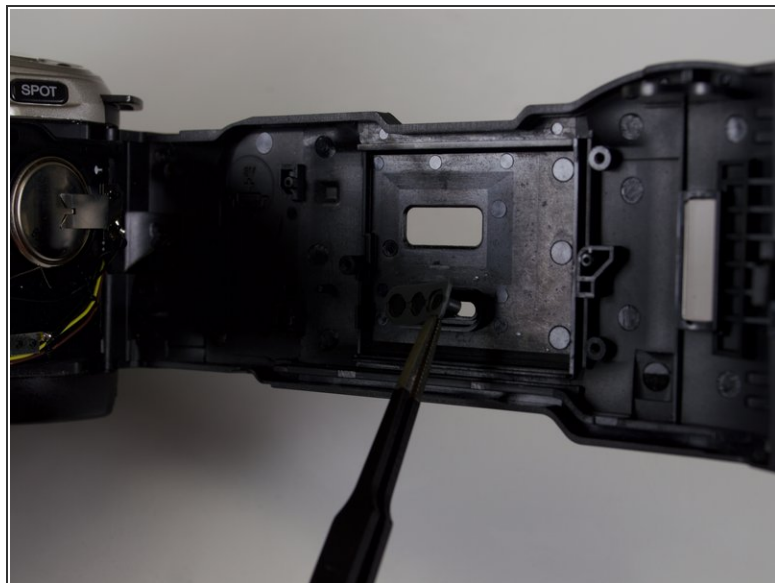
## Step 5

- Use the tweezers to carefully peel off the rubber clock button.
