# Microsoft Lumia 535 Loudspeaker ,Vibra Motor or Camera Light Replacement

Written By: ZFix

Microsoft Lumia 535

RM-1090 / RM-1091/ RM-1089 / RM-1092

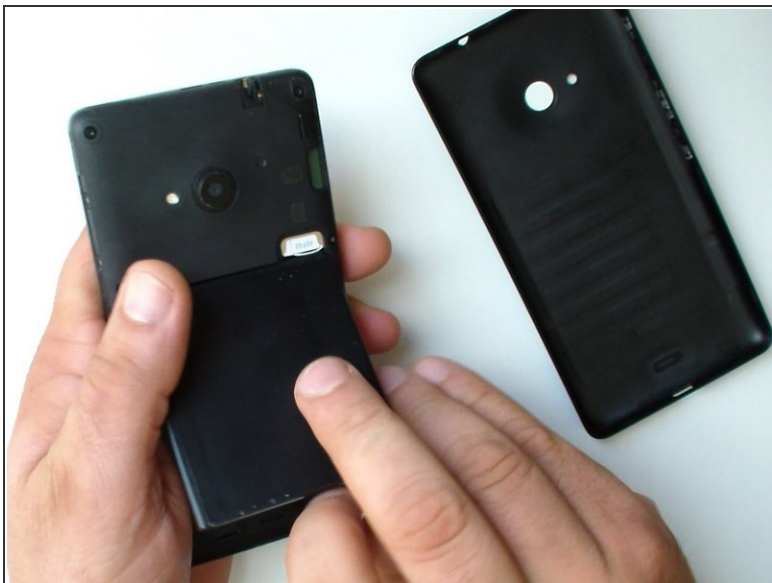
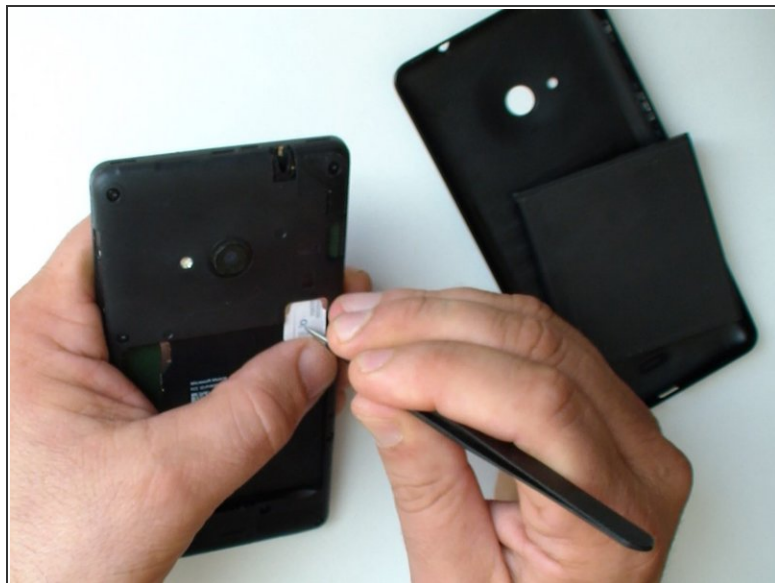
## Step 1 — Back Cover / Rear Case

- Turn off the phone.
- Remove the battery and any SIM and memory cards.

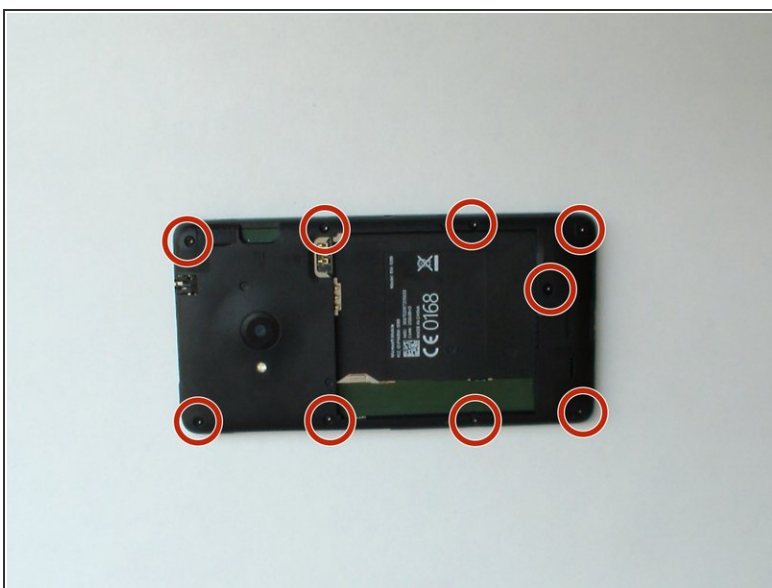
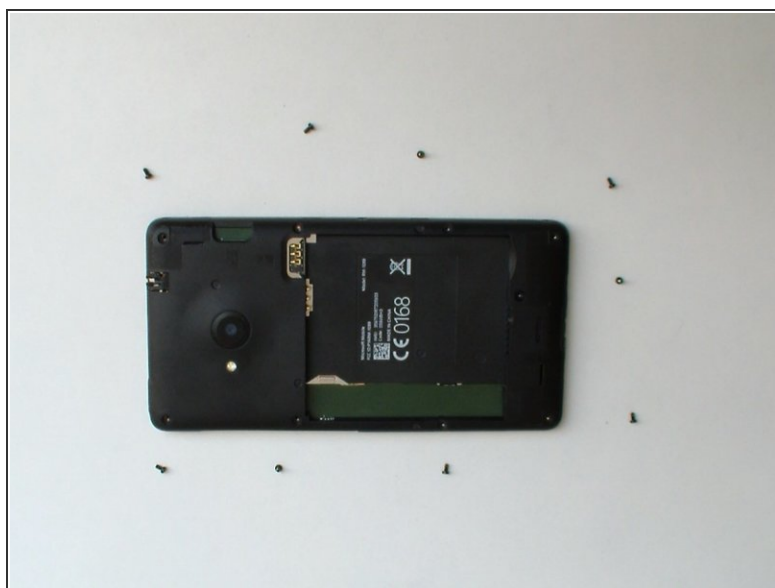
## Step 2

- With a screwdriver Torx T4 remove the 9x screws.

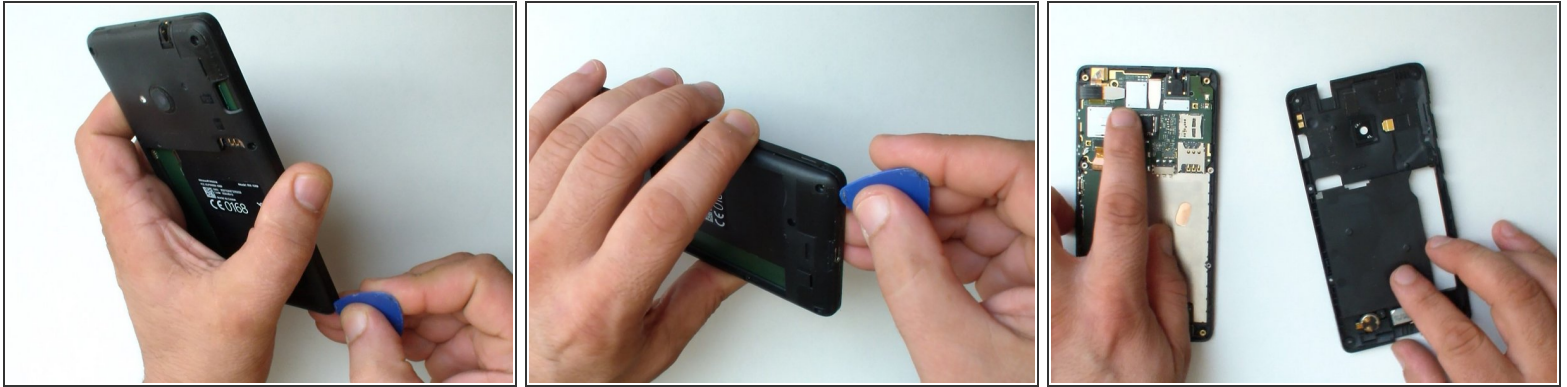
### Step 3

- With a plastic opening tool separate the back cover from the middle frame.

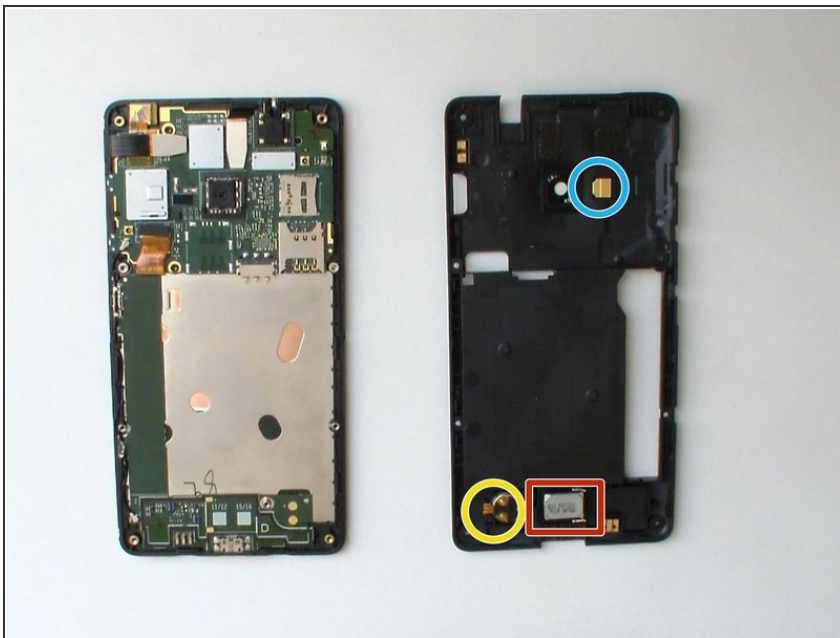
### Step 4 — Loudspeaker and Vibra Motor

- Loudspeaker
- Vibration motor
- Camera light

To reassemble your device, follow these instructions in reverse order.
