HP ElitePad 900 Volume Control Buttons Replacement

Use this guide to replace the volume control...

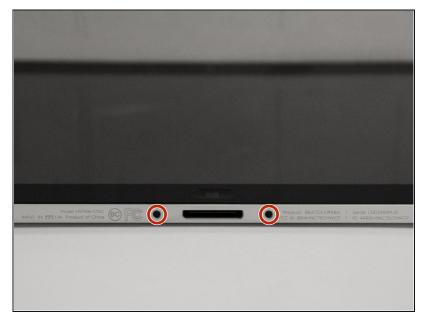
Step 1 — Front Panel Assembly

Unscrew the two 2.8mm Phillips #000 screws near the power connector.

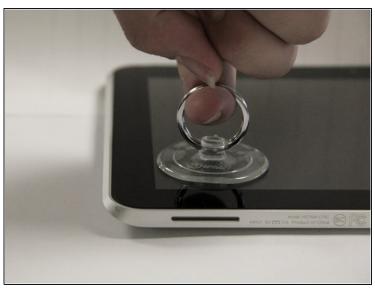
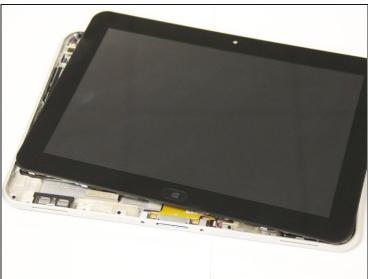
Step 2

Use a suction cup to pull the display assembly up.

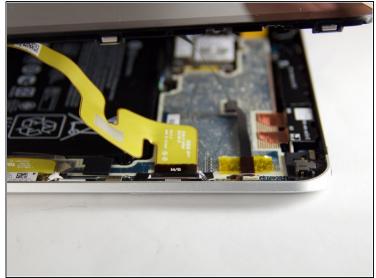
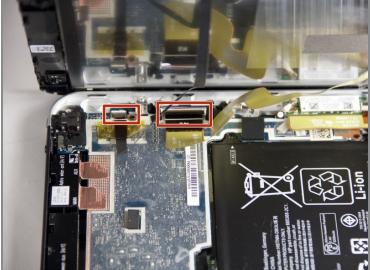
Step 3

• Use the tip of a spudger to disconnect the two display **ZIF** connectors.
