Turtle Beach Ear Force P11 Microphone Replacement

Malfunctioning of the microphone and inability to transmit sound might require disassembling of the receiver.

Written By: Bhavesh Gandhi

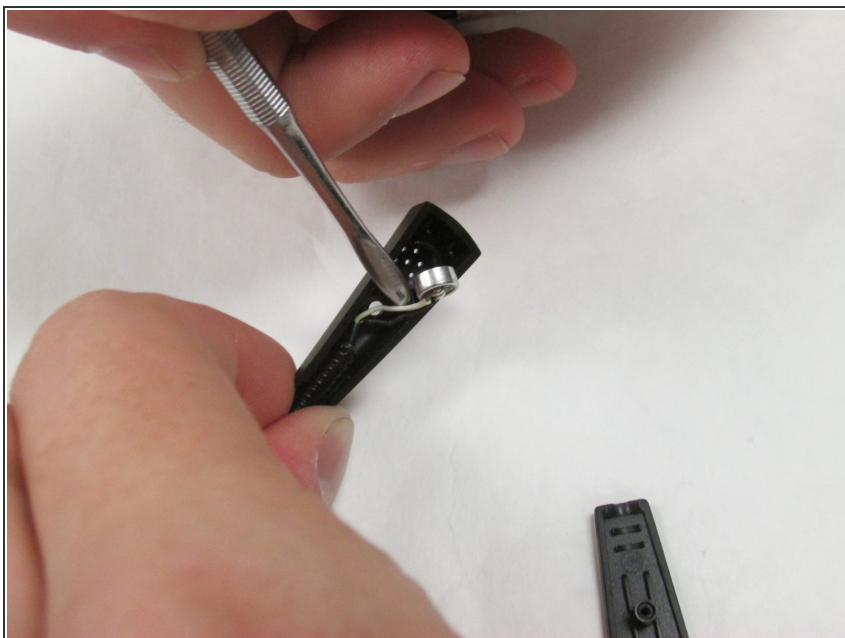
Step 2

- Use a nylon or metal spudger set to lift out the microphone.
- ⚠ Be careful lest you might break the fragile wires.
- Always try using a plastic tool before resorting to a metal tool as shown in the picture.

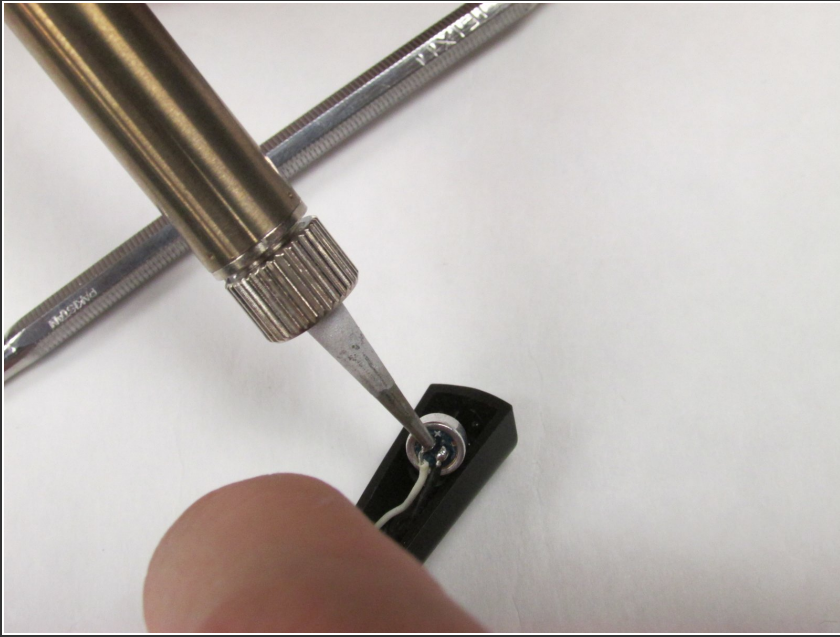
Step 3

- De-solder the microphone wires and remove the microphone.
- ⓘ Use low heat for de - soldering
- ⚠ Do not cut the white and black wires soldered to the microphone as you might reduce the length of wire required to reassemble.
