Black and Decker TO1303SB Door Spring Removal/Replacement

This guide will help repair the spring in your toaster oven door. If your door is squeaky or not opening/closing properly, this will help fix that problem. Even though this guide only has a couple steps, you must be careful when pulling the spring and twisting it. This guide is best done when using needle nose pliers.

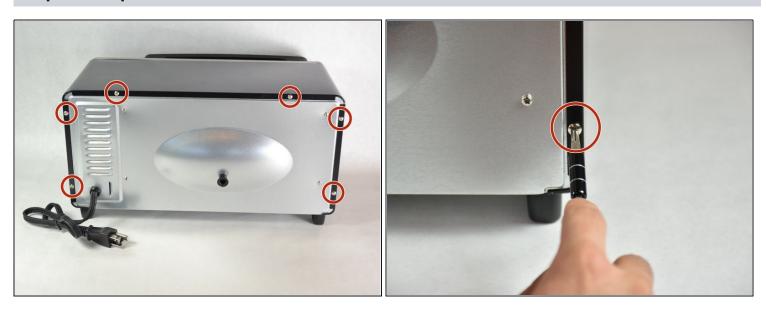
Step 1 — Top Cover

• Remove the six 9.5mm screws on the back panel using a #2 Phillips screwdriver.

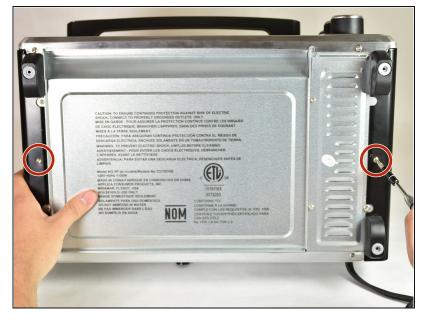
Step 2

- Remove the two 13mm screws, located between the feet on the bottom of the cover, using a Torx T15 screw driver.
- On the TO1313SB, a Security Torx T15 driver is required — the screws have a center pin that prevents use of a regular T15 driver.

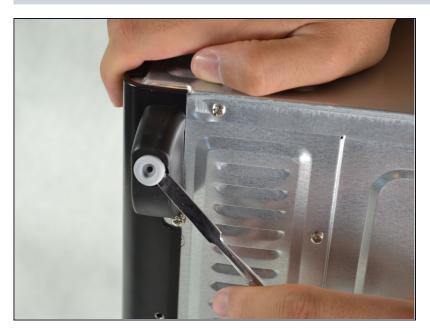
Step 3

Using the metal spudger, carefully pry out the rubber base on each foot to access the screws.

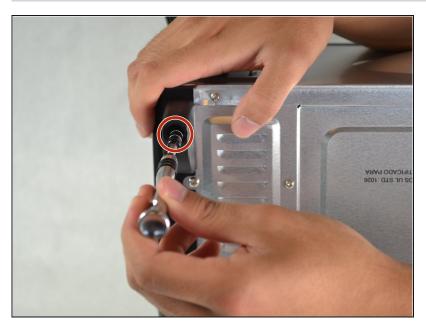
Step 4

• Remove the 11.5 mm screws using a #2 Phillips screwdriver.

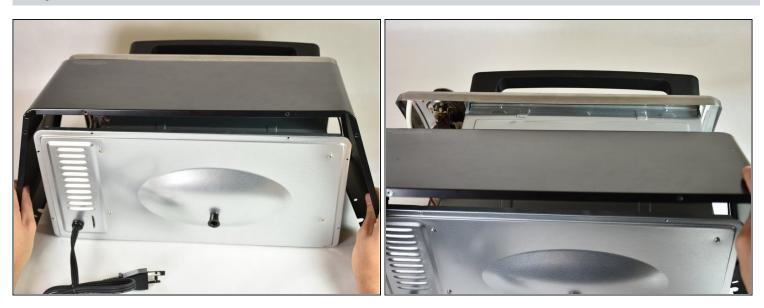
Step 5

• Remove the back cover by gently pulling the sides of the cover apart from the rest of the oven. Then, tilt the cover towards the face and pull back at an upward angle. The cover should slide right off.

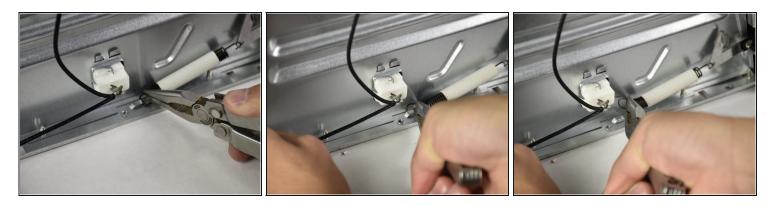
Step 6 — Door Spring

- With the needle nose pliers, grasp the hook of the rear spring as close as you can to the coils. Stretch the spring back and, with a twisting motion, pull the hook out of its catch.
- (i) It is recommended to close the door before doing this.
- A Slowly relieve the tension after pulling it out of the catch or else it may damage the spring attachment.

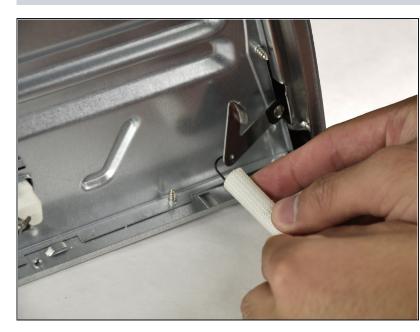
Step 7

- Pull the front hook out of the spring attachment.
- When replacing the spring, it is recommended to start by reattaching the hook onto the rear catch, then the front spring attachment. Attaching to the front spring attachment first will cause unnecessary stress to the attachment and may cause it to deform.
