Lenovo Tab 2 A8 Front-Facing Camera Replacement

Front-facing camera isn't working? This guide will show you how to switch it out with a new one.

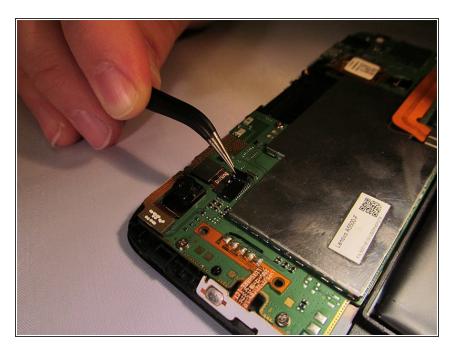
Step 3 — Front-Facing Camera

Using tweezers, peel off the antistatic sticker from the camera connection port.

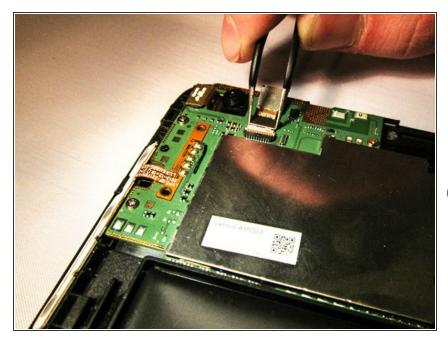
Step 4

- Lift the camera out of its socket in the motherboard. Then, using tweezers to grasp the camera connector, carefully pull the connector horizontally out of the port.
- Be aware that the camera connector will be firmly lodged in the port.
 When successfully removed, the top side of the port pops up.

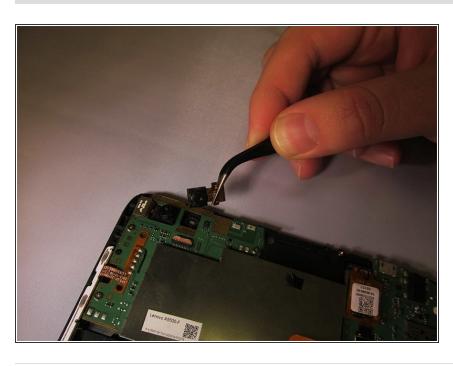
Step 5

Using tweezers to grasp the camera connector, lift the camera out of its socket.
