Lenovo IdeaPad G50-45 DVD Drive Replacement

After reading this guide you should be able successfully replace your DVD drive.

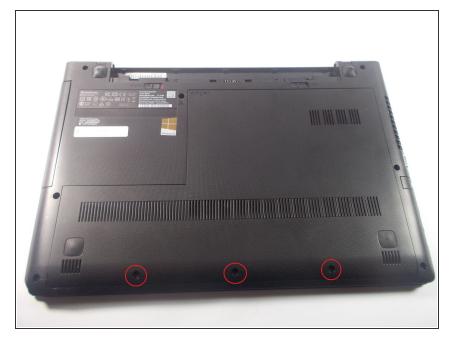
Step 1 — DVD Drive

- First, remove the three screws located on the bottom panel of the laptop using a Philips #2 screwdriver.
- To avoid losing the small screws, put them in a container.

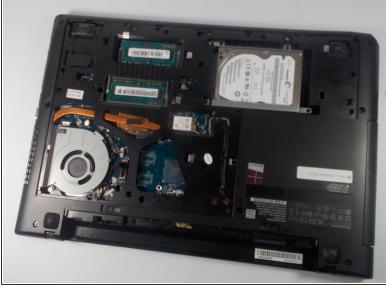
Step 2

- To remove the panel on the laptop, gently slide the panel away from the battery.
- ↑ Make sure to slide the panel away before you lift to keep the panel from breaking.
- Lift up the panel and place it to the side.

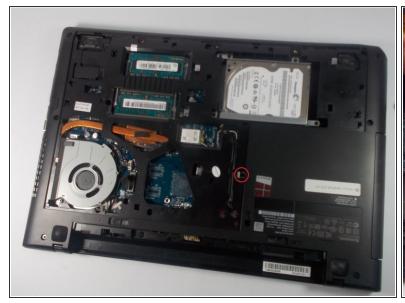
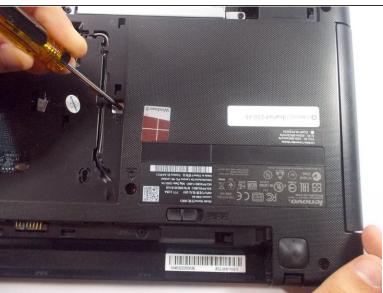
Step 3

- Remove the indicated screw holding the DVD Drive.
- To avoid losing the screw, place it in the same container used to hold the other three screws.

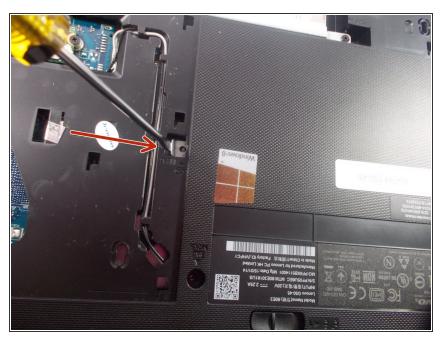
Step 4

- Push the now-free tab towards the DVD Drive using a flathead screwdriver.
- not pry up the now-free tab.

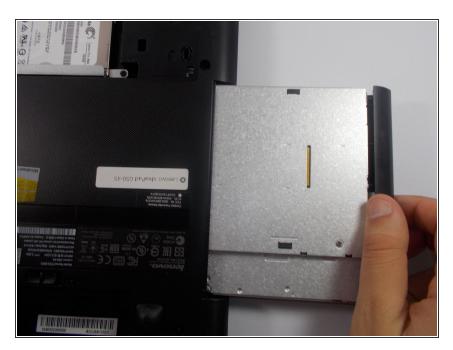
Step 5

Lastly, pull out the DVD Drive; it should come out easily.
