# Blackberry Torch 9800 Replacing rear camera

This guide will help you replace a not working camera on a Blackberry Torch 9800 phone. Making any physical change to this phone will void the warranty.

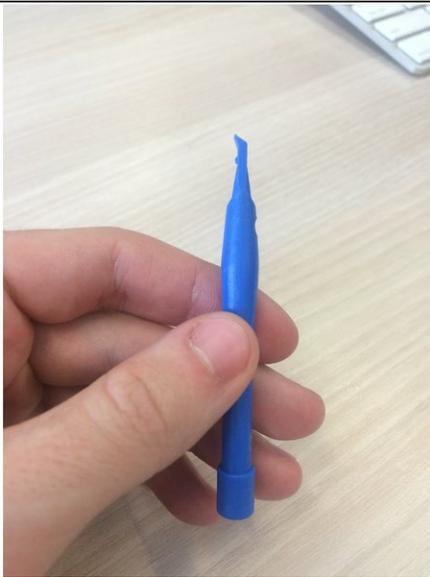
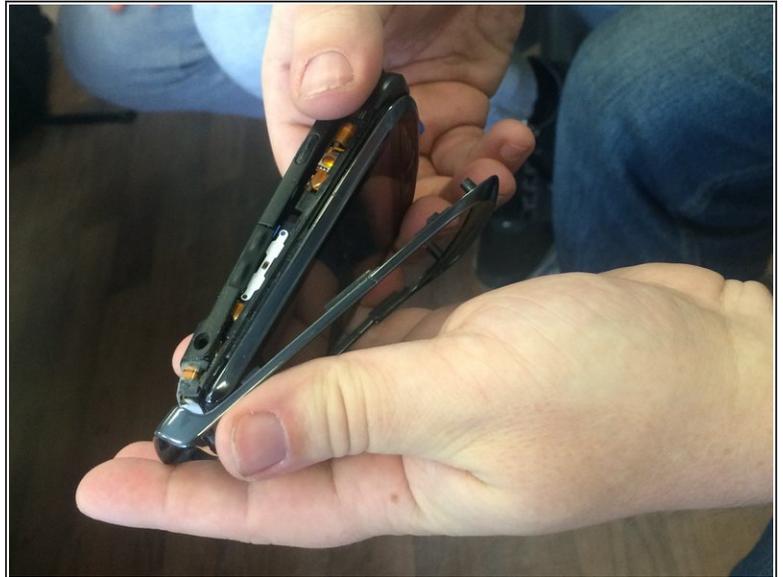
## Step 2

- Remove the side trim using the plastic opening tool.
- When loose, push the top backwards and the bottom forwards to remove.

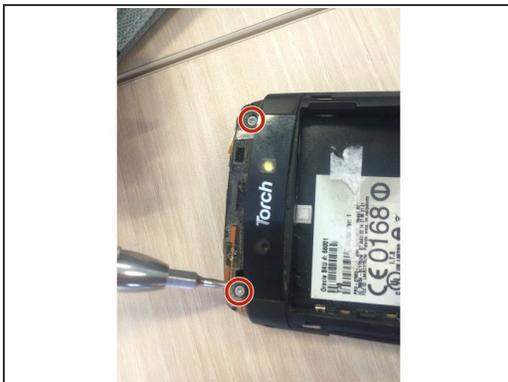
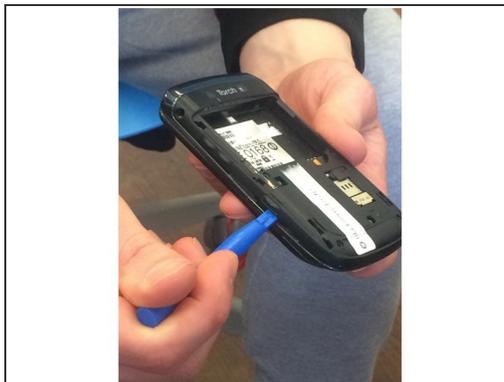
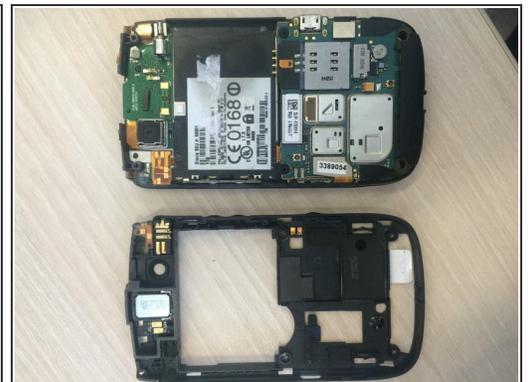
## Step 3

- Two new screws have been exposed near the top of the back.
- Remove the two screws using the T7 screwdriver.
- Remove the back panel using the plastic opening tool.

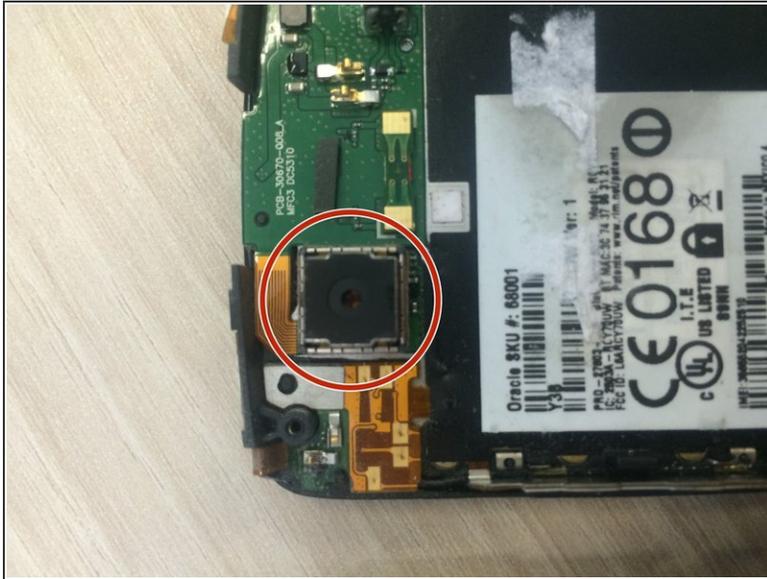
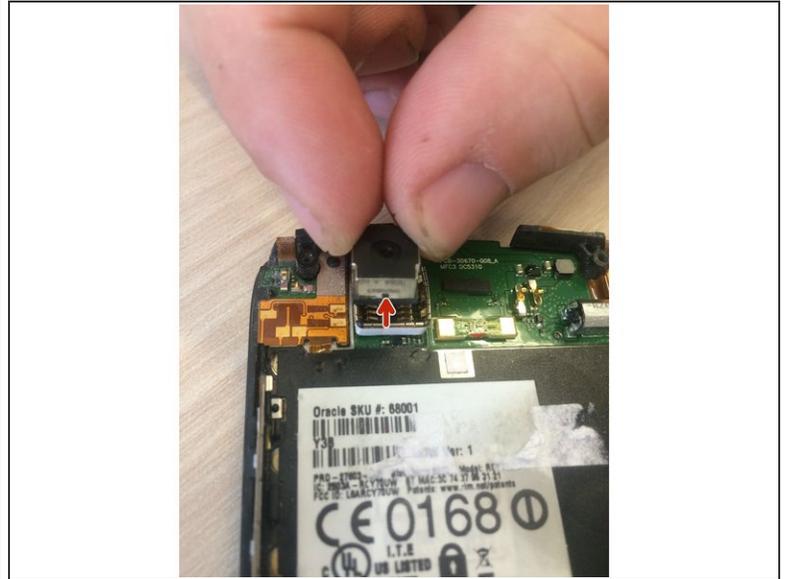
## Step 4

- Carefully use flathead screwdriver to free camera sensor.
- Wiggle on the right and left sides, not the top and bottom sides.

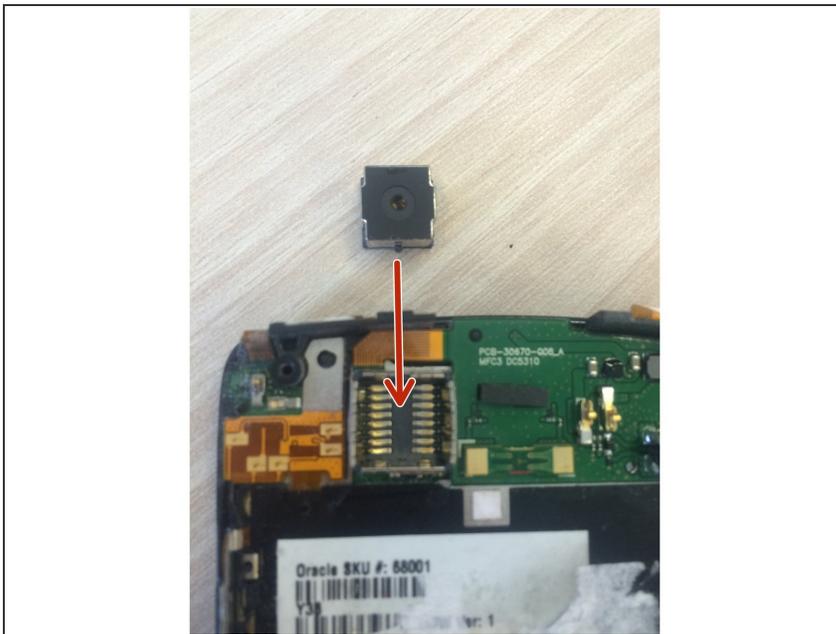
## Step 5

- To install the new camera sensor, place in slot. Reassemble phone by doing steps 1-3 in reverse order.
