Canon Vixia HF R500 Speaker Replacement

This guide will help you replace your broken or damaged speaker in your device.

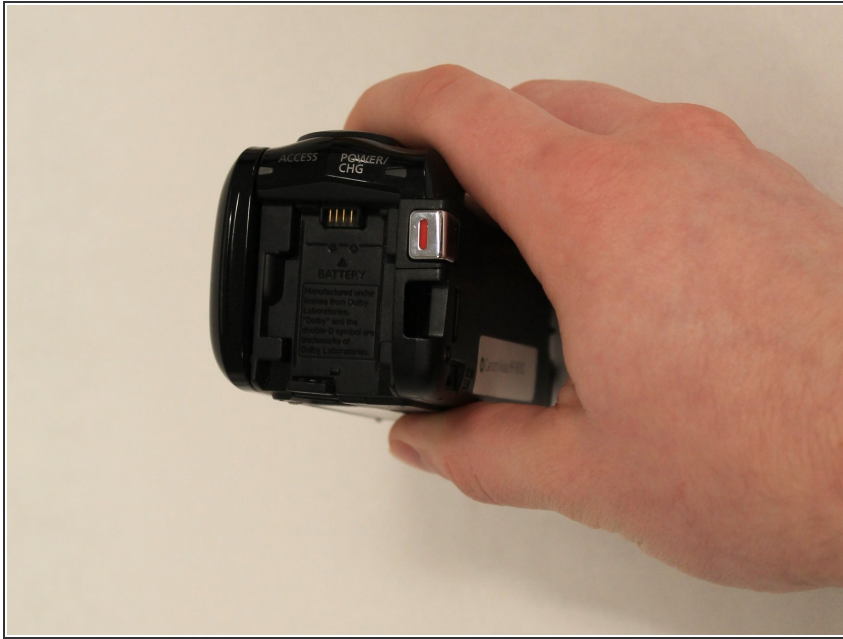
Step 1 — Battery

- Hold on to the battery.

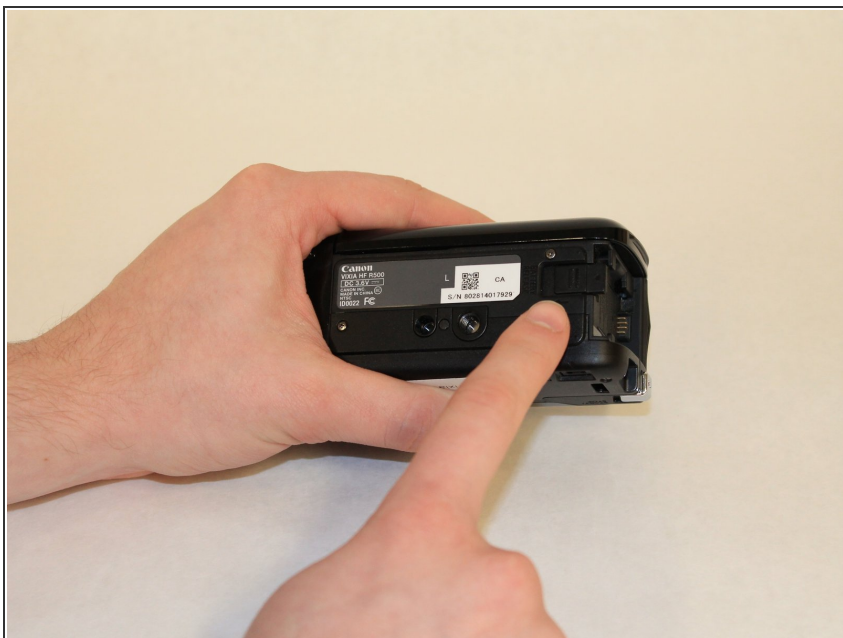
Step 2

- On the bottom of the battery hold the battery release switch.

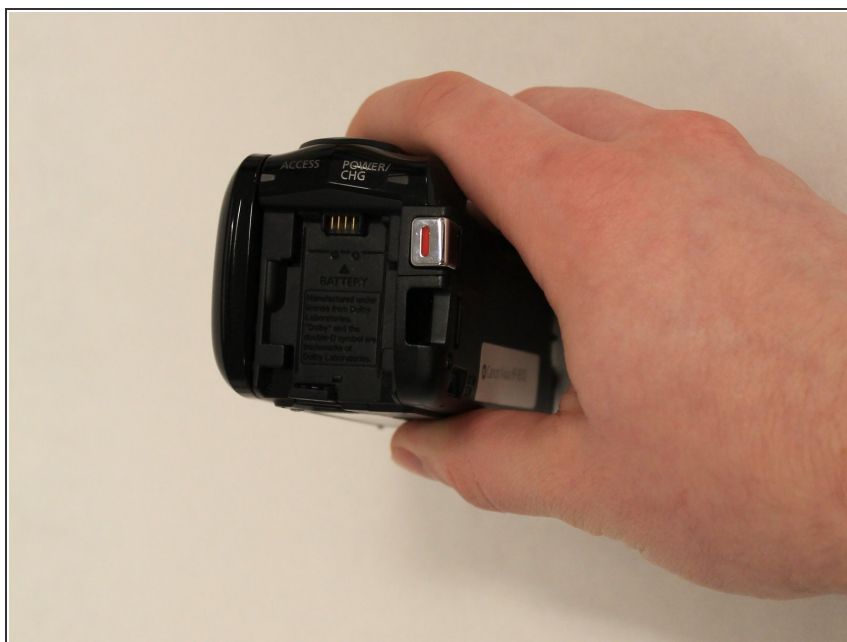
Step 3

- Remove the battery slowly away from the camcorder.

Removing the battery quick or in a different angle may cause sparks and damage to device.

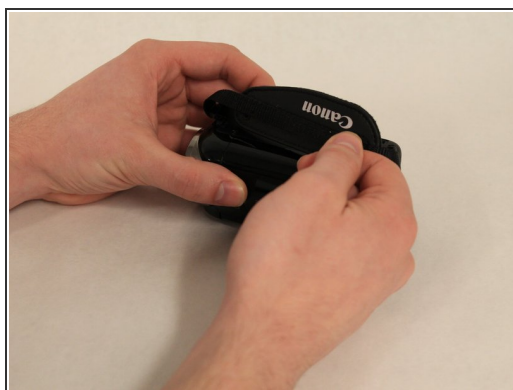
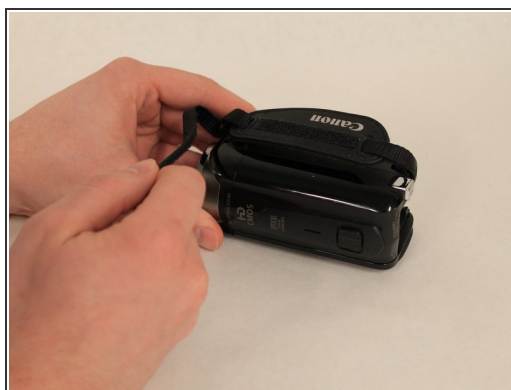
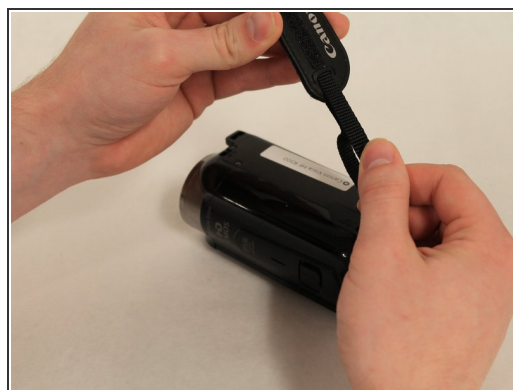
Step 4 — Grip Belt

- On the right side of the camcorder remove the grip belt.

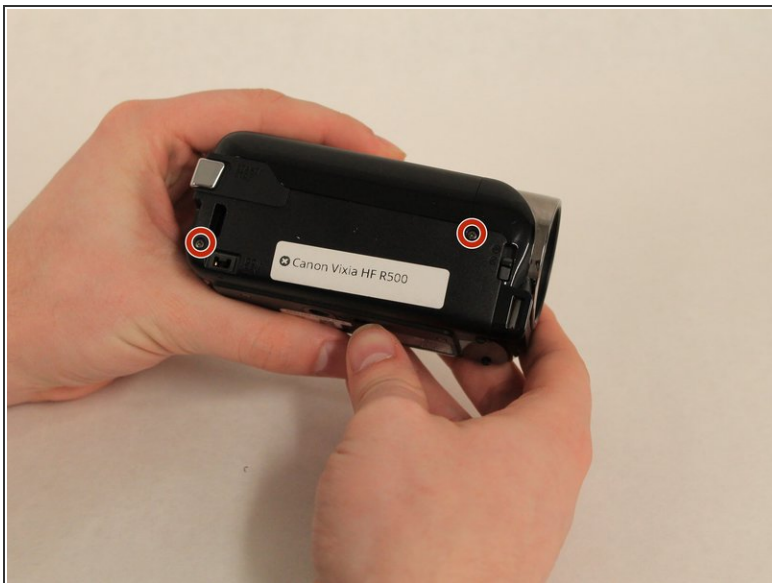
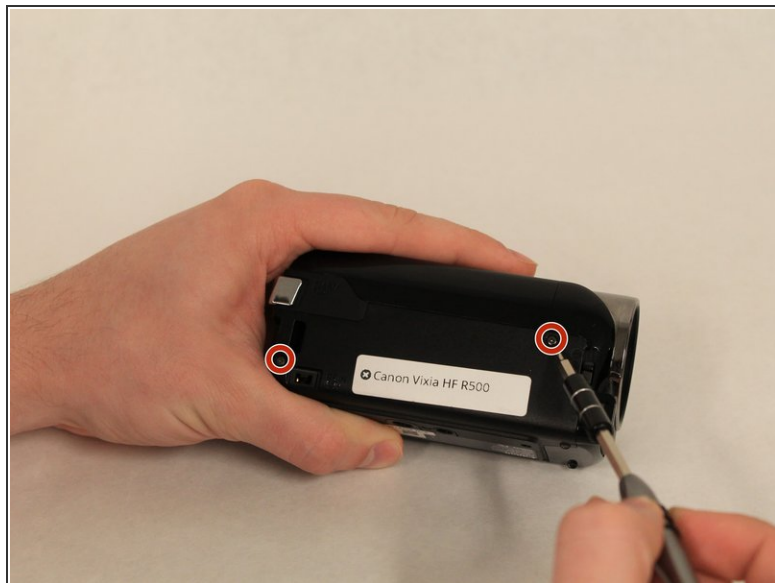
Step 5 — Canon Vixia HF R500 Disassembly

- Remove the two 8mm Philips #000 screws on the side where the grip belt was located on.

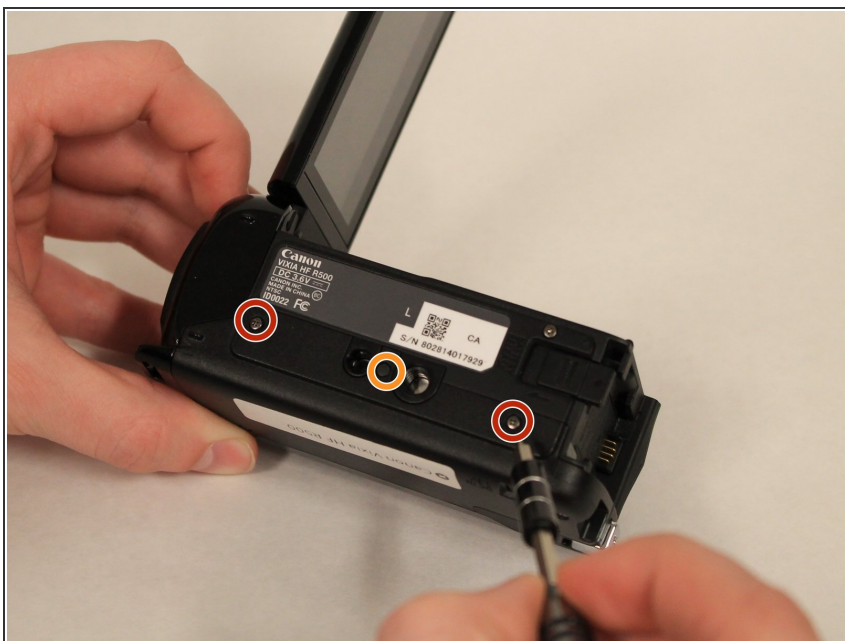
Step 6

- Remove the two 4mm Philips #000 head screws from the bottom of the camcorder.
- A hidden 4mm Philips #000 screw is shown under the black plug shown.

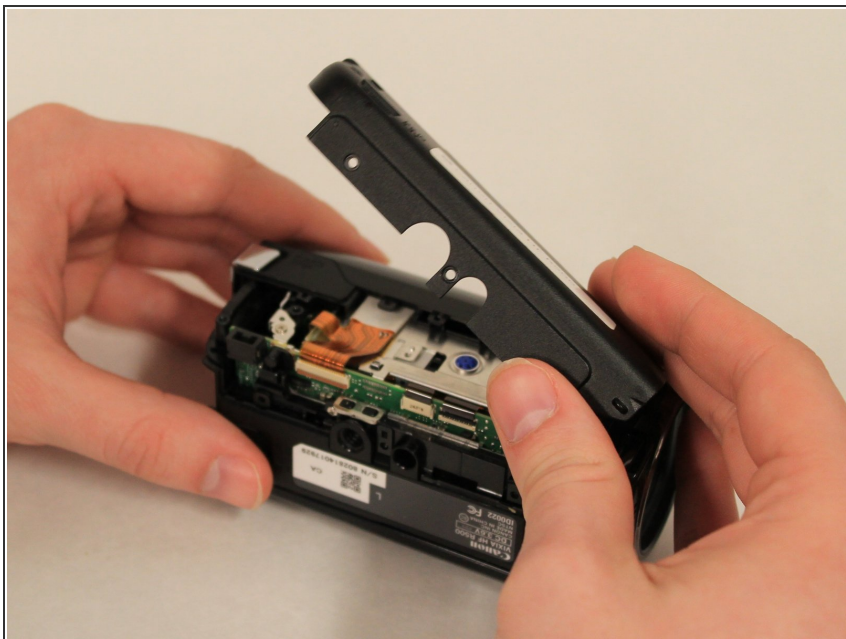
Step 7

- Remove the side piece plate.

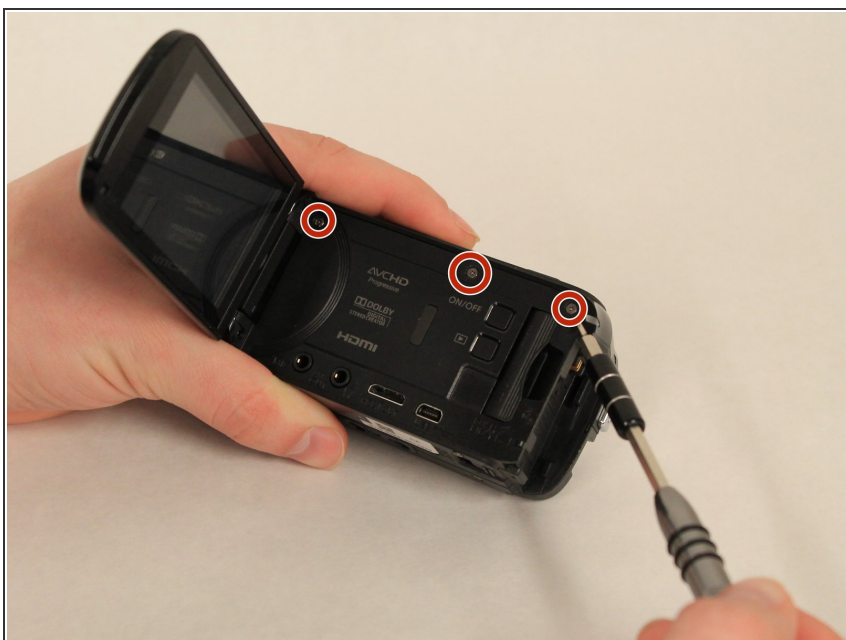
Step 8

- Near the LCD screen, remove the three 7mm Philips #000 screws in the picture shown.

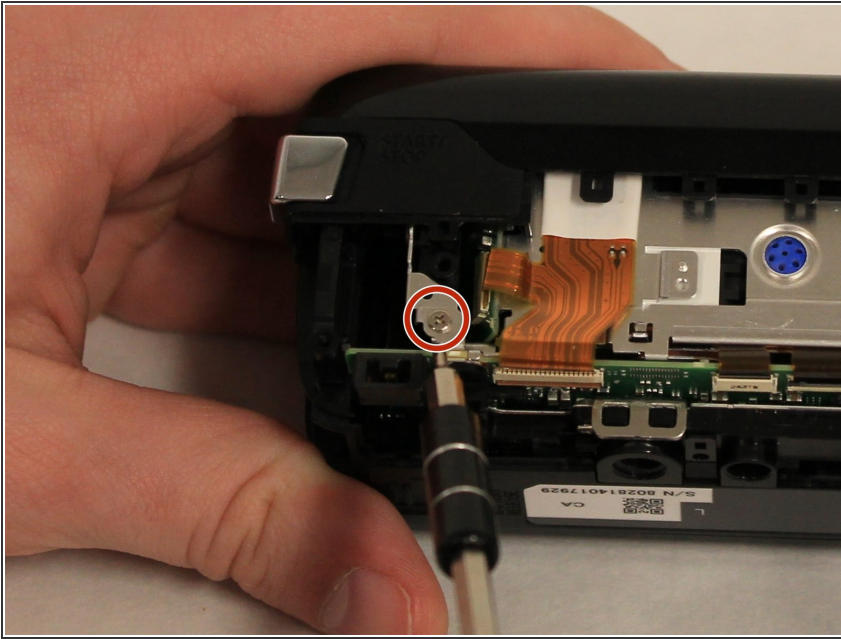
Step 9

- Carefully place the camcorder where the inside of the device is facing upwards and remove the 3mm Philips #000 screw shown.

⚠ Do not use strong magnetic parts on the inside, as they may damage the device.

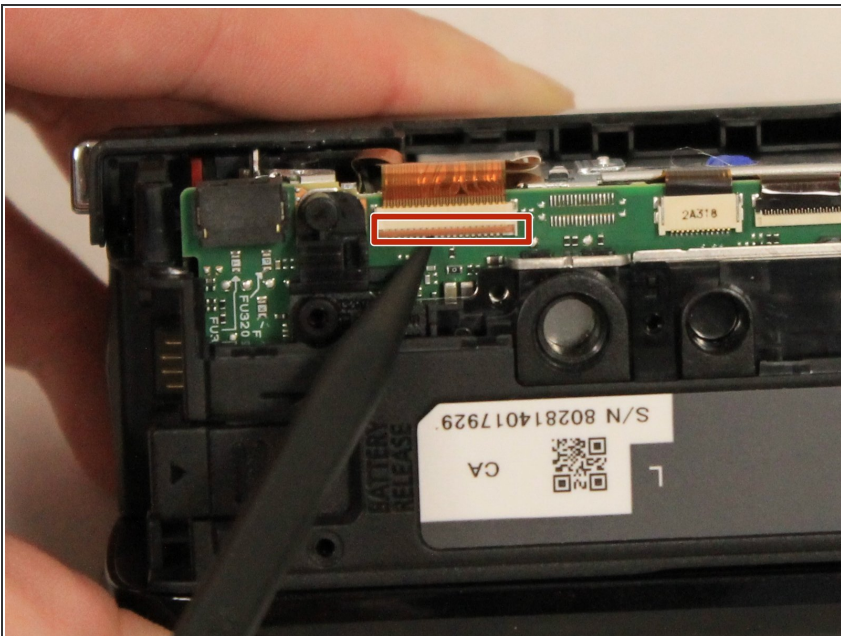
Step 10

- Using the spudger, pull the tab shown to start removing the ribbon cable.

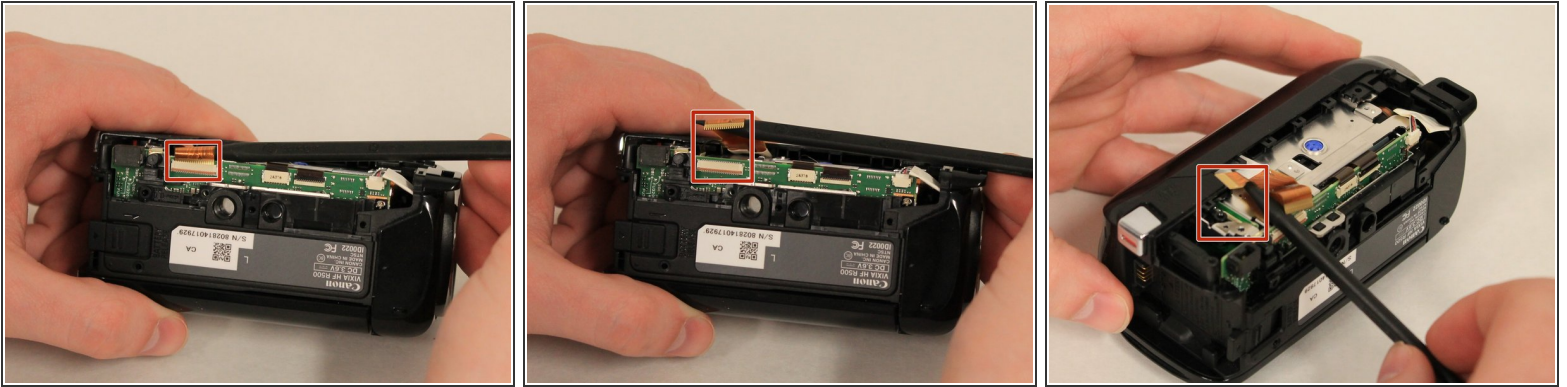
Step 11

- Using the Spudger, carefully remove the two ribbon cables that are connected to the top of the device.

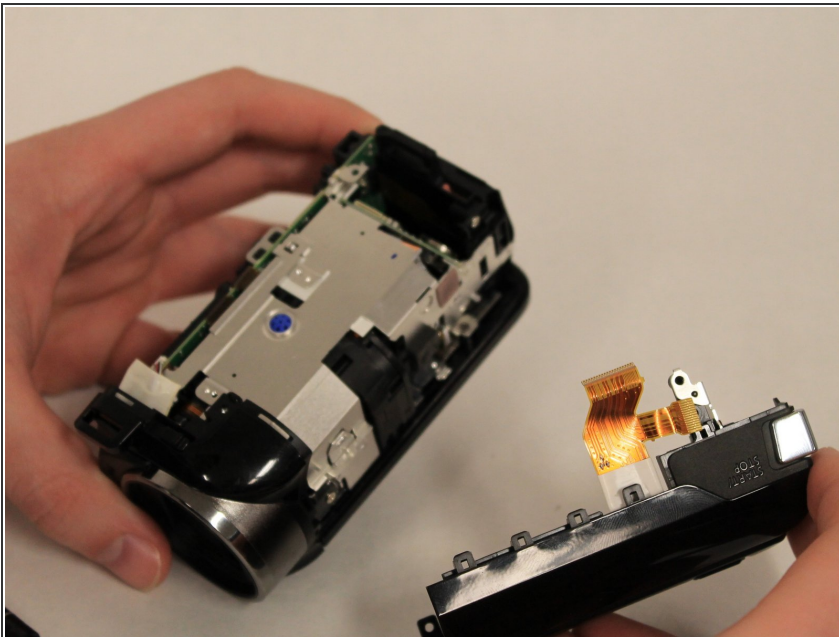
Step 12

- Remove the top piece.

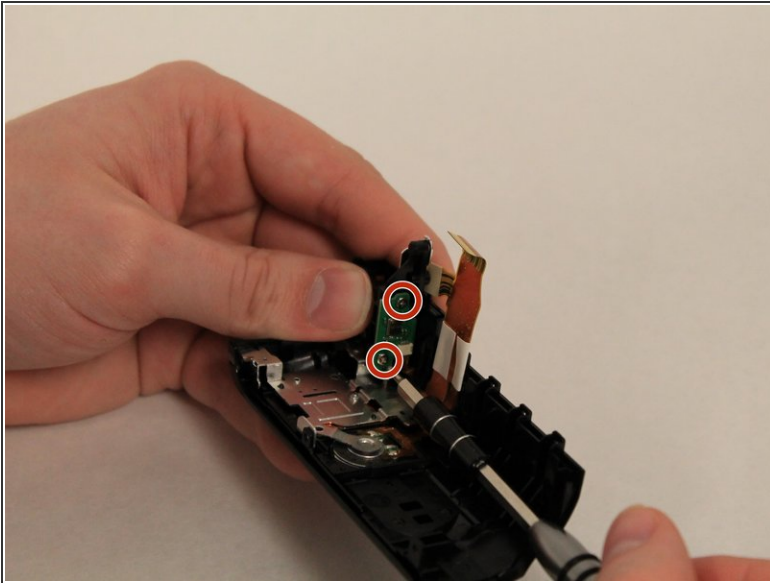
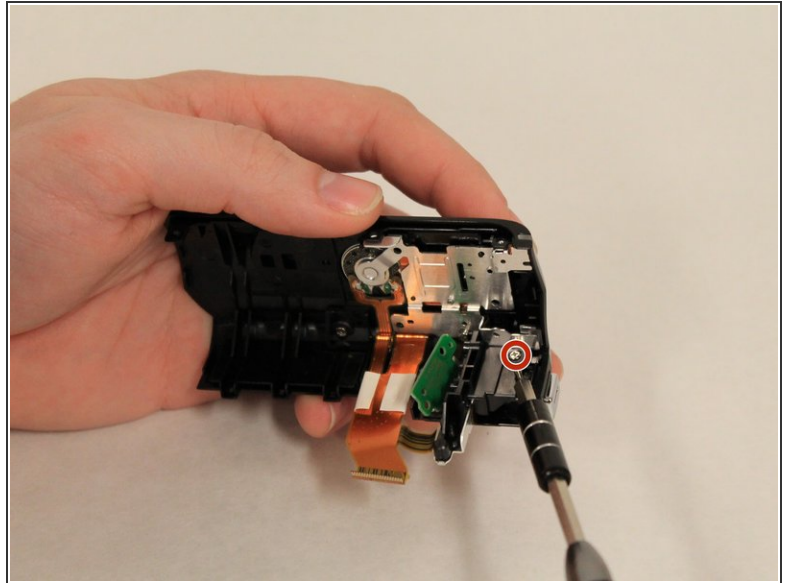
Step 13 — Speaker

- Remove the three 6mm Philips #000 screws holding the black record piece.

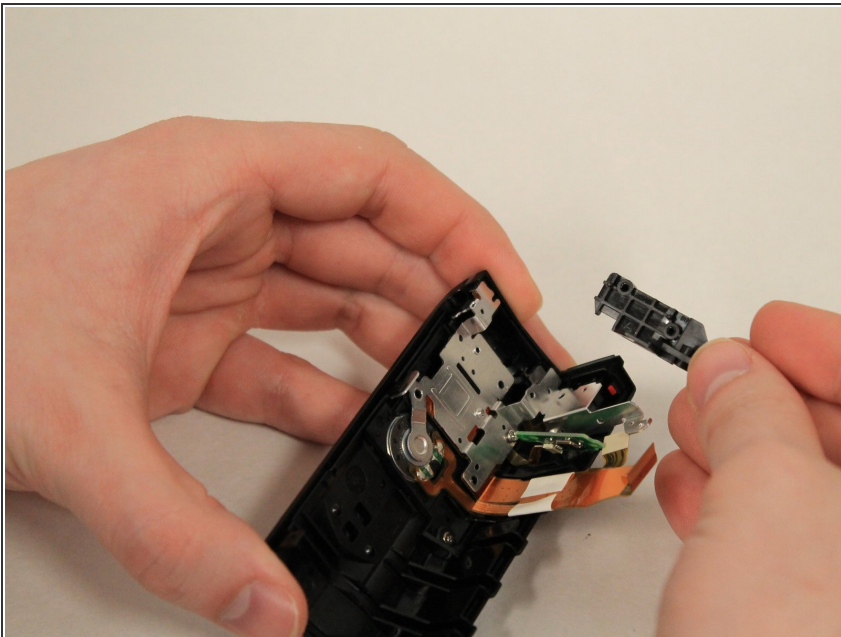
Step 14

- Remove the black record piece.

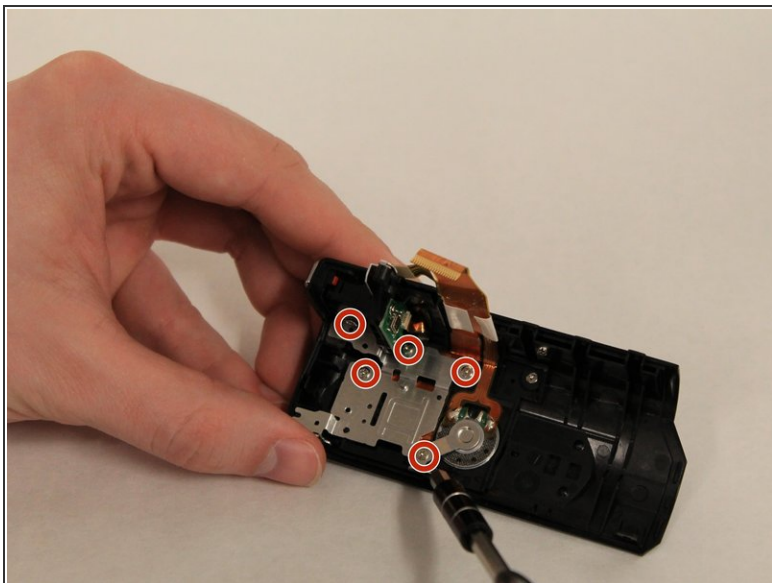
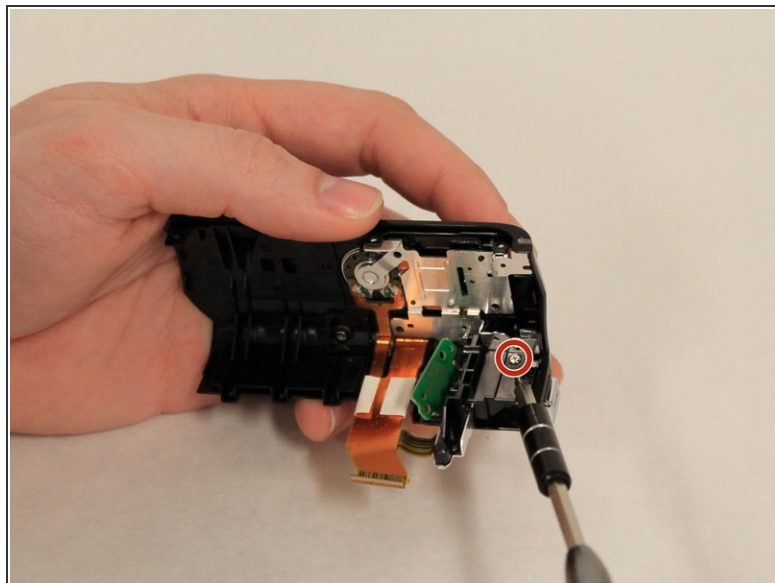
Step 15

- Holding the full top piece remove the six 5mm Philips #000 screws holding the metal frame to the top piece.

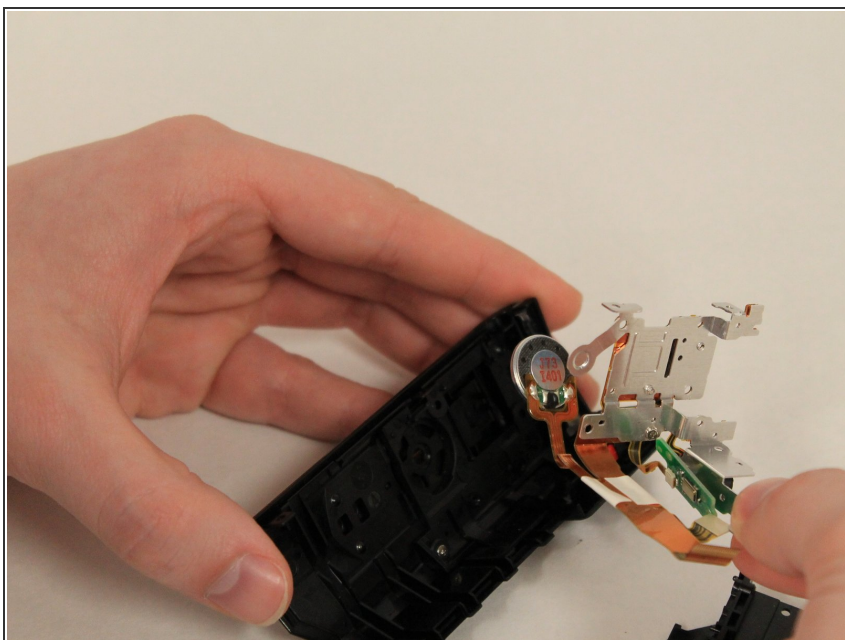
Step 16

- Carefully remove the the whole metal frame out of the device piece.

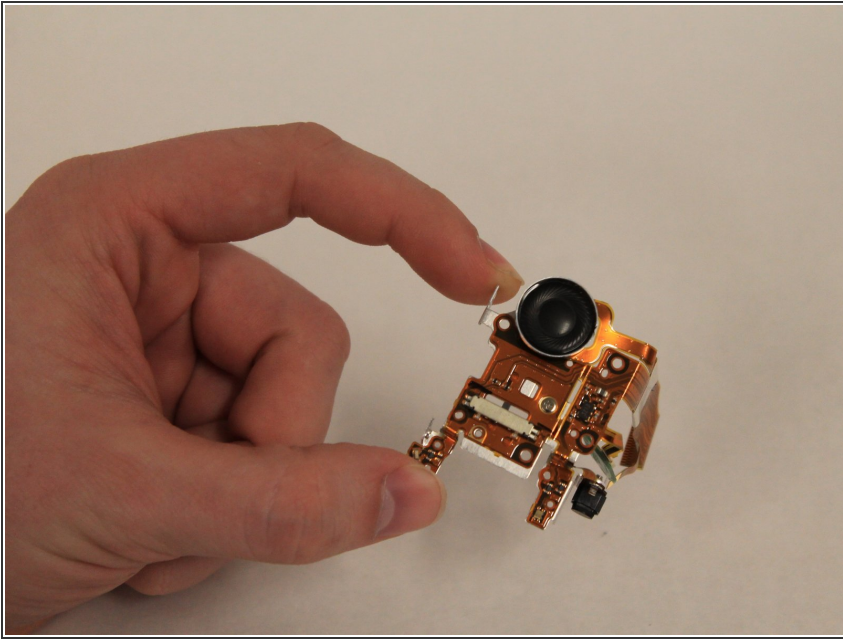
Step 17

- Replace the defective speaker with a functioning one.

To reassemble your device, follow these instructions in reverse order.
